# Aquatic Plant Point-Intercept Survey for Haas Lake, Scott County, Minnesota

[Plant Survey Conducted August 29, 2017]

Prepared for:  
Prior Lake-Spring Lake  
Watershed District

Prepared by:  
Steve McComas  
Jo Stuckert  
Blue Water Science

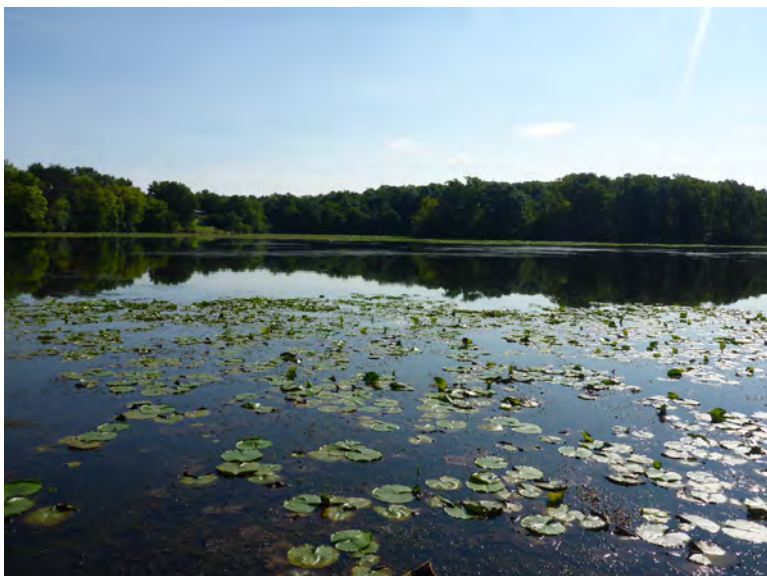
**Figure S1. White lilies were widespread in Haas lake.**

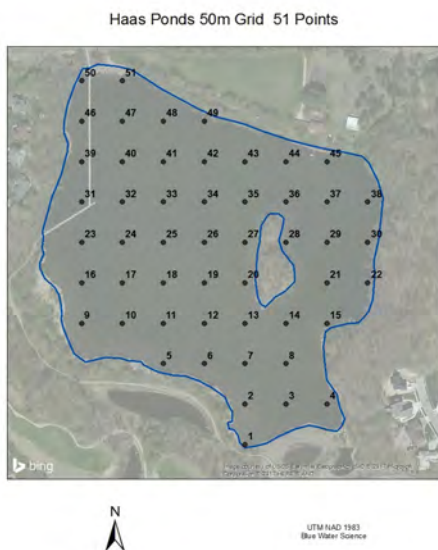
Figure 1. Sample location map for the aquatic plant survey conducted on Haas Lake.

An aquatic plant point-intercept survey of Haas Lake was conducted by Blue Water Science on August 29, 2017 and 51 points were sampled. Sample points were placed 50 meters apart on a grid that covered the lake (Figure 1). At each sample point, a sampling rake was lowered into the water and a plant sample was taken. The plant species were recorded and the density of each species was assigned. Densities were based on the coverage on the teeth of the rake. Density ratings were from 1 to 4 with 1 being sparse and 4 being a nuisance. Based on these sample sites, a plant distribution map was constructed.

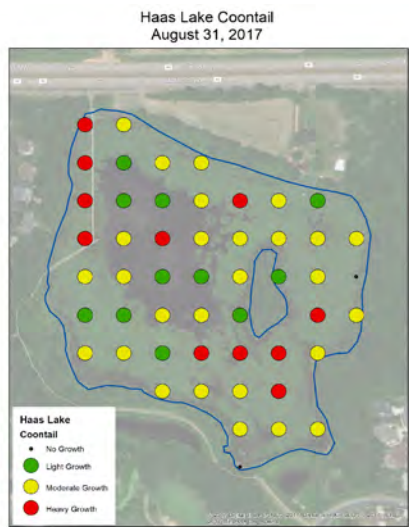
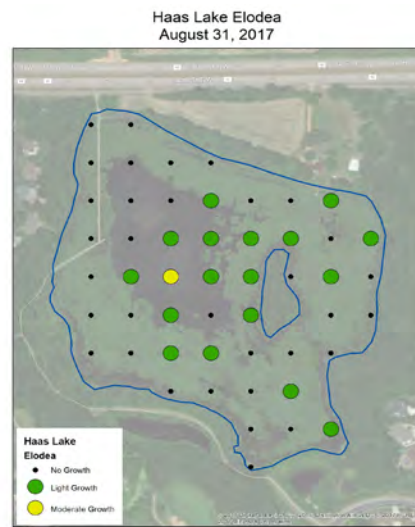
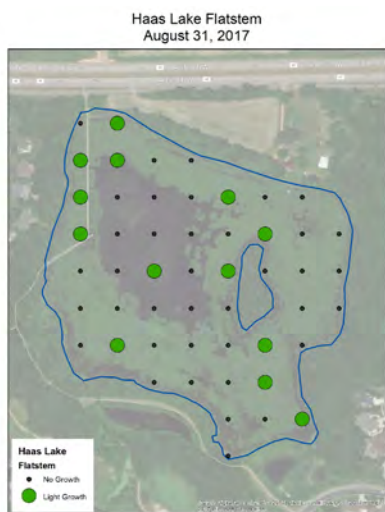
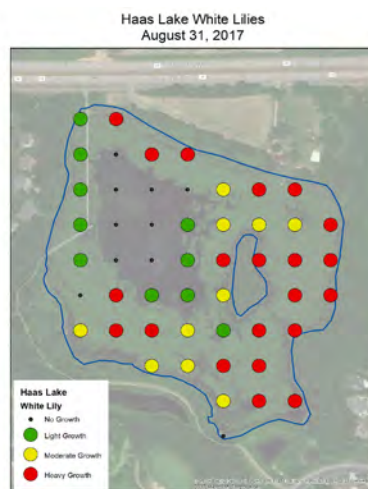
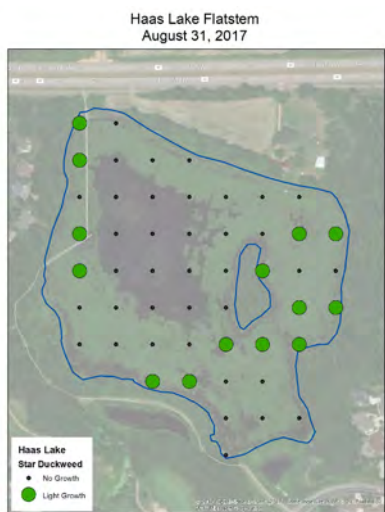
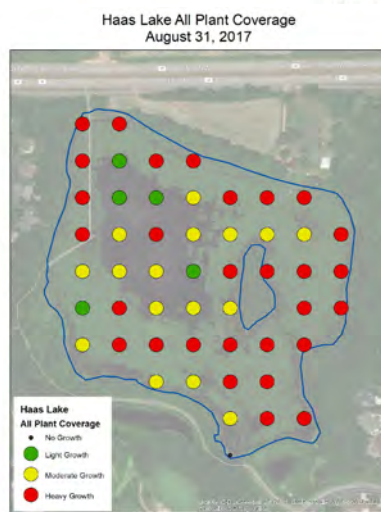
Figure 2. Haas Lake aquatic plant coverage maps. For individual species maps: green = light growth, yellow = moderate growth, and red = heavy growth.

Results of the summer aquatic plant survey conducted on August 29, 2017 found there were 3 submerged plant species (Table 1)(Figure 2). Coontail was the dominant plant. Aquatic plant coverage was about 98% of the lake area.

Maps of the distribution and abundance for each plant species are shown in Figure 2.
