# Aquatic Plant Survey for Pike Lake, Scott County, Minnesota

[Plant Survey Conducted August 6, 2012]

Prepared for:  
Prior Lake/Spring Lake  
Watershed District

Prepared by:  
Steve McComas  
Jo Stuckert  
Blue Water Science

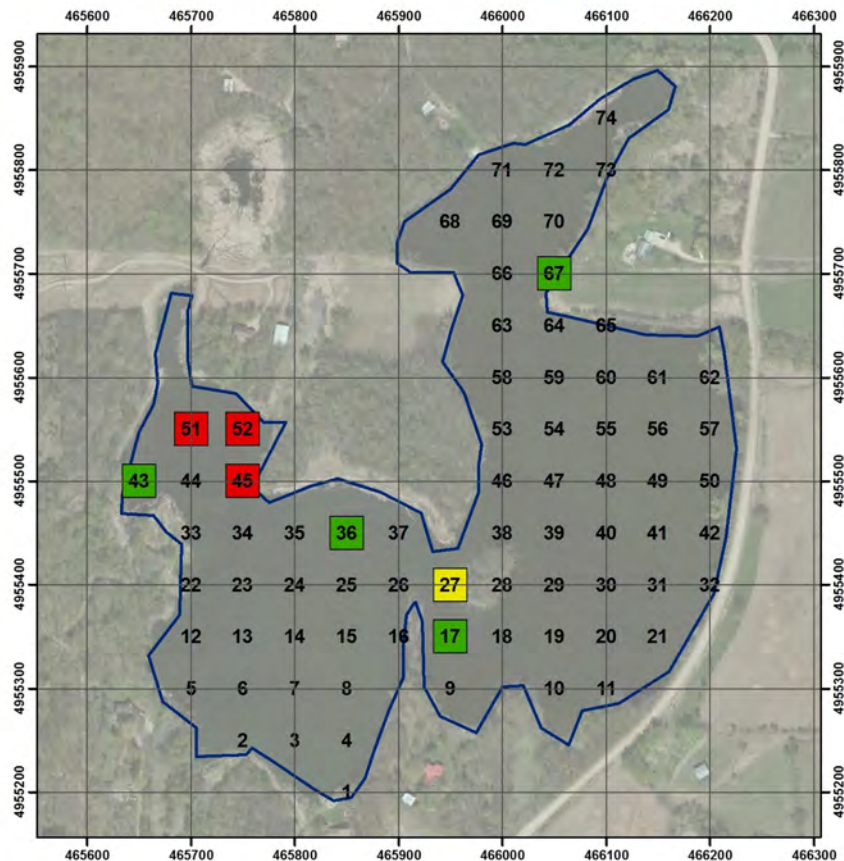
Pike Lake has a low diversity of submerged aquatic plants with four species of submerged plants found in the survey. The submerged plants observed in the survey were coontail, elodea, northern watermilfoil, and sago pondweed (Figure 1). It appears a fifth species, Eurasian watermilfoil, is present in Pike Lake and was observed just north of sample point 37. This is the first time Eurasian watermilfoil has been observed in Pike Lake. All submerged plants were found in water depths of three feet or less. The shoreline was ringed with natural emergent vegetation.

Figure 1. Submerged aquatic plant coverage for Pike Lake on August 6, 2012. Green squares = light growth, yellow squares = moderate growth, and red squares = heavy growth.

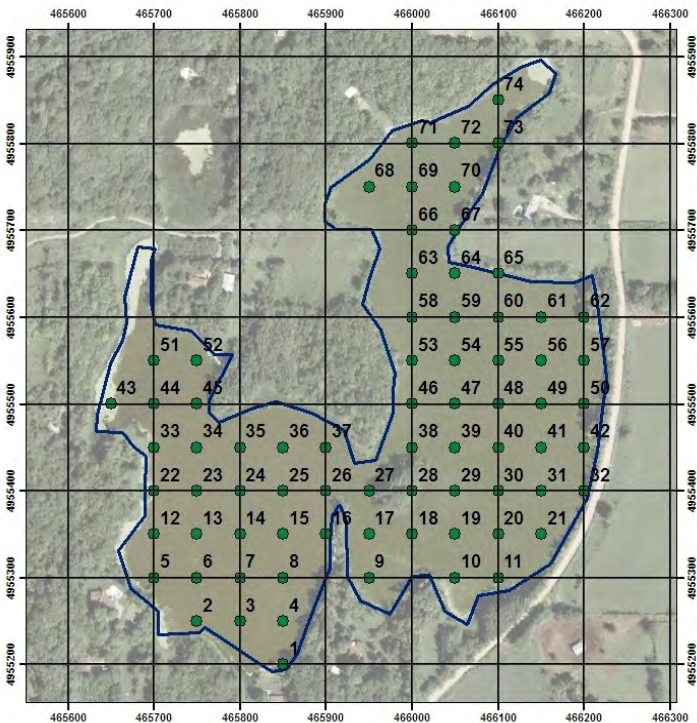
An aquatic plant point-intercept survey of Pike Lake was conducted by Blue Water Science on August 6, 2012, and all 74 points were sampled. Sample points were spaced 50 meters apart on a grid that covered the lake (Figure 1). At each sample point, a sampling rake was lowered into the water and a plant sample was taken. The plant species were recorded and the density of each species was assigned. Densities were based on the coverage on the teeth of the rake. Density ratings ranged from 1 to 5 with 1 being sparse and 5 being heavy growth. Based on these sample sites, a plant distribution map was constructed.

Figure 1. Sample location map for the aquatic plant survey conducted on Pike Lake.

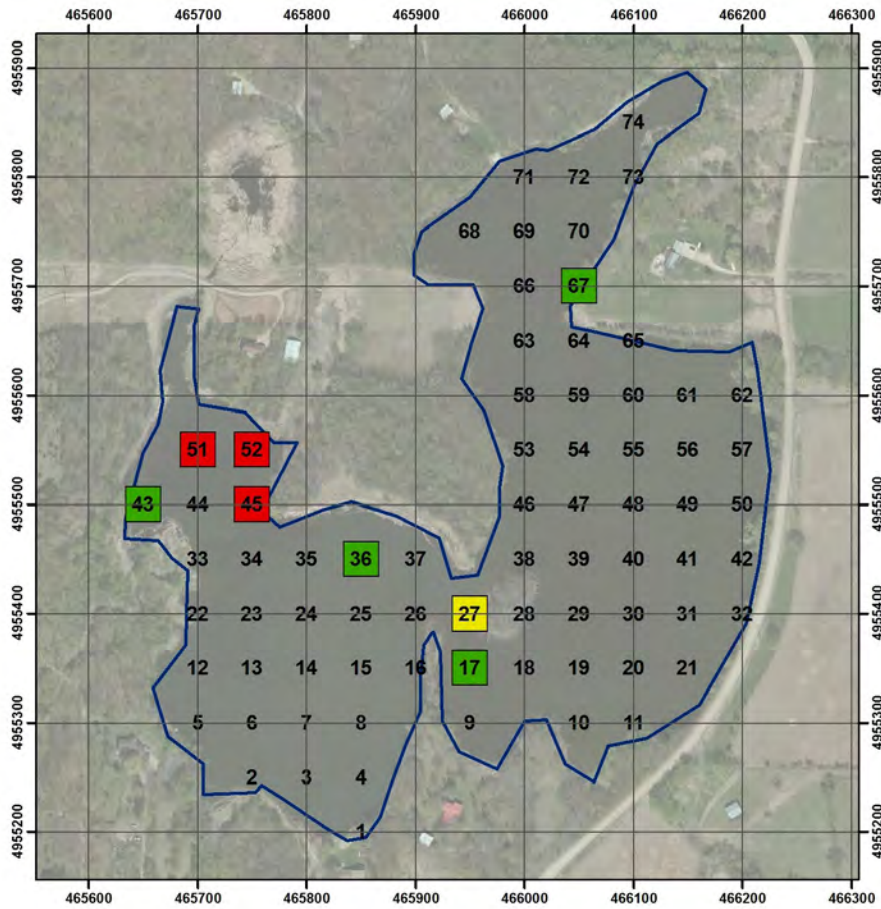
In 2012 four submerged aquatic plants were found in the survey (Figures 2 and 3) with a fifth species, Eurasian watermilfoil, found at one location north of point 37. However, abundant native emergent plants were found around the perimeter of Pike Lake.

Figure 2. Native submerged aquatic plant coverage for Pike Lake on August 6, 2012. Green squares = light growth, yellow squares = moderate growth, and red squares = heavy growth.

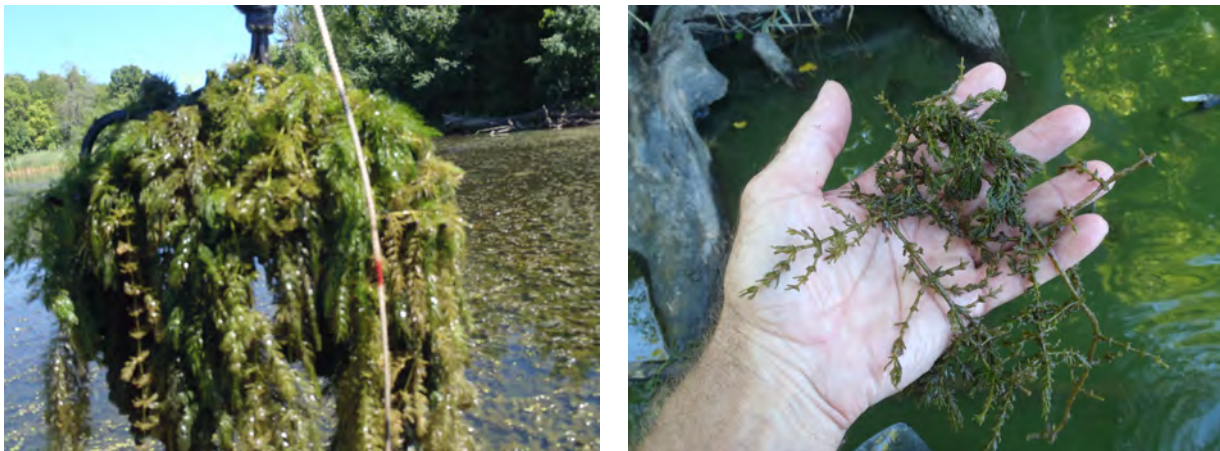
Figure 3. [left] Aquatic plants were sparse in Pike Lake but coontail was abundant in the shallow northwest bay. [right] In shallow water at site 67 coontail was present but was not abundant.

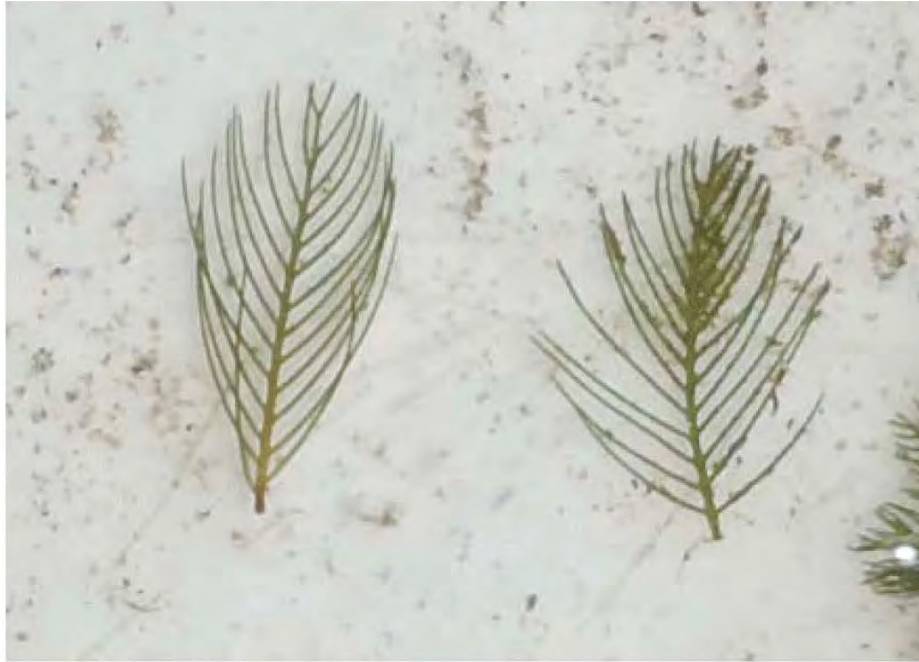
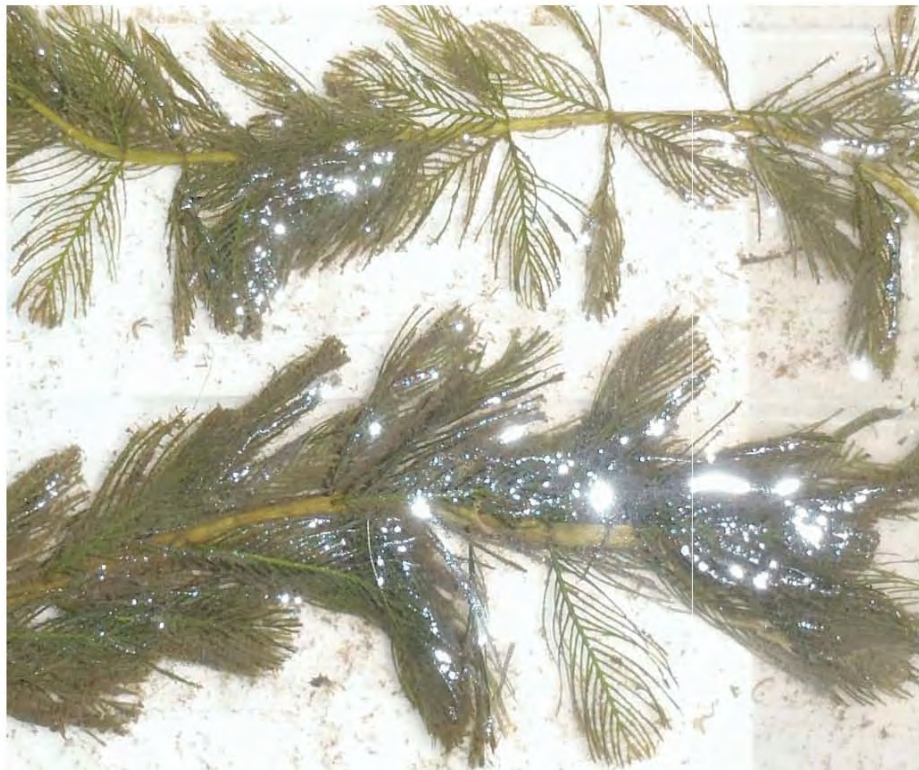
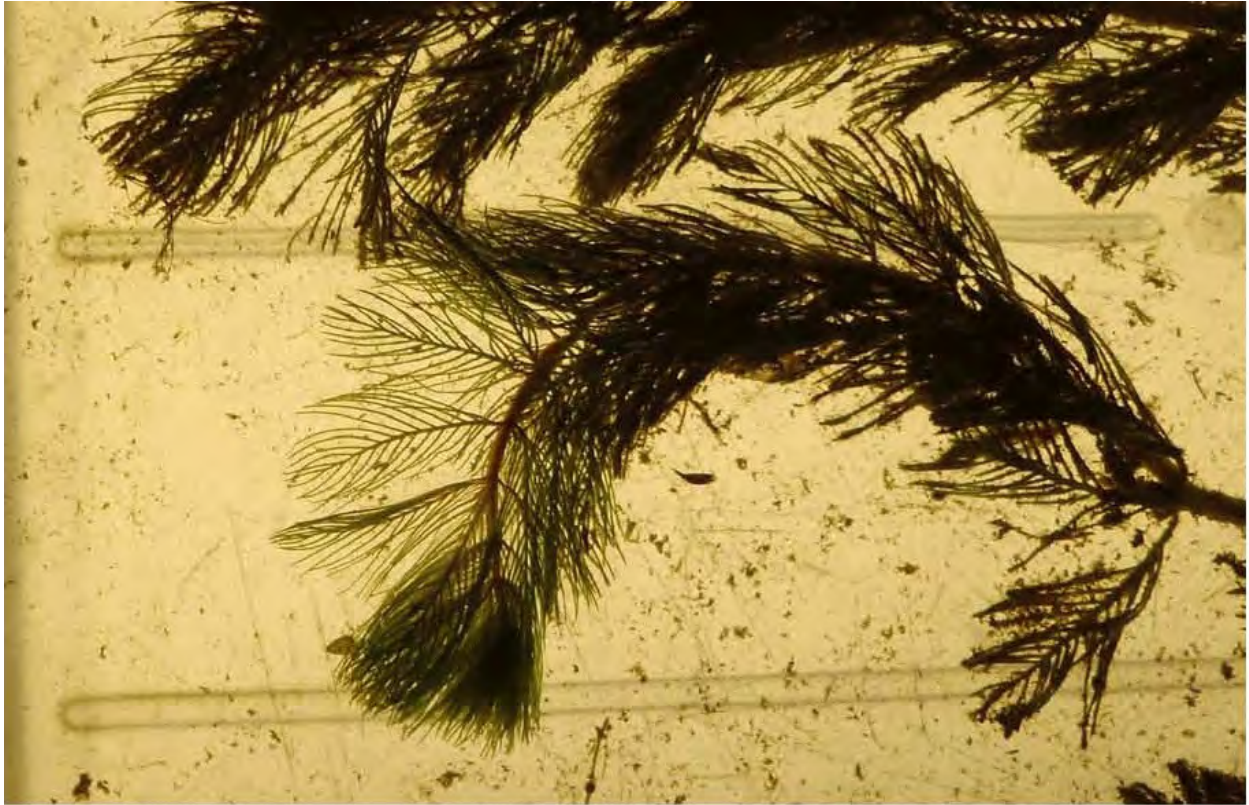
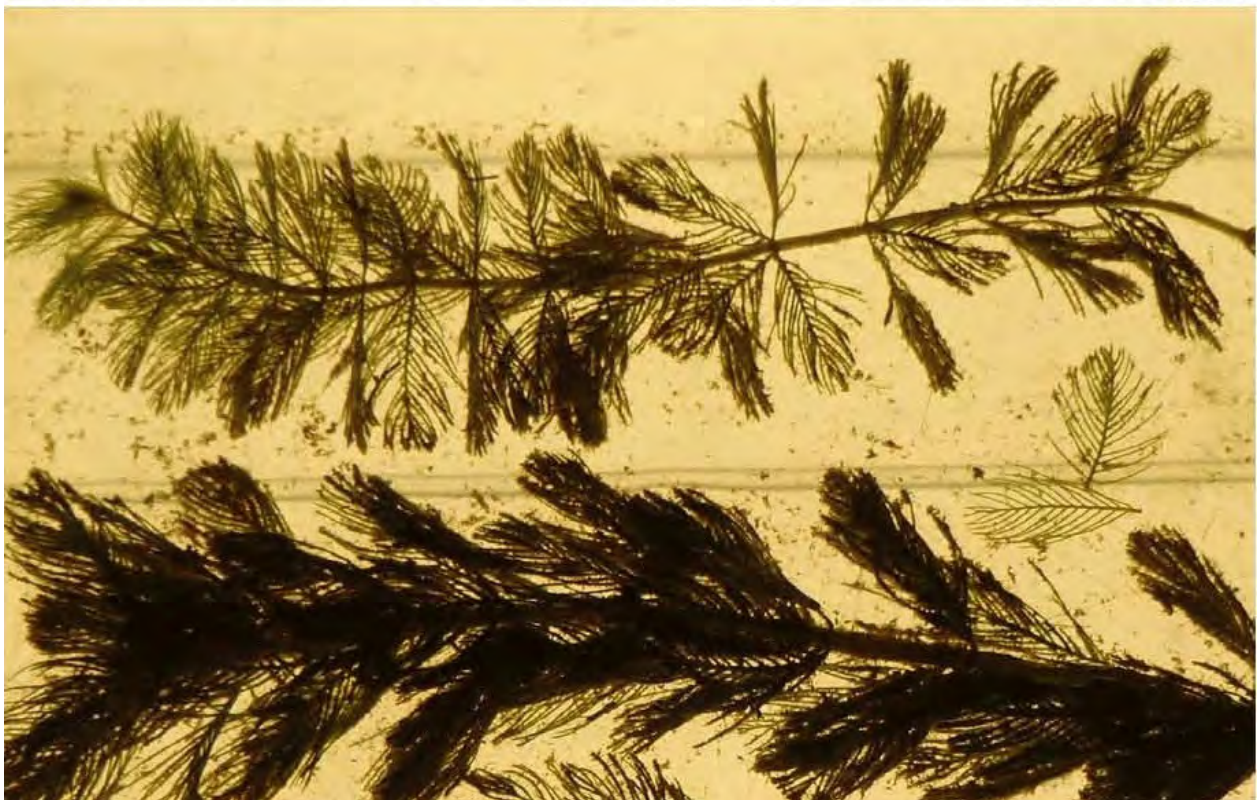
Eurasian watermilfoil was observed in this survey, however it was not found at a sample site on the grid, but rather north of sample point 37.

Suspected Eurasian watermilfoil, *Myriophyllum spicatum*, observation

**Eurasian watermilfoil collected in Pike Lake on August 6, 2012.**

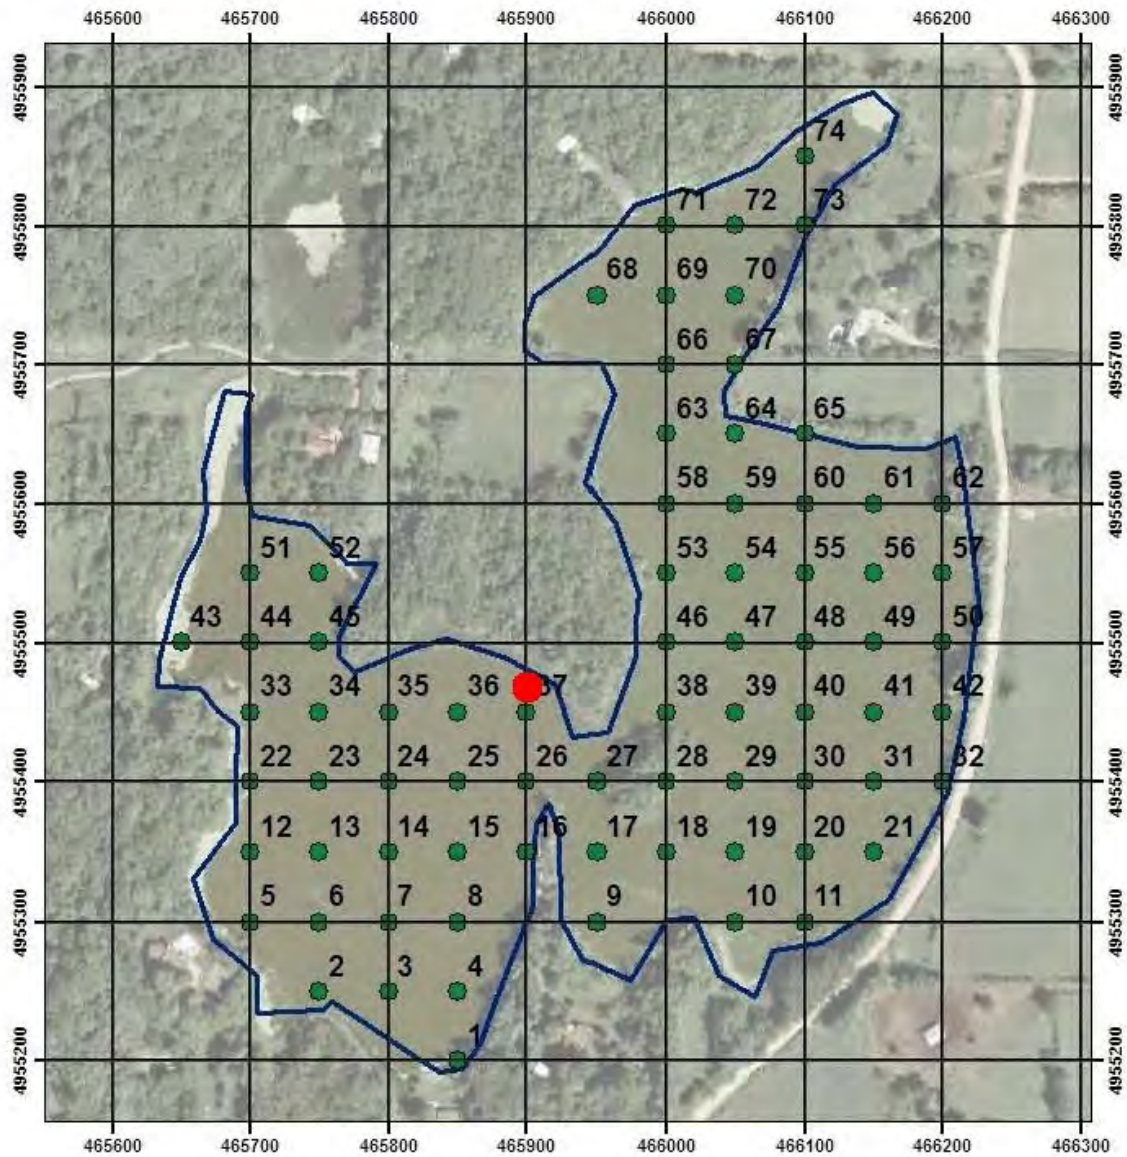
● Red dot indicates location of suspected Eurasian watermilfoil occurrence.

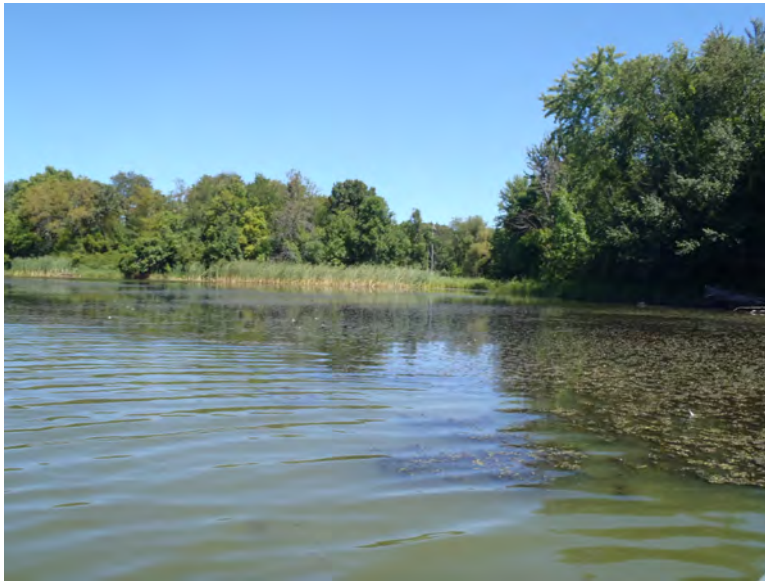
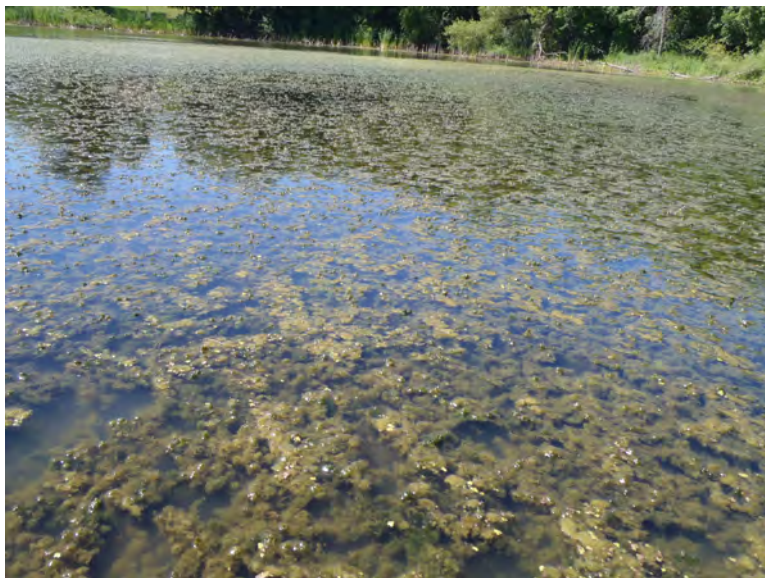
- Emergent plants along the shoreline were abundant and offer good wildlife habitat.
- Submerged plants were found in water depths of three feet or less and were scarce except for the shallow northwest bay where coontail was growing to the surface in shallow water (Figure 4). Coontail was the dominant plant in the lake. The reasons for low plant abundance are likely a combination of low light penetration and the impact of bottom feeding fish such as carp.
- An increase in submerged plants probably will not occur unless the roughfish population in Pike Lake is reduced.

- The first observation of Eurasian watermilfoil was found in the western side of the lake, on the northern shoreline in several small patches.

**Figure 4. [top] Most of the shoreline of Pike Lake is in a natural state. [bottom] Coontail, a native submerged aquatic plant, was abundant in a few sites, especially in the northwest bay in Pike Lake in 2012.**
