Prepared by Emmons & Olivier Resources, Inc.
Prepared for Prior Lake-Spring Lake Watershed District
Adopted by PLSLWD Board of Managers March 8, 2022

Sutton Lake Iron Enhanced Sand Filter

Feasibility Study

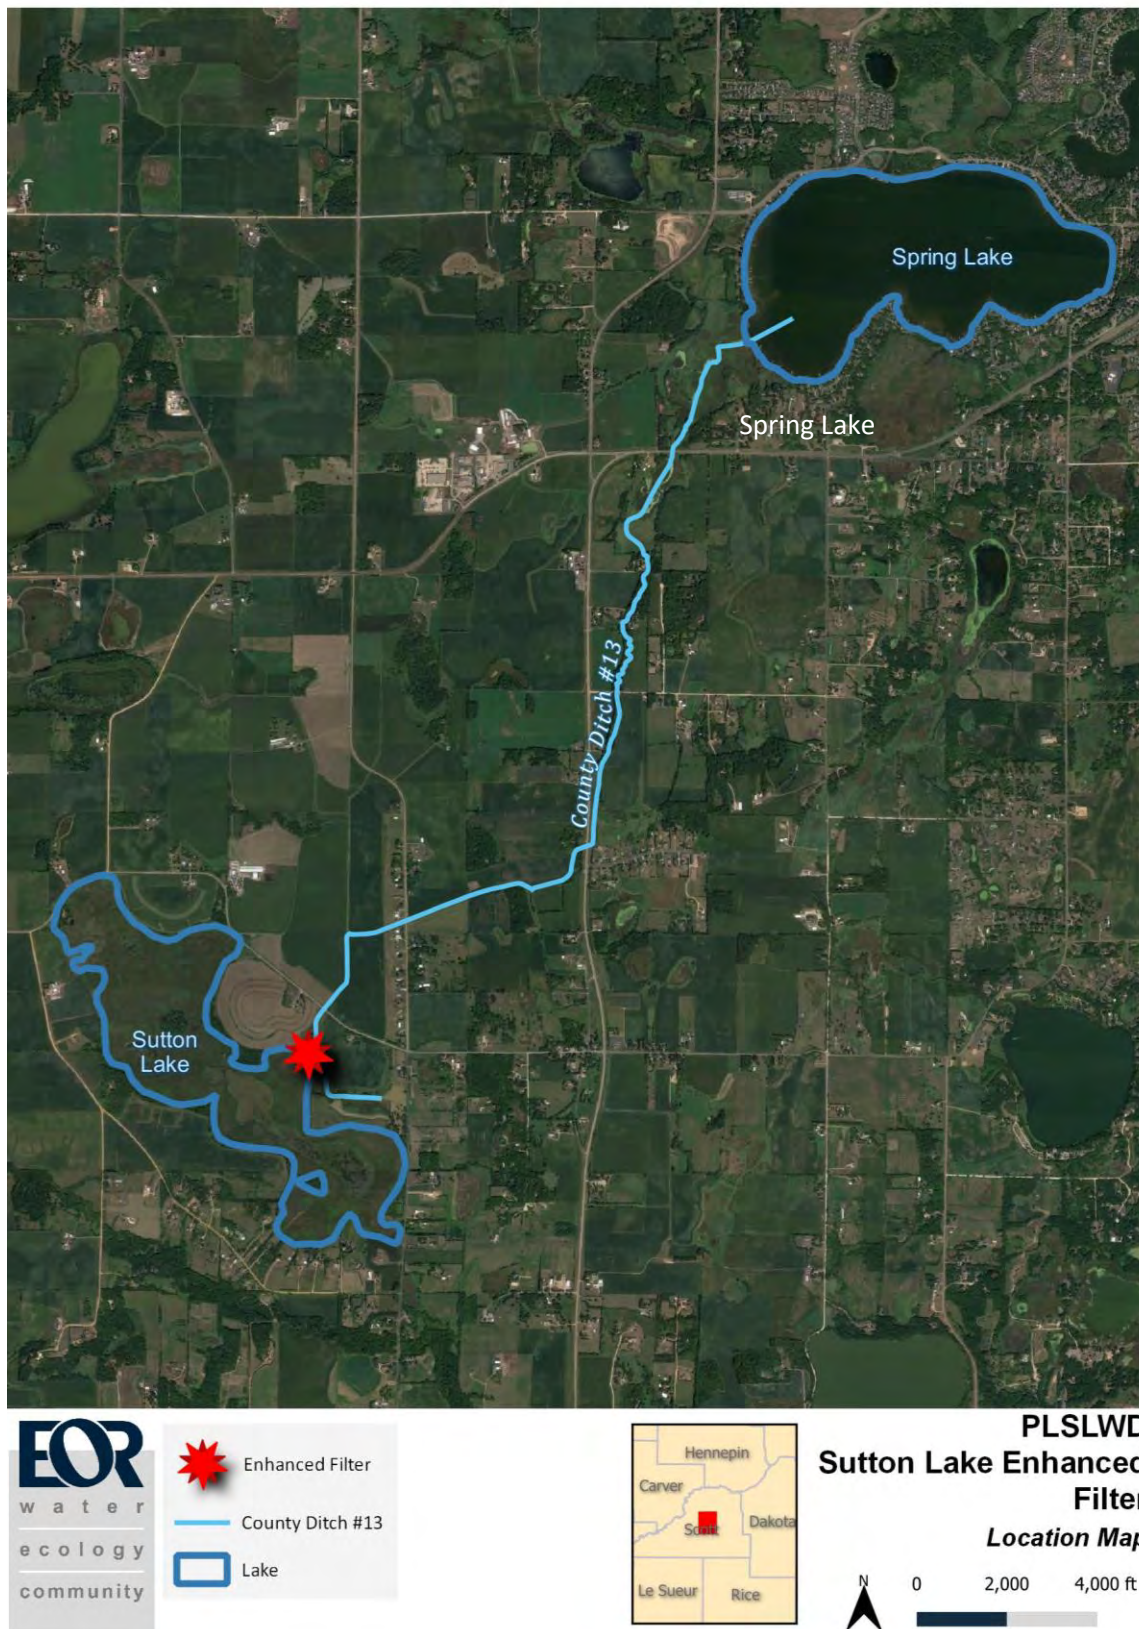
Figure 1. Sutton Lake Iron Enhanced Sand Filter Location and Flow Path to Spring Lake.

The Prior Lake-Spring Lake Watershed District (PLSLWD) authorized the following study for an iron-enhanced sand filter (IESF) project at the outlet of Sutton Lake, a tributary to Spring Lake (Figure 1). Sutton Lake outflow was estimated to contribute 20% of the external load to Spring Lake, which is impaired for nutrients. PLSLWD recently completed the Upper Watershed Blueprint study to identify potential projects to address flooding and water quality opportunities. The Blueprint indicated that adding an iron-enhanced sand filter at that outlet of Sutton Lake could reduce up to 80% of the total phosphorus (TP) loading from the lake.

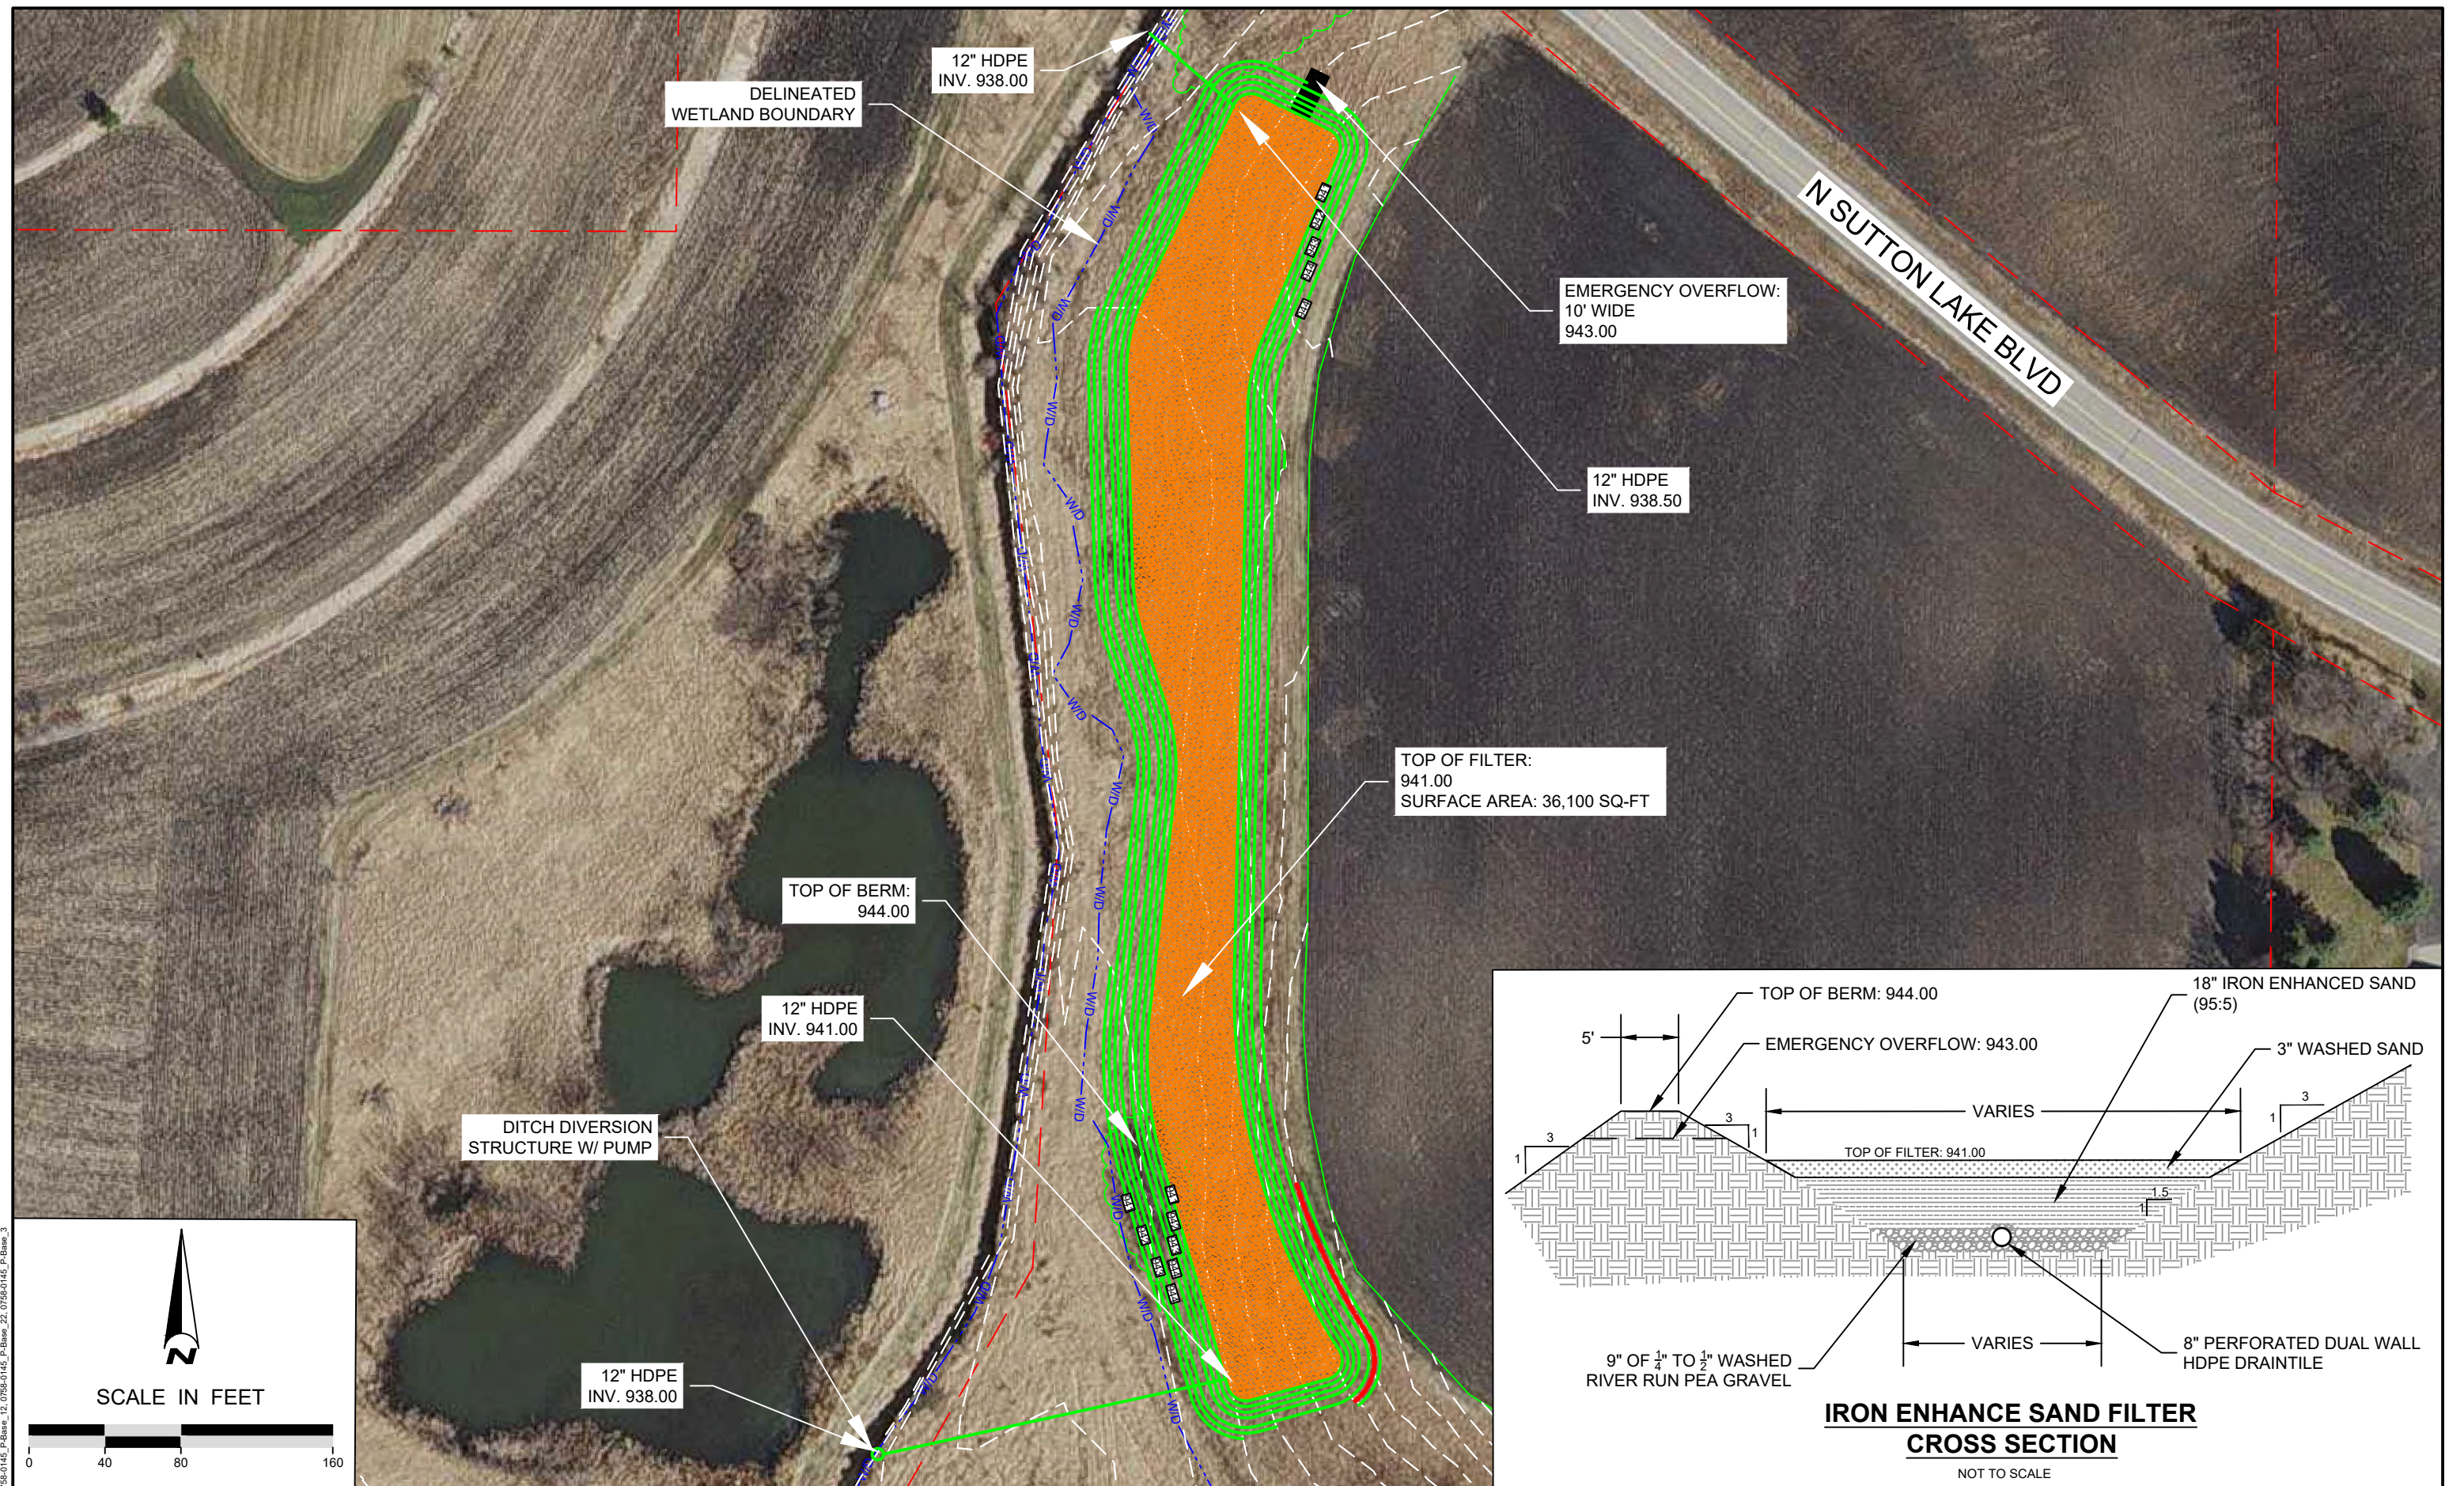
| IRON ENHANCED SAND FILTER - ITERATION 1 | |

Design Iteration #1 was developed creating a standard IESF in an area of land preferred by the landowner representative. This area was just east of the existing ditch that outlets from Sutton Lake and south of North Sutton Lake Blvd. Siting the filter footprint was guided by the constraints of the draft wetland boundary along the ditch and not impacting the farm field to the east. This area yielded a filter size of 36,100 sq-ft. This iteration would have a ditch diversion structure direct base flows and a portion of storm flows to the filter. The structure would include a pump to pull water from the channel to the filter surface. A pump was necessary because this filter was designed at the highest elevation possible to reduce excavation as much as possible.

From the diversion structure would be a 12" HDPE pipe to the filter which has a capacity of about 5 cfs depending on final layout. All water would flow through the filter until the discharge to the filter exceeds the infiltration capacity of the IESF at approximately 2.4 cfs and the head in the filter exceeds the overflow elevation at which point the remaining water would go untreated. Treated water would be captured in the underdrain and directed back to the ditch via a 12" HDPE pipe. The basins would include a 10' wide emergency overflow set at an elevation 1 foot below the top of berm elevation. The overflow would also be directed towards the ditch, to provide a stable outlet for large rainfall events. The filter surface would allow for 2 feet of ponding in the basin before the emergency overflow would be utilized (see Appendix A).

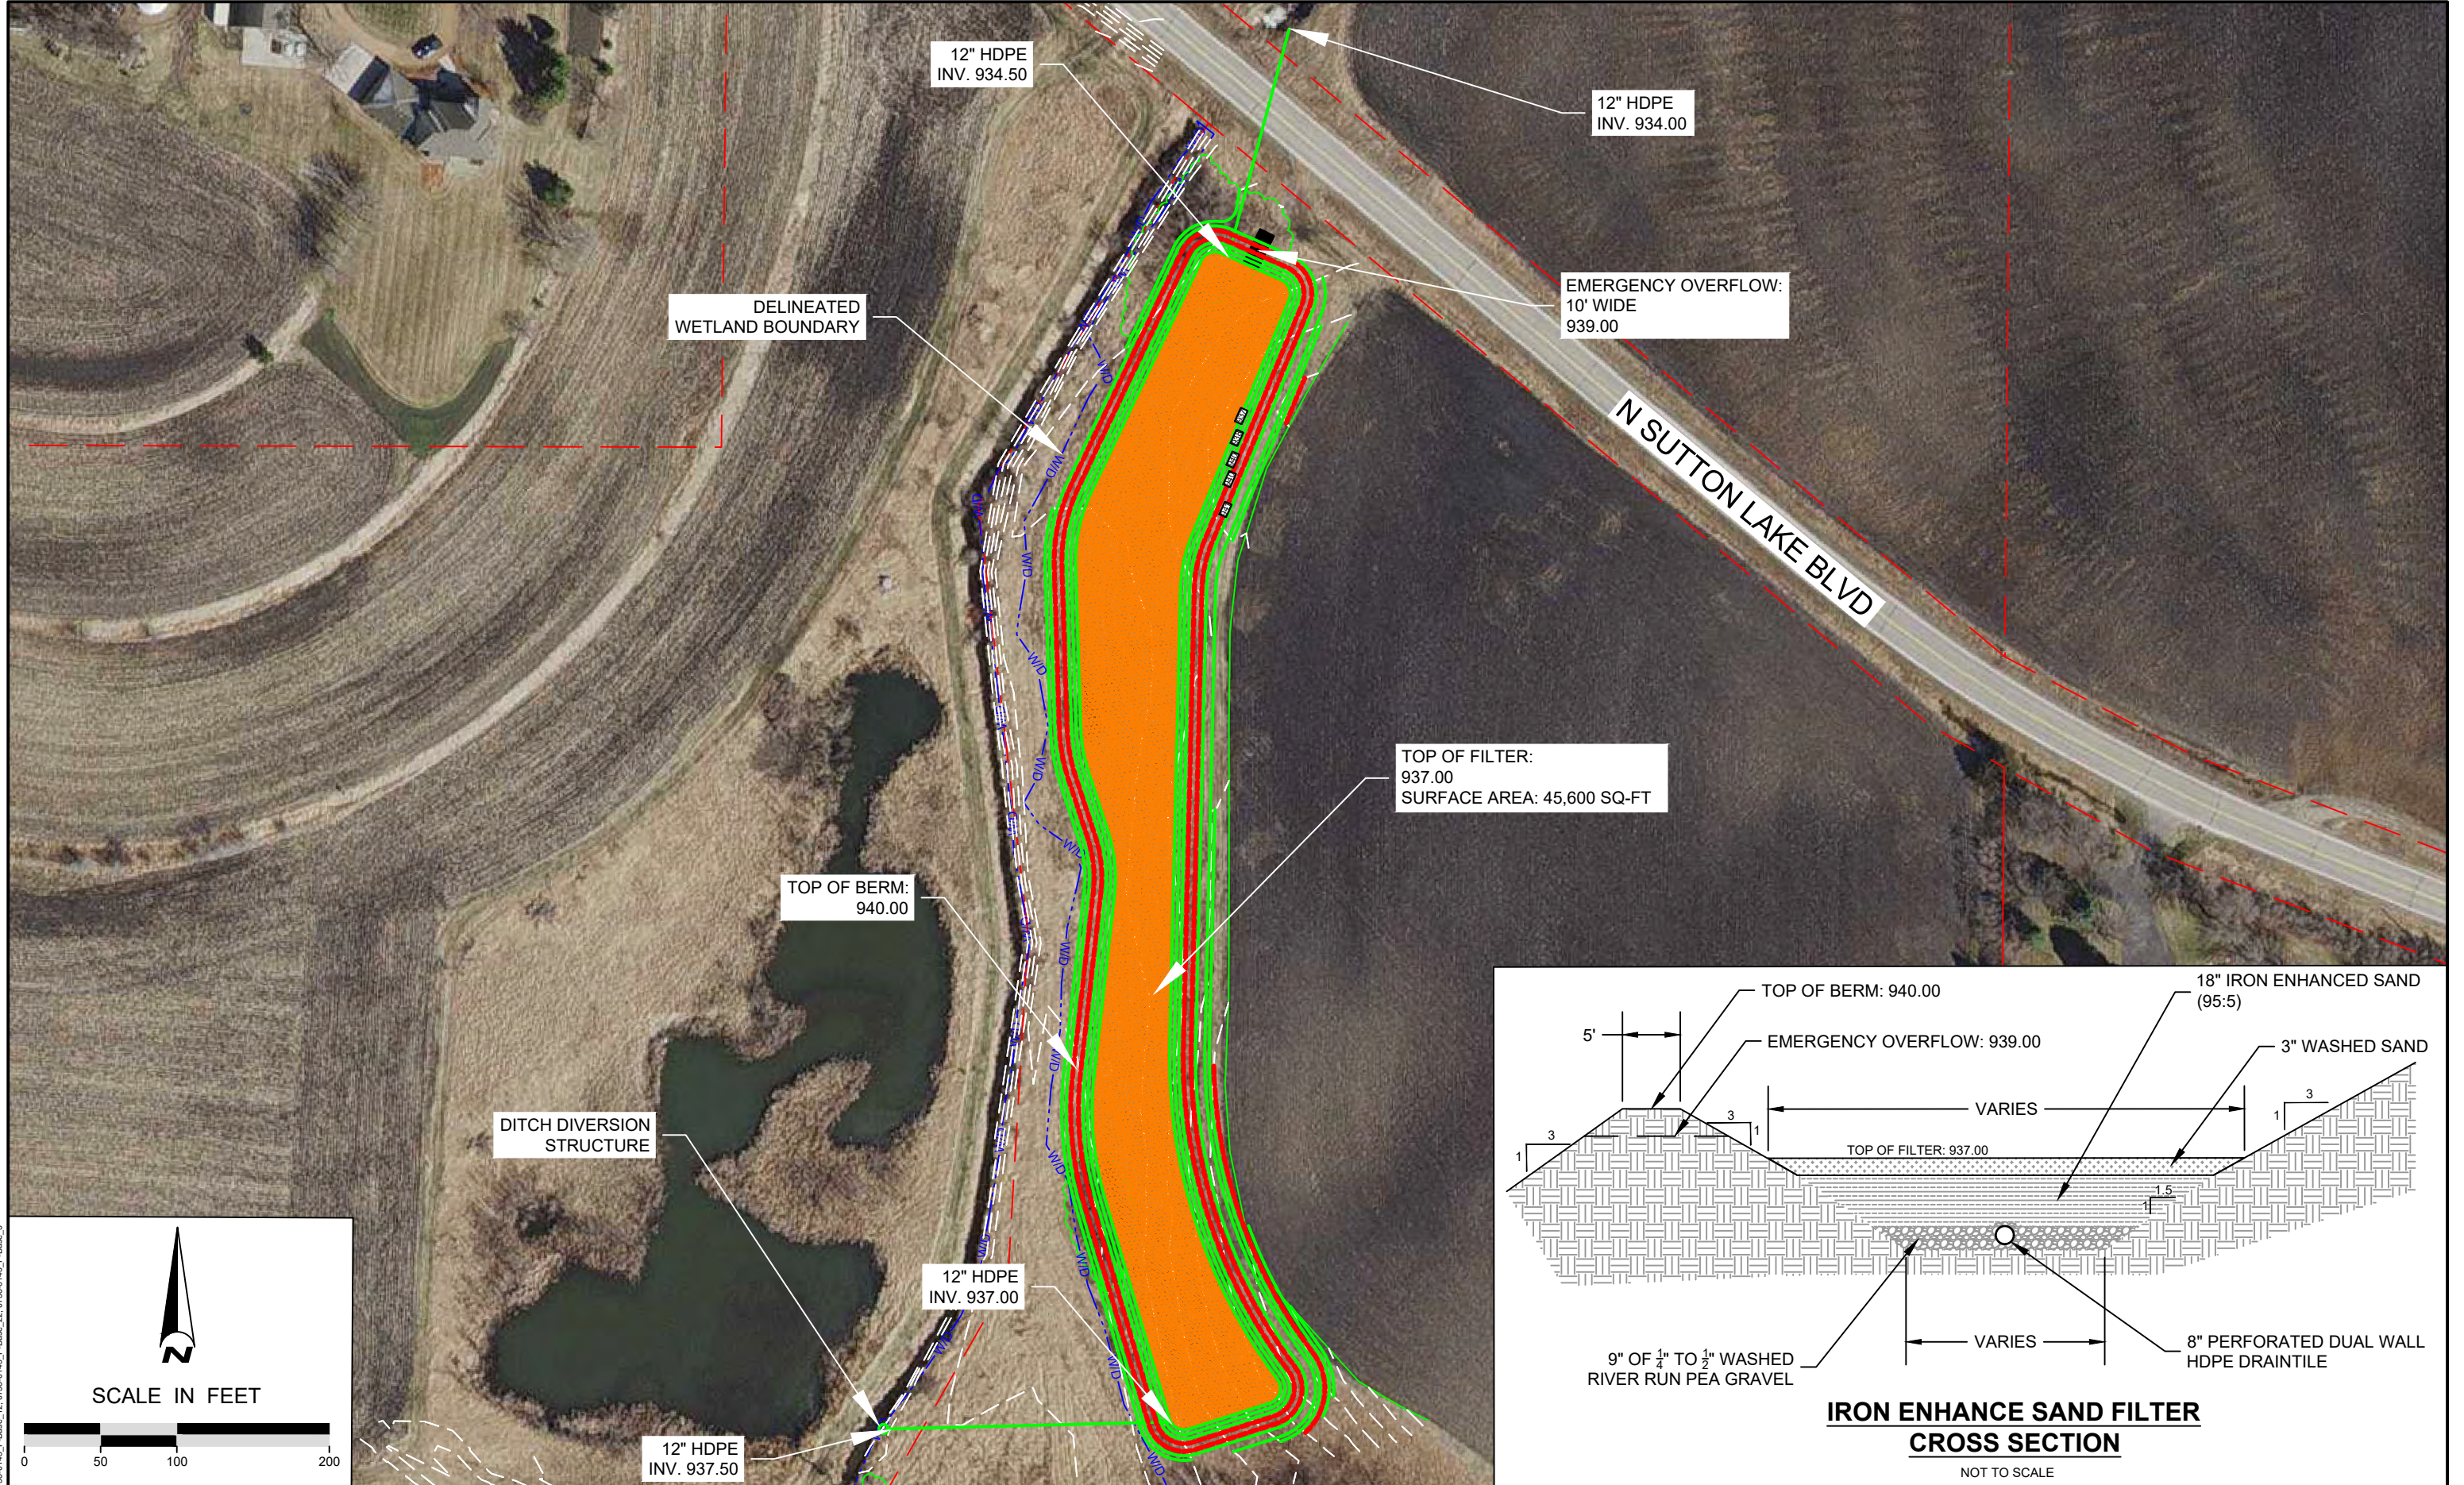
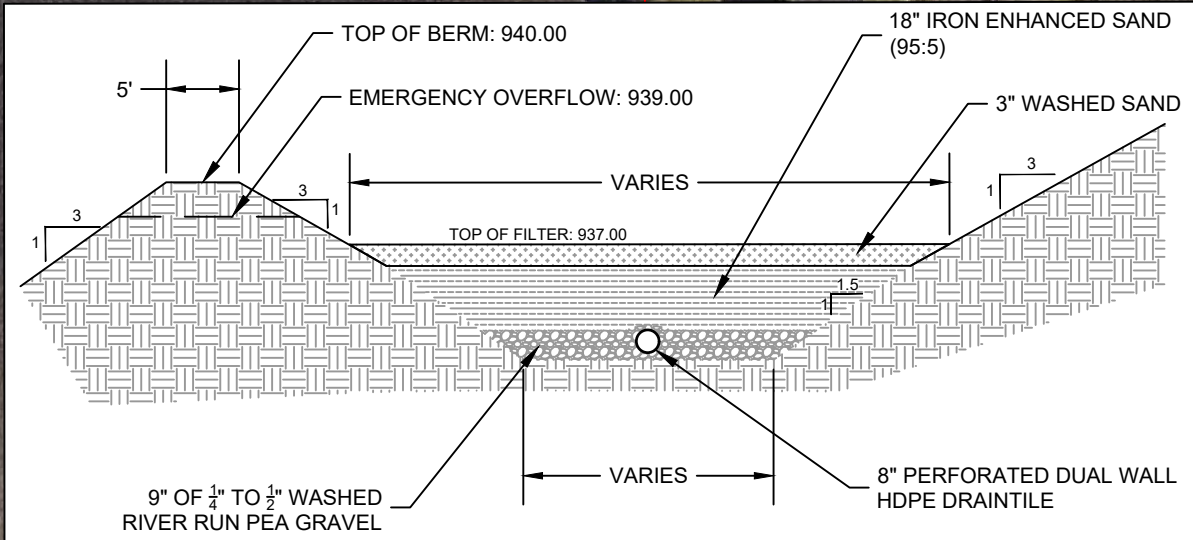
**IRON ENHANCED SAND FILTER
- ITERATION 2**

Design Iteration #2 built upon Iteration #1 with the intent of maximizing filter size to the fullest extent possible without impacting the farm field to the east while also eliminating the need for a pump. Baseflows in this design would be diverted to the filter via gravitational flow due to the filter being at a lower elevation. With this came the need for more excavation. Also with a lower filter, the outlet pipe needed to be lowered, which required the outlet pipe to be directionally bored to the north side of North Sutton Lake Blvd. The filter size for this iteration was increased to 45,600 sq-ft.

**IRON ENHANCE SAND FILTER
CROSS SECTION**

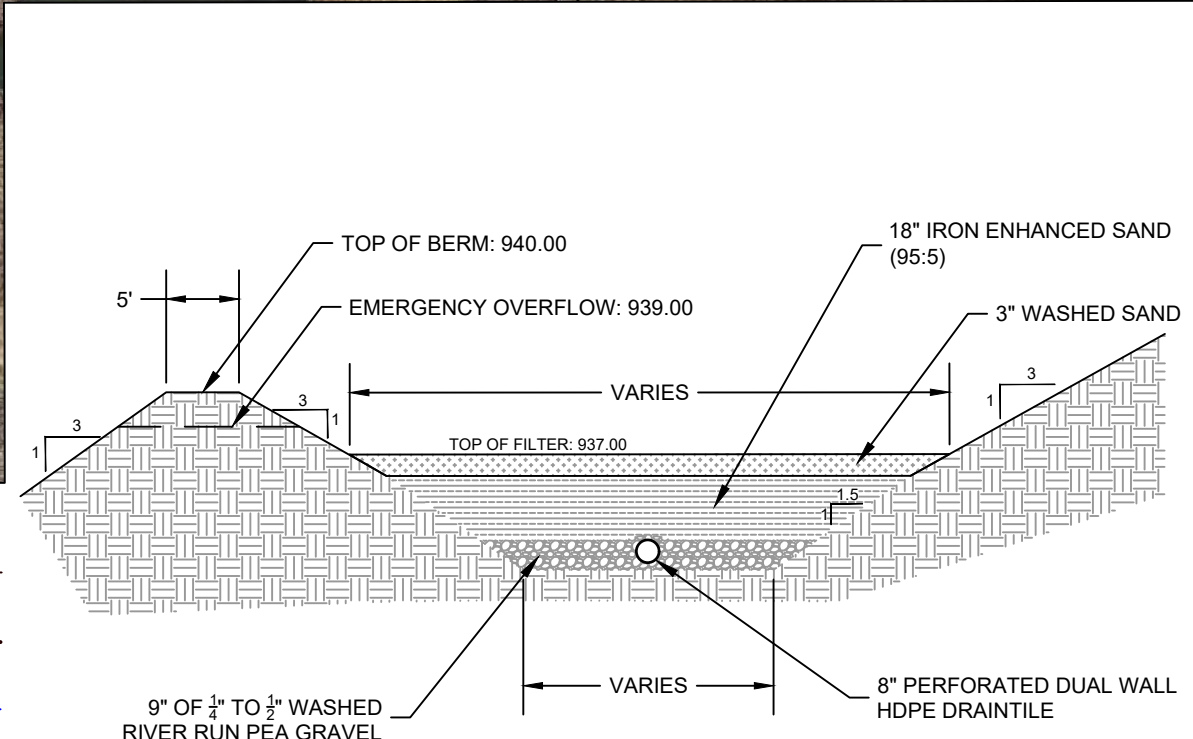
SHEET 03 OF 03 SHEETS

EOR met with District staff and the landowner to review the initial design iterations. Based on this input Design Iteration #3 (the Preferred Alternative) was prepared. Building off of Design Iteration #2, this iteration would also not require a pump but would still require the outlet pipe to be directionally bored under North Sutton Lake Blvd. Also incorporated into this iteration was a wetland depression just south of the IESF. This wetland depression would be connected to the ditch via a diversion structure to provide hydrology to the wetland. The depression would also intercept and treat agricultural runoff from the farm field to the east before entering the ditch. A trail/field access from North Sutton Lake Blvd, around the filter and back across the ditch to where a bridge could be installed (by others) has also been included in the design.

This iteration also includes grading to stabilize any existing ditch banks experiencing failure, and to modify the ditch channel cross section downstream of the diversion to increase channel stability for high flow conveyance. This grading includes impact within delineated wetland, which will require future WCA permitting. Similar to wetland impact associated with construction of the Sutton Lake Outlet, it is anticipated that wetland impacts will be deemed temporary or quality for exemptions. The filter size of this iteration was further increased to 51,500 sq-ft.

This iteration also incorporates a two-cell approach where one cell receives flow for treatment while the other is allowed to dry since IESFs are meant to be aerobic for peak performance. A riprap divide with non-permeable liner is included to separate the cells. The elevation is only 1 ft above the top of filter, so during large storm events both cells will be utilized to maximize removal. This two-cell approach will also be useful to facilitate maintenance.

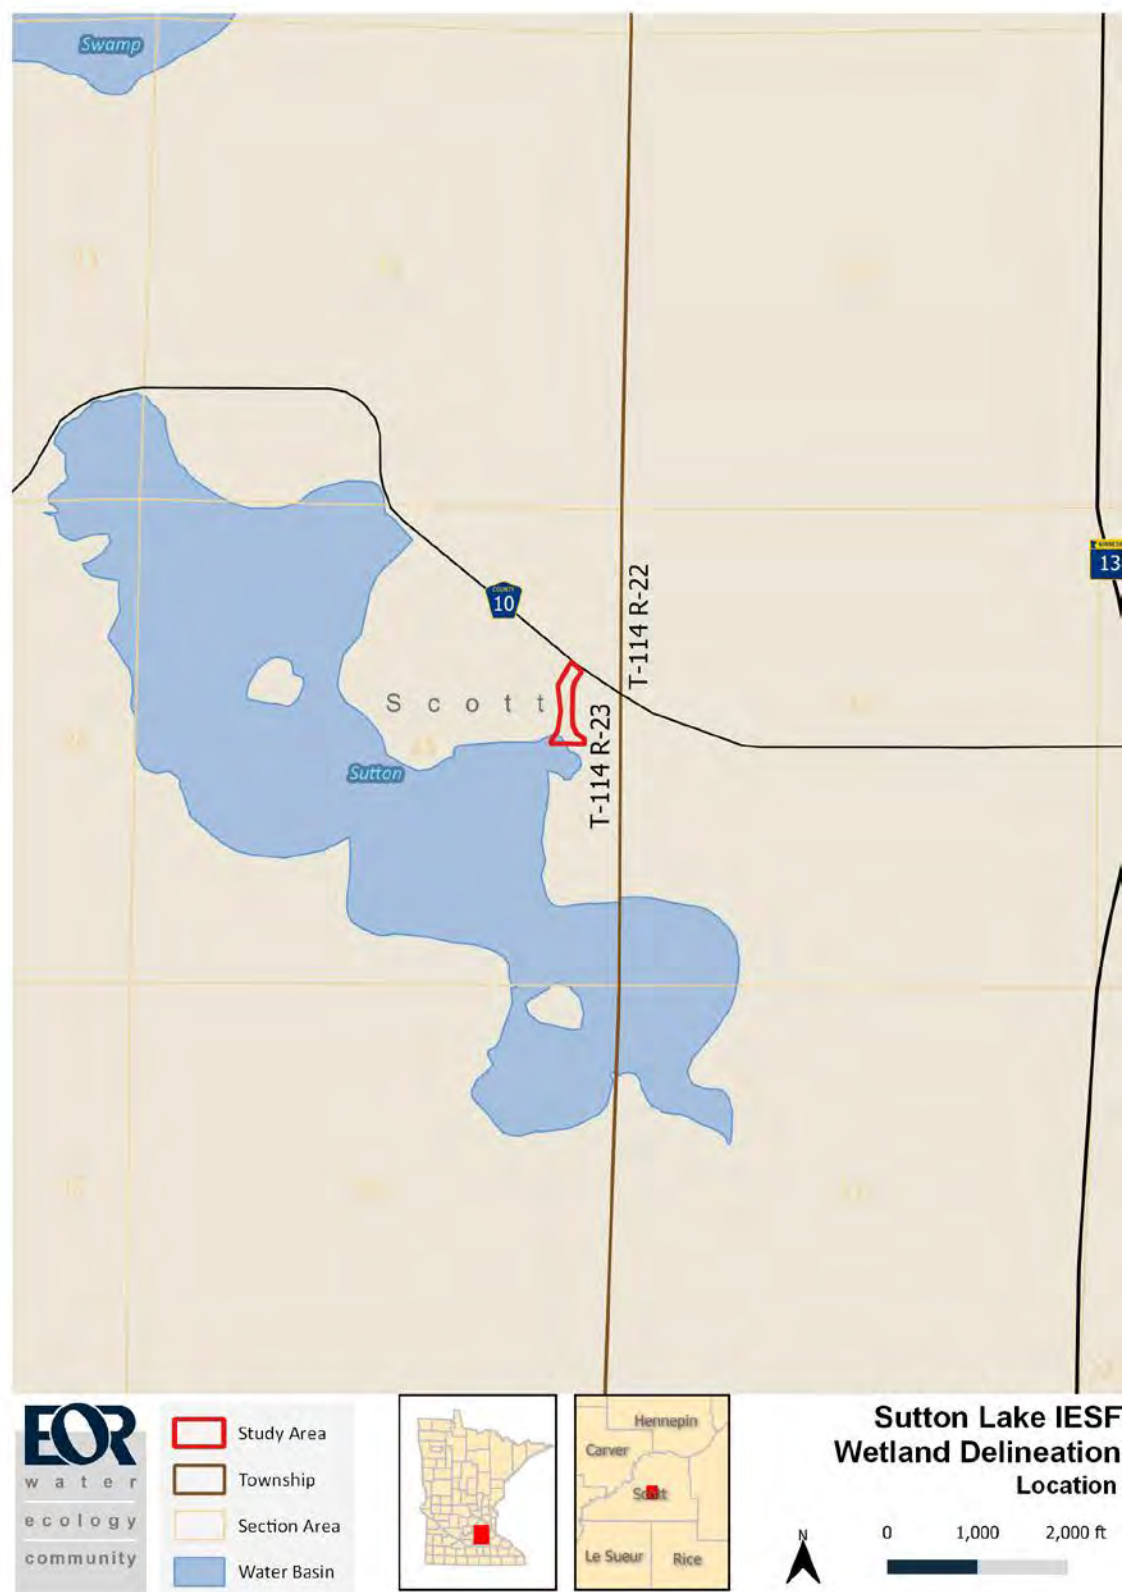
Figure 2. The Study Area is located along the east side of the Sutton Lake outlet channel, just south of County Highway 10 and near the eastern boundary of Sand Creek Township.

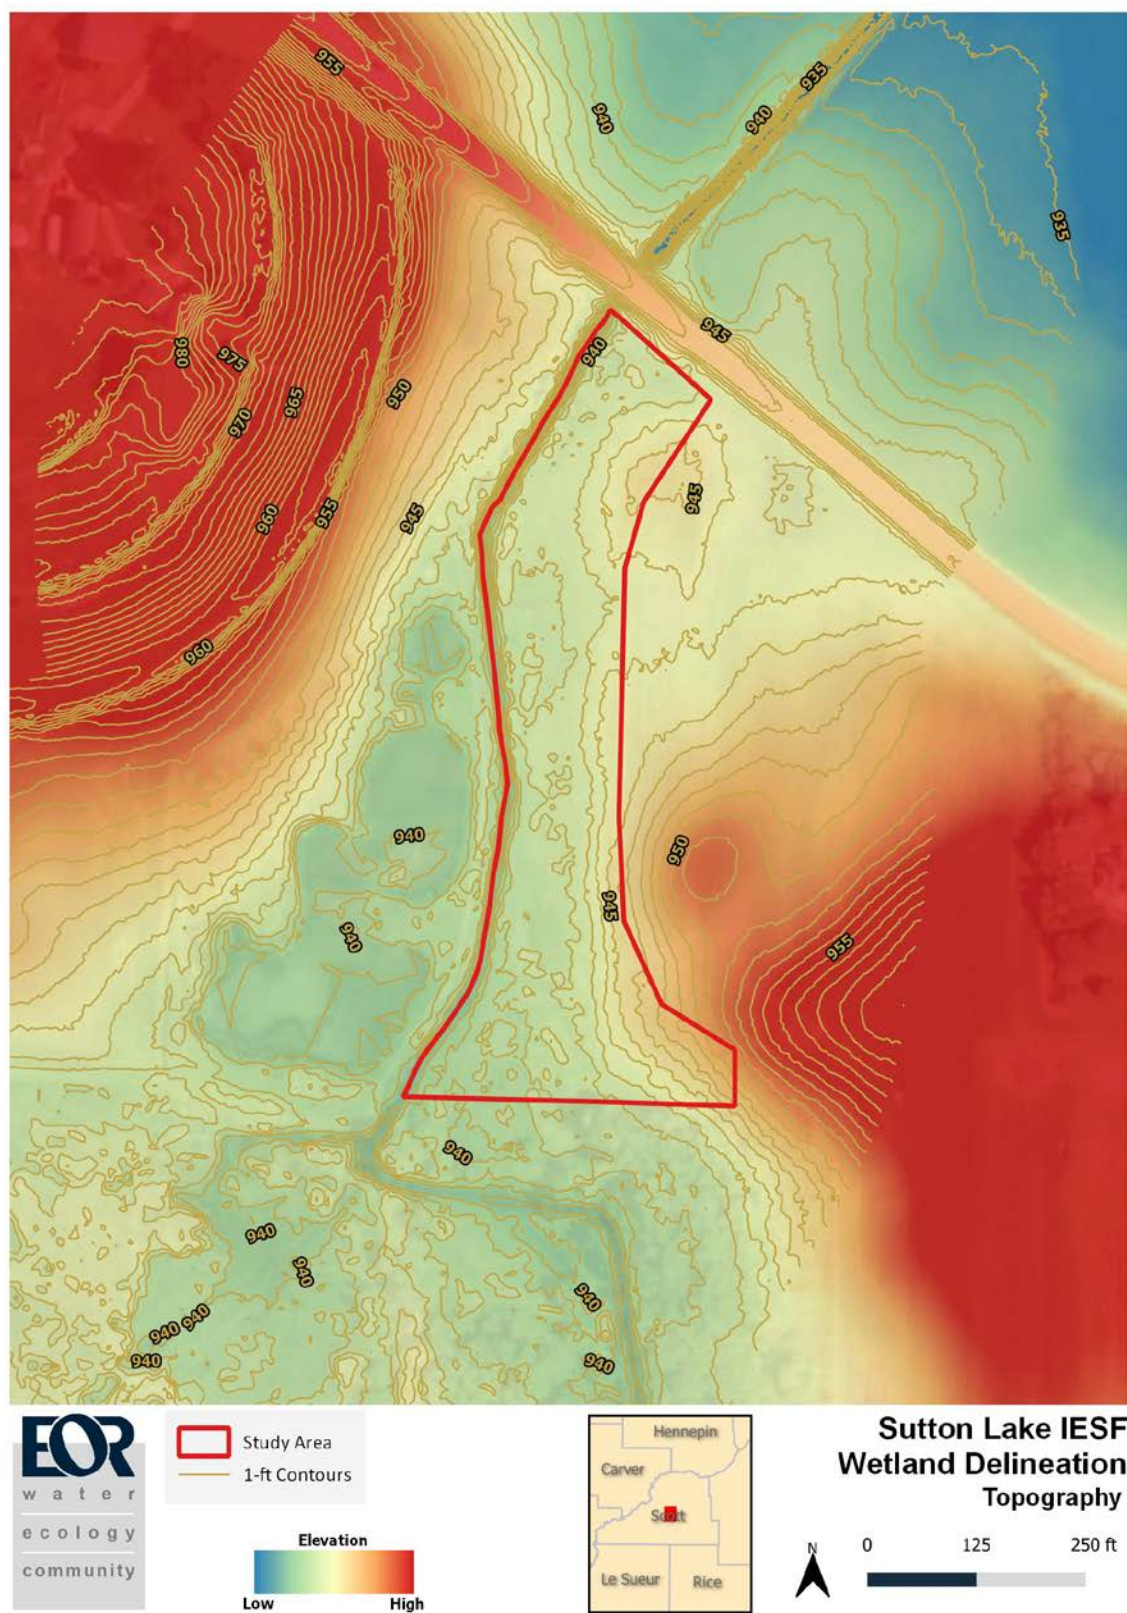
Figure 3. High resolution 1-meter DEM and lidar-derived 1-foot elevation contours for the Study Area.

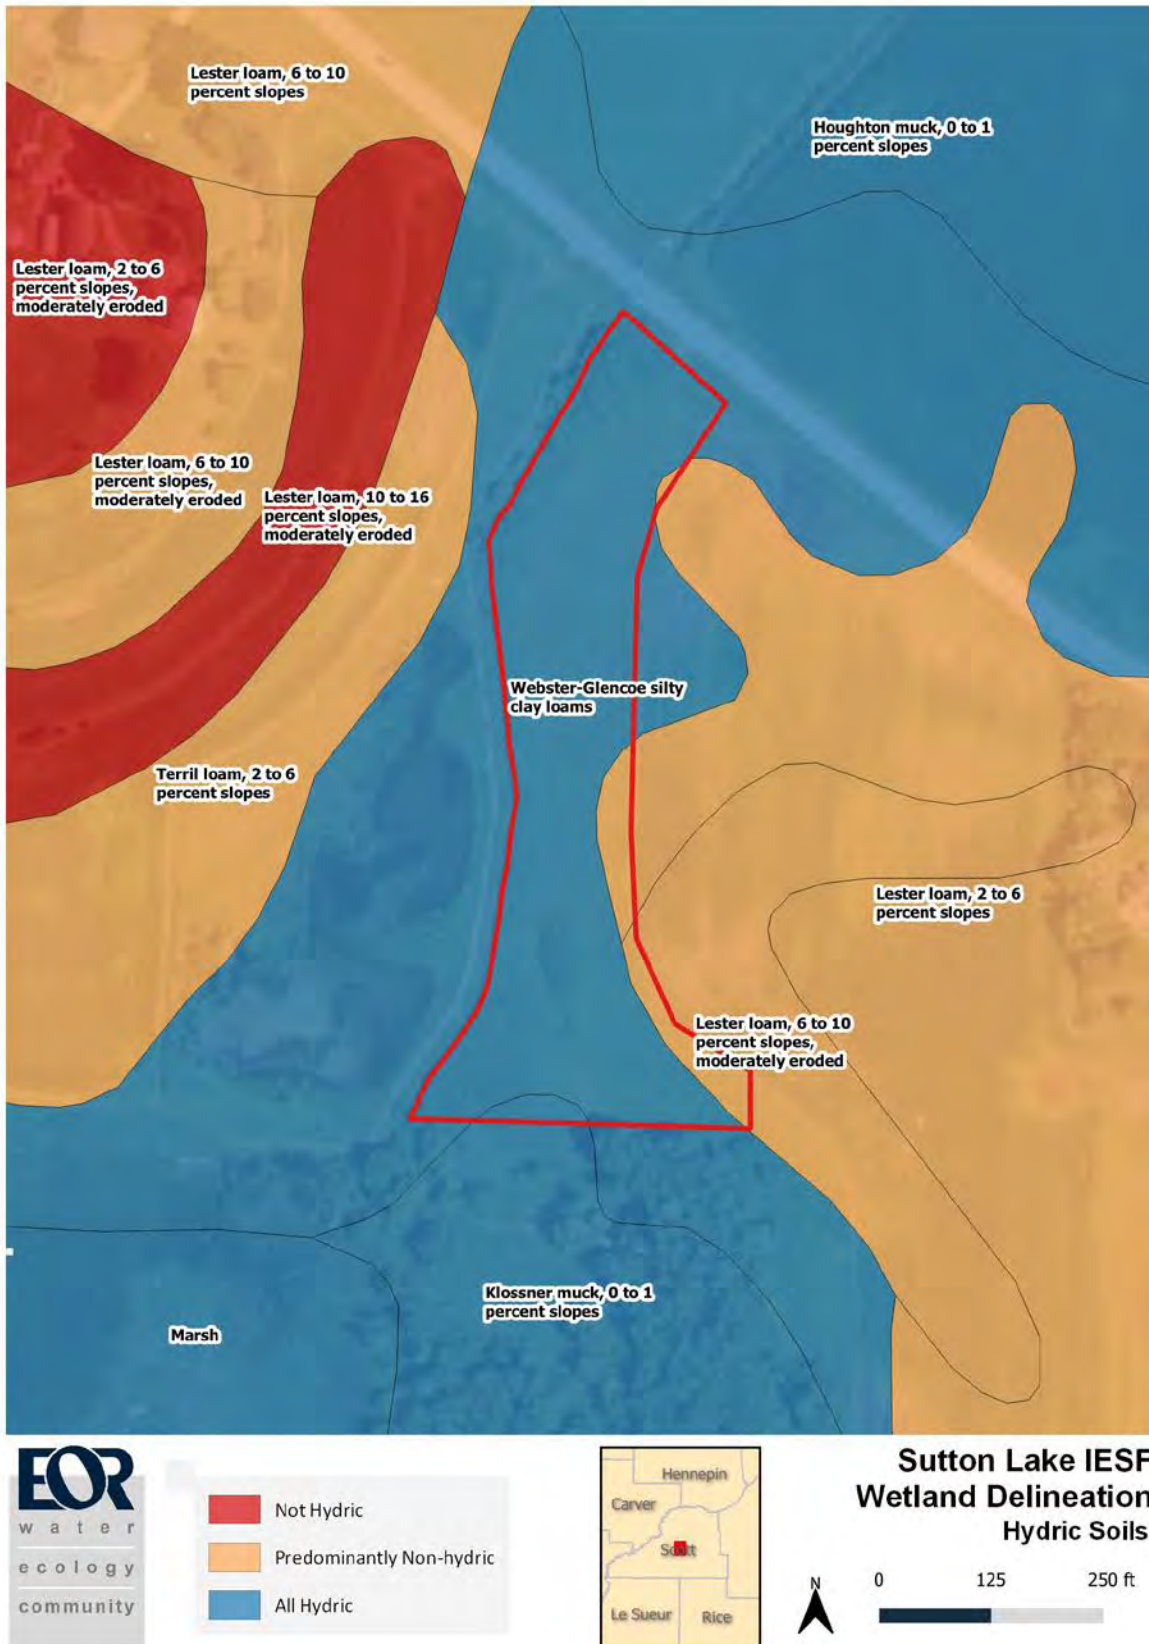
Figure 4. NRCS SSURGO soils data identified seven soil units within the Study Area.

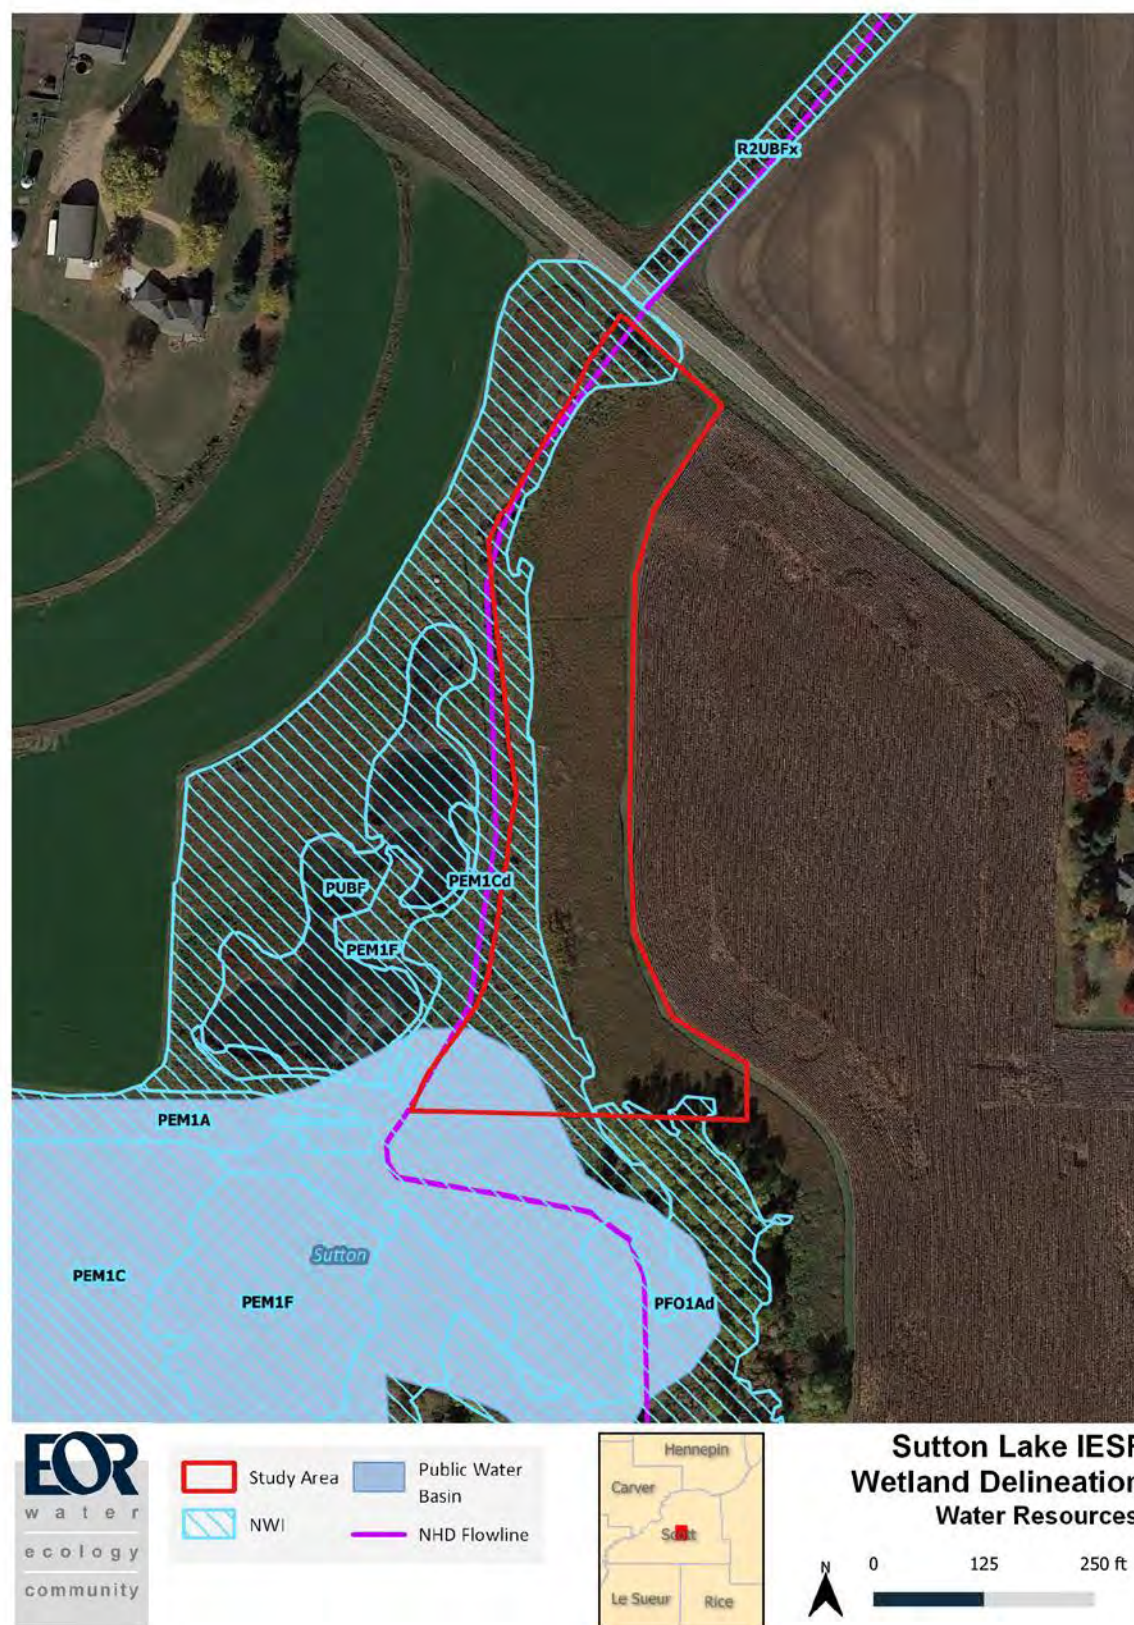
Figure 5. NWI, PWI, and NHD water resources in the Study Area vicinity.

Mapped NWI wetlands within the Study Area include PEM1Cd and PF01Ad-type wetlands along the western boundary (**Figure 5**). The Sutton Lake DNR public water basin is mapped in the southwestern corner of the Study Area. An NHD watercourse in approximate alignment with the outlet channel runs along the western boundary of the Study Area. Several additional NWI-mapped wetlands are located beyond the Study Area and associated with Sutton Lake to the south and west or the outlet channel north of County Highway 10.

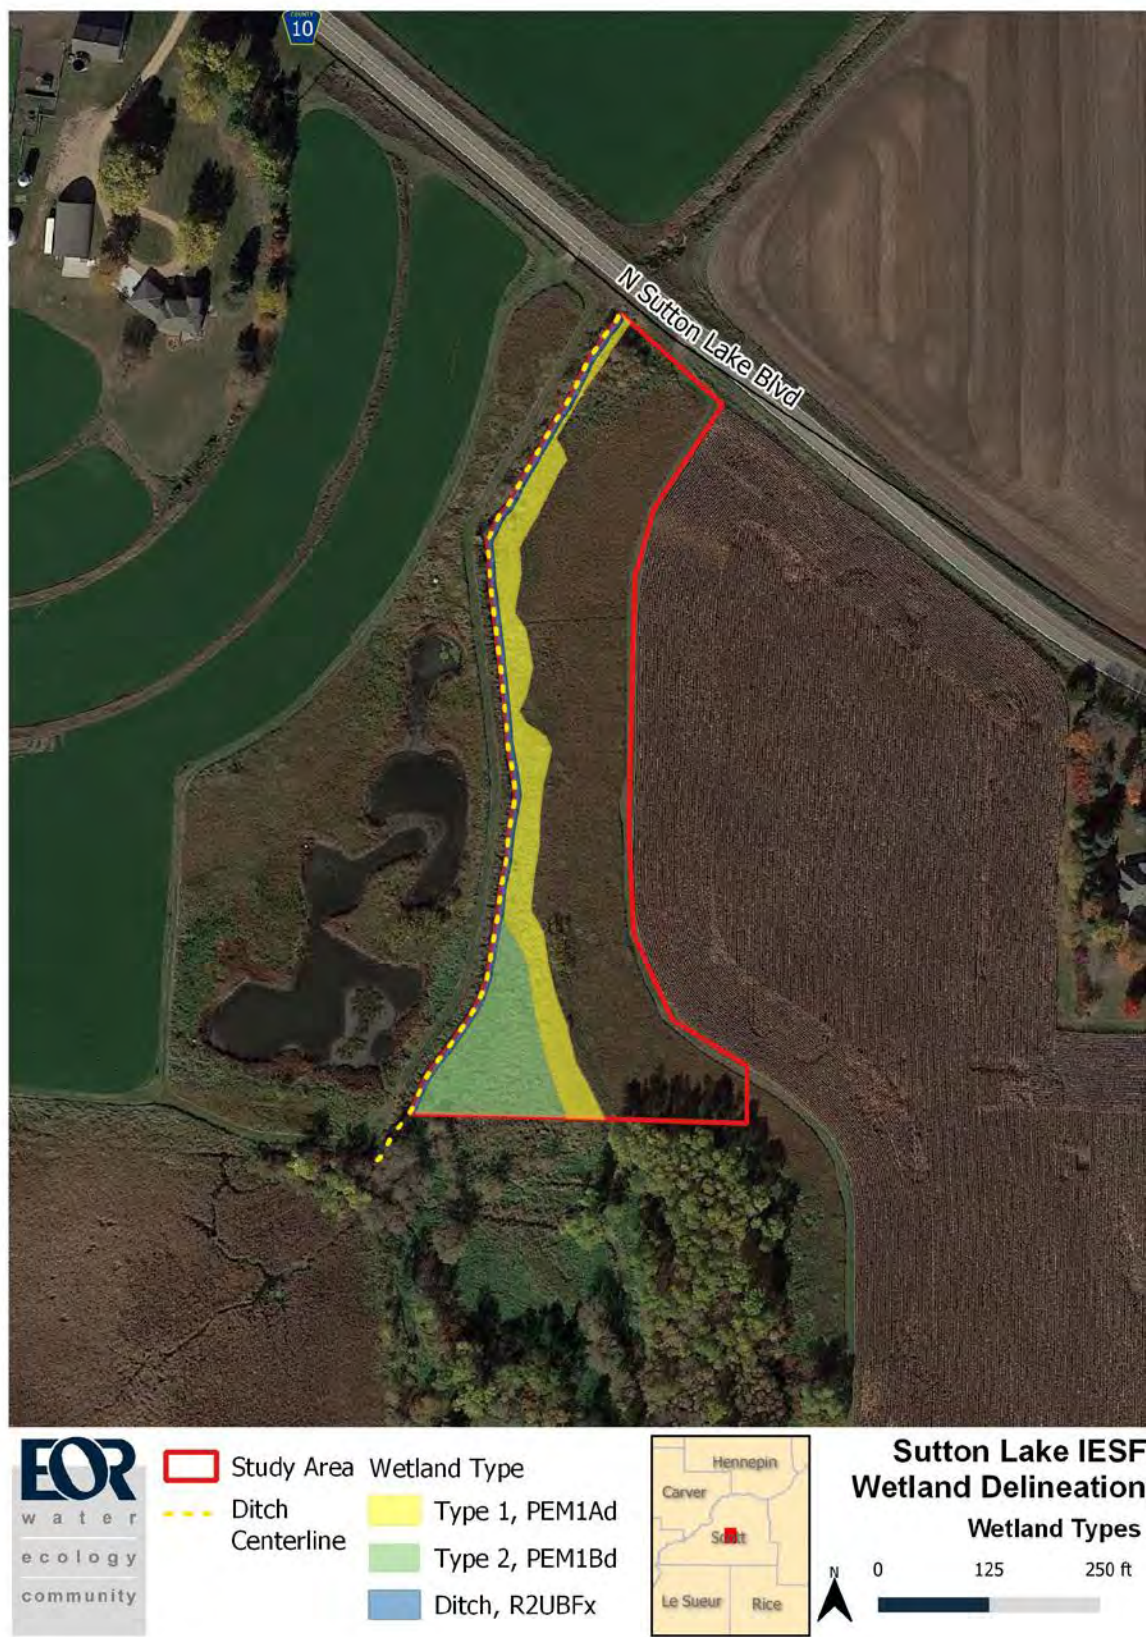
Figure 7. Wetland types within the Study Area.

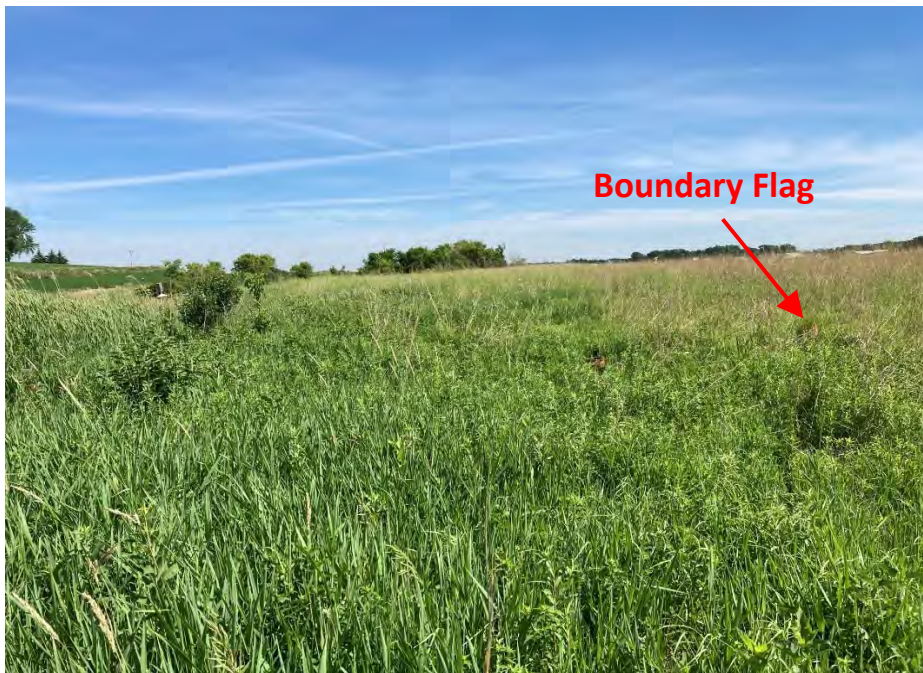
Overview of the delineated wetland looking north along the boundary. A boundary flag is visible at the transition from reedcanary grass-dominated wetland to indian grass-dominated upland.

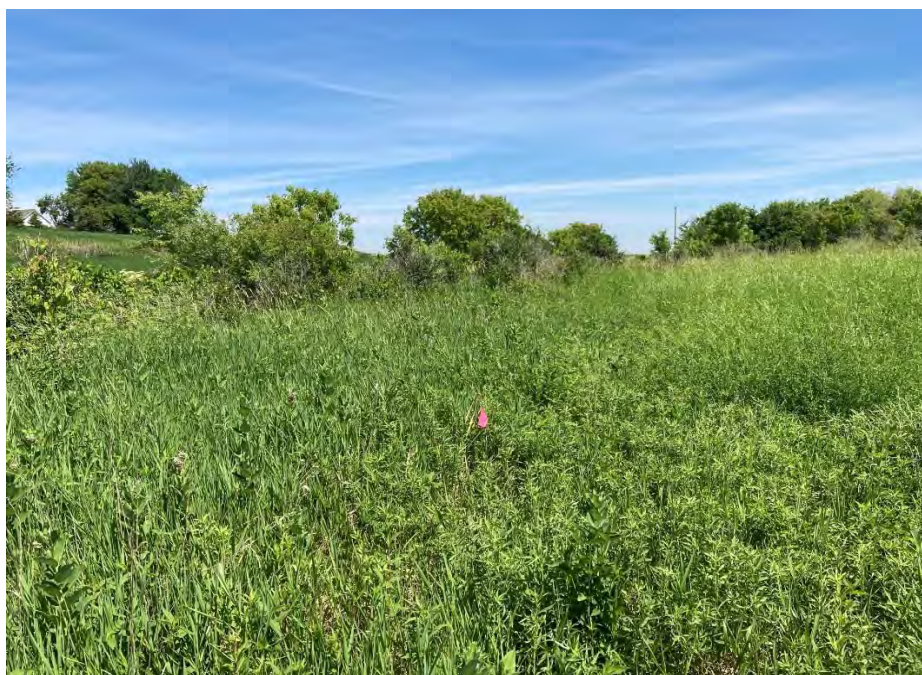
Wetland boundary overview looking north near non-wetland sample point W1C.
