Prepared by Emmons & Olivier Resources, Inc.
Prepared for Prior Lake-Spring Lake Watershed District
Adopted by PLSLWD Board of Managers March 8, 2022

Sutton Lake Iron Enhanced Sand Filter

Feasibility Study

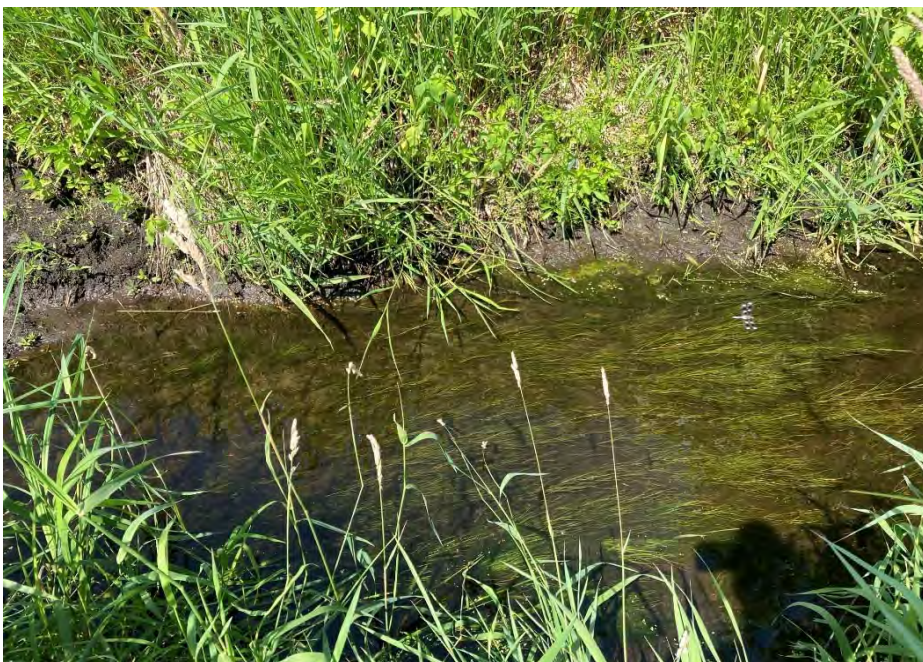
Looking west across the ditch.

The centerline of the ditch was surveyed and forms the west boundary of the Study Area. The ditch channel ranged in width from 5-6 feet wide. The centerline was buffered to a 6-foot width using GIS to digitize the ditch boundary. The ditch flows to the north and water depth at the thalweg was 6-8 inches.

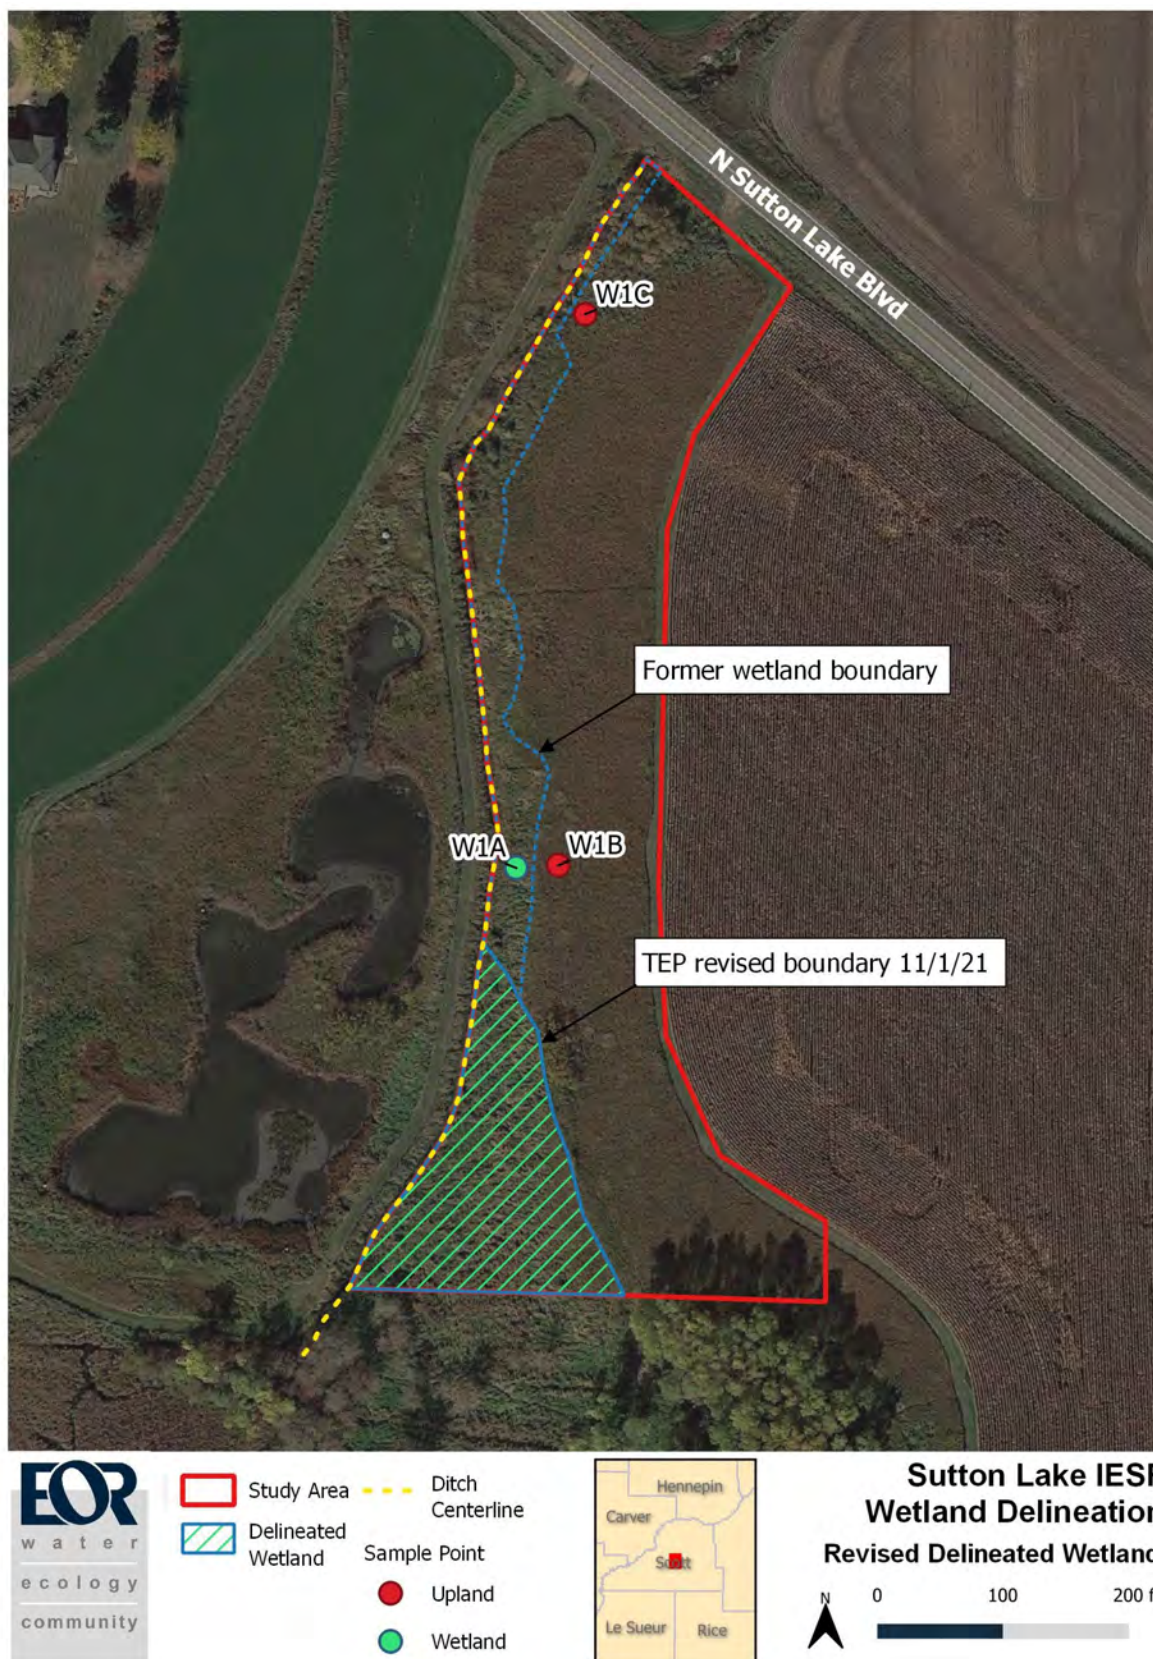
Figure 1. Wetland boundary revisions recommended by the TEP.

The following memo summarizes revisions made to the boundary and type of a wetland complex delineated at the proposed site for an iron-enhanced sand filter on the east side of the Sutton Lake outlet channel. A Level 2 delineation report and joint project application were received by the LGU from EOR on 10/5/2021. The TEP reviewed the delineation in the field on 11/1/2021. The TEP recommended a major revision to the wetland boundary and type originally delineated by EOR.

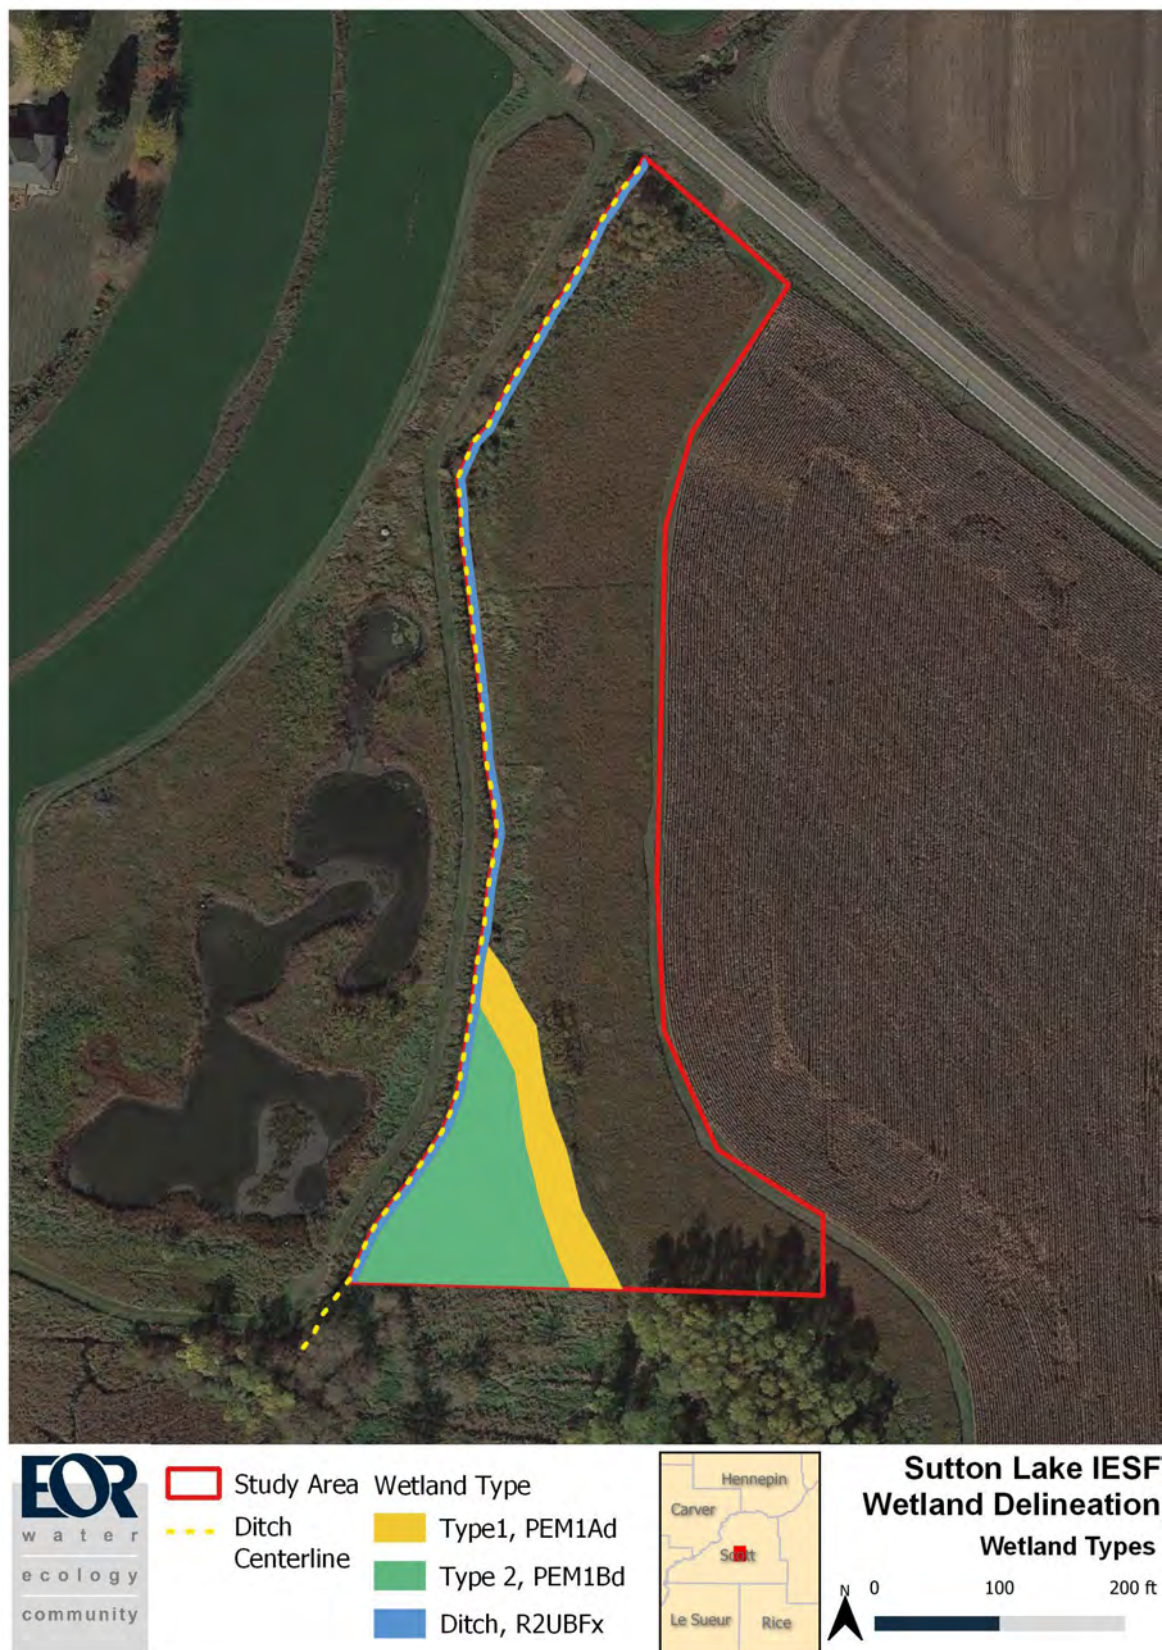
Figure 2. Revised wetland types and boundaries.
