Sediment Survey and Aquatic Plant Survey for Buck Lake, Scott County, Minnesota for 2010

[Sediment Survey Conducted: September 16, 2010]
[Aquatic Plant Survey Conducted: September 16, 2010]

Prepared by:
Steve McComas & Jo Stuckert
Blue Water Science
St. Paul, Minnesota

Prepared January 2011

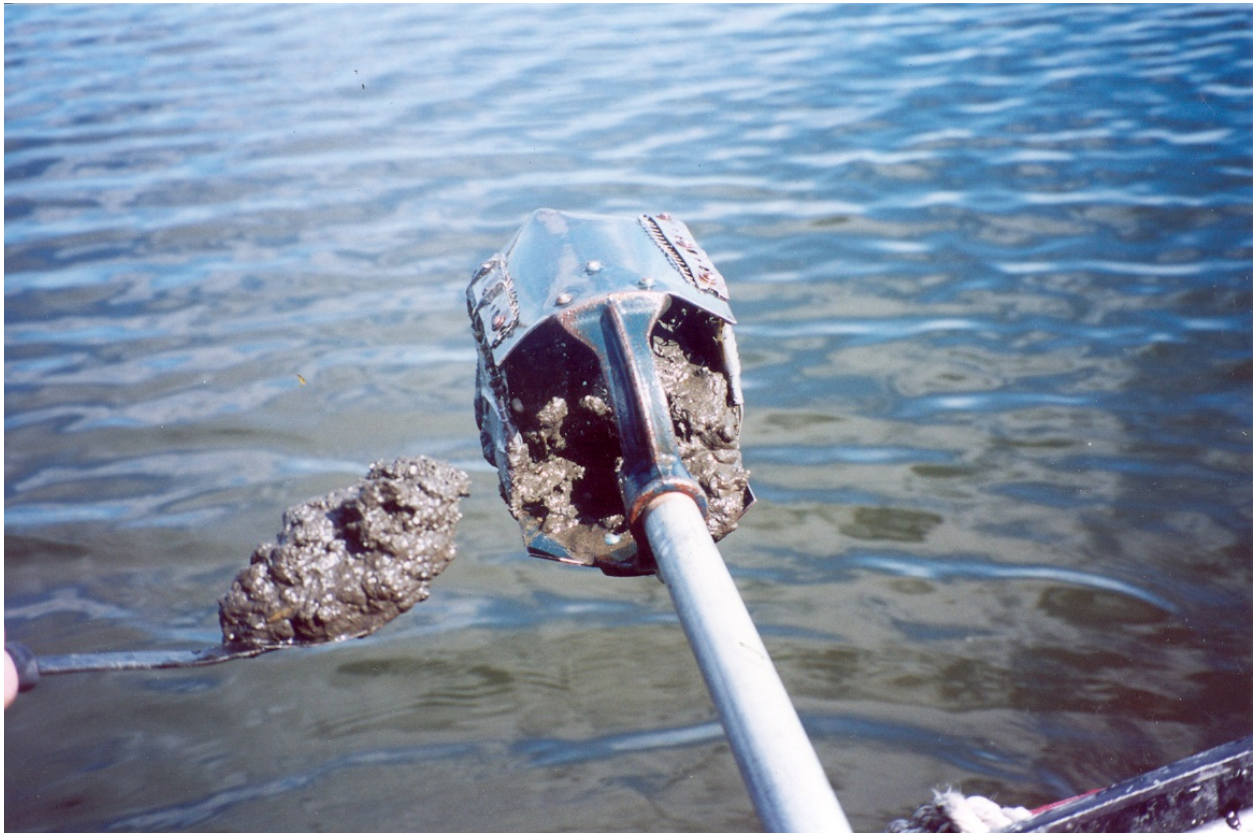
Figure 2. Soil auger used to collect lake sediments.

Sediment Survey: A total of 6 lake sediment samples were collected from depths ranging from 4 to 7 feet in Buck Lake on September 16, 2010. Samples were collected using a modified soil auger, 5.2 inches in diameter (Figure 2). Soils were sampled to a depth of 6 inches. The lake soil from the sampler was transferred to 1-gallon zip-lock bags and delivered to a soil testing laboratory. Sample locations are shown in Figure 3.

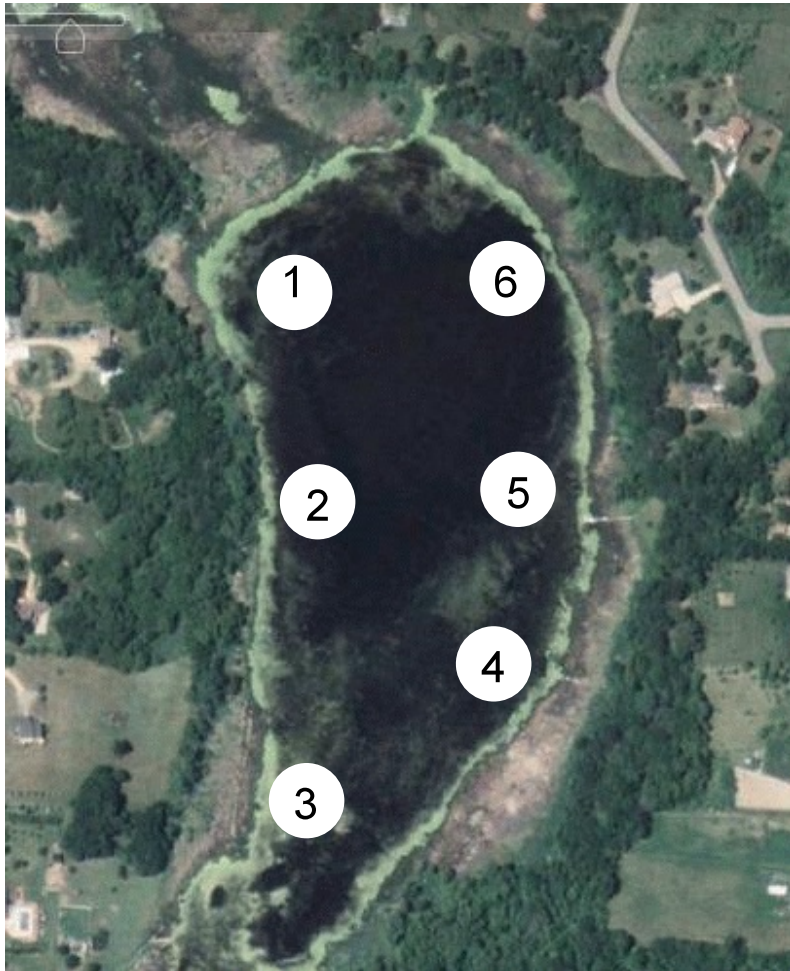
Figure 3. Six sediment samples were collected on September 16, 2010.

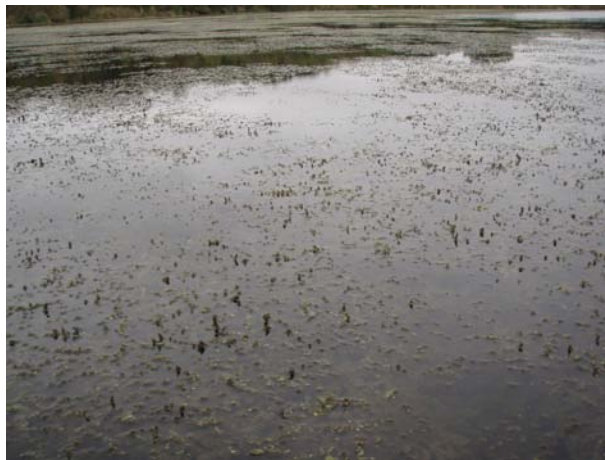
Figure 4. [left] Coontail was found growing to the surface in some areas of Buck Lake on September 16, 2010.

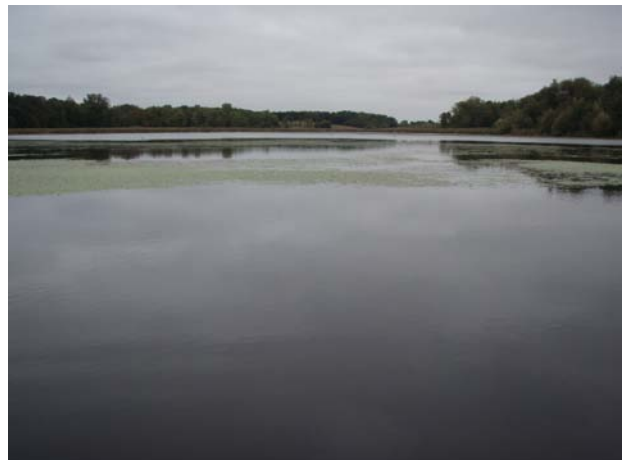
[right] Buck Lake plant conditions on September 16, 2010. Some plants were growing to the surface.

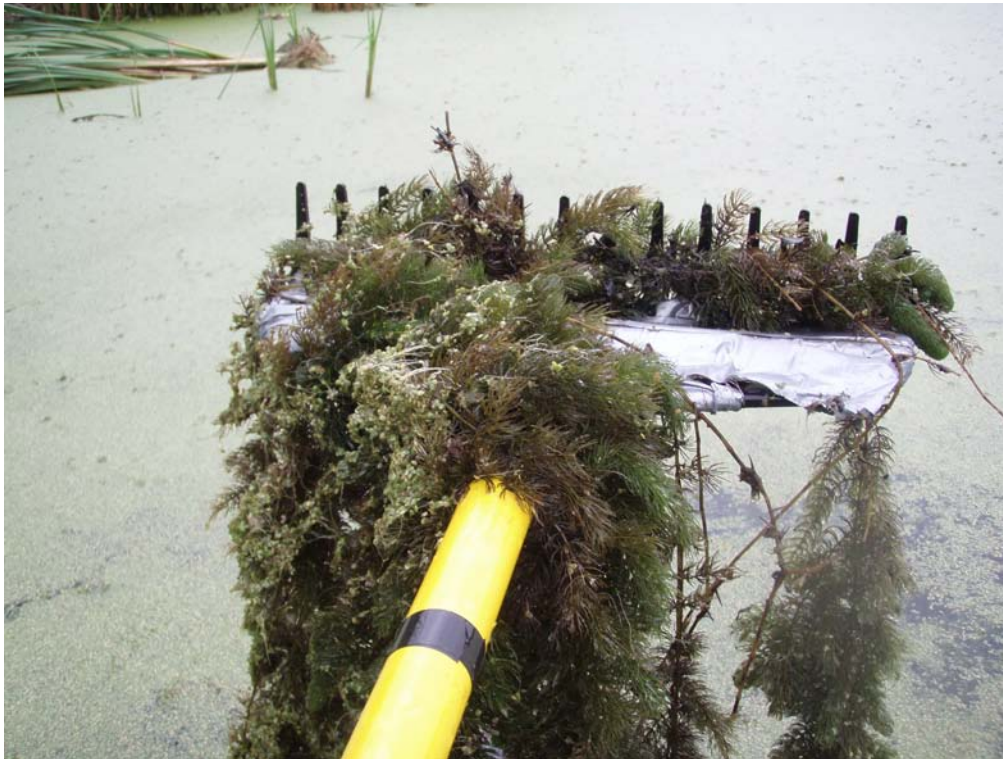
Figure 5. Coontail was the dominant plant in Buck Lake.

Coontail was the dominant plant in Buck Lake in 2010 (Table 3). Other plants present included flatstem pondweed, sago pondweed, and stringy pondweed. Plants grew out to a depth of 5 feet. The lake has a maximum depth of 9 feet although that is a small area in the northern end of the lake (Table 4). Overall plant species diversity is low, but plant abundance, primarily coontail, is high. Submerged plant distribution, which is dominated by coontail, covers about 73% of the lake bottom.

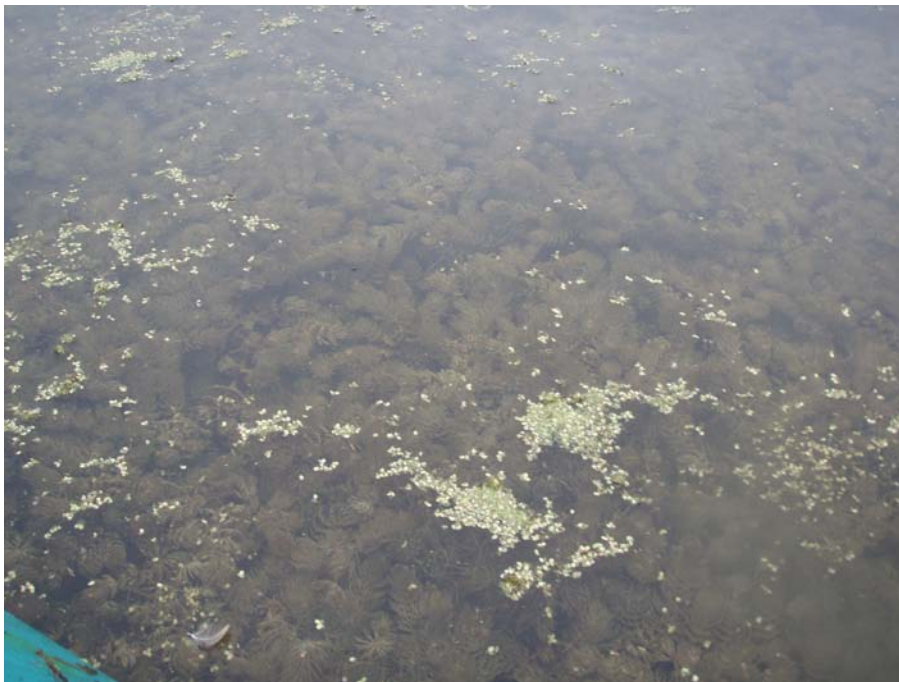
Figure 6. Buck Lake has fairly good water clarity, especially in areas with thick coontail growth. Duckweed (shown floating on the water) was common as well.

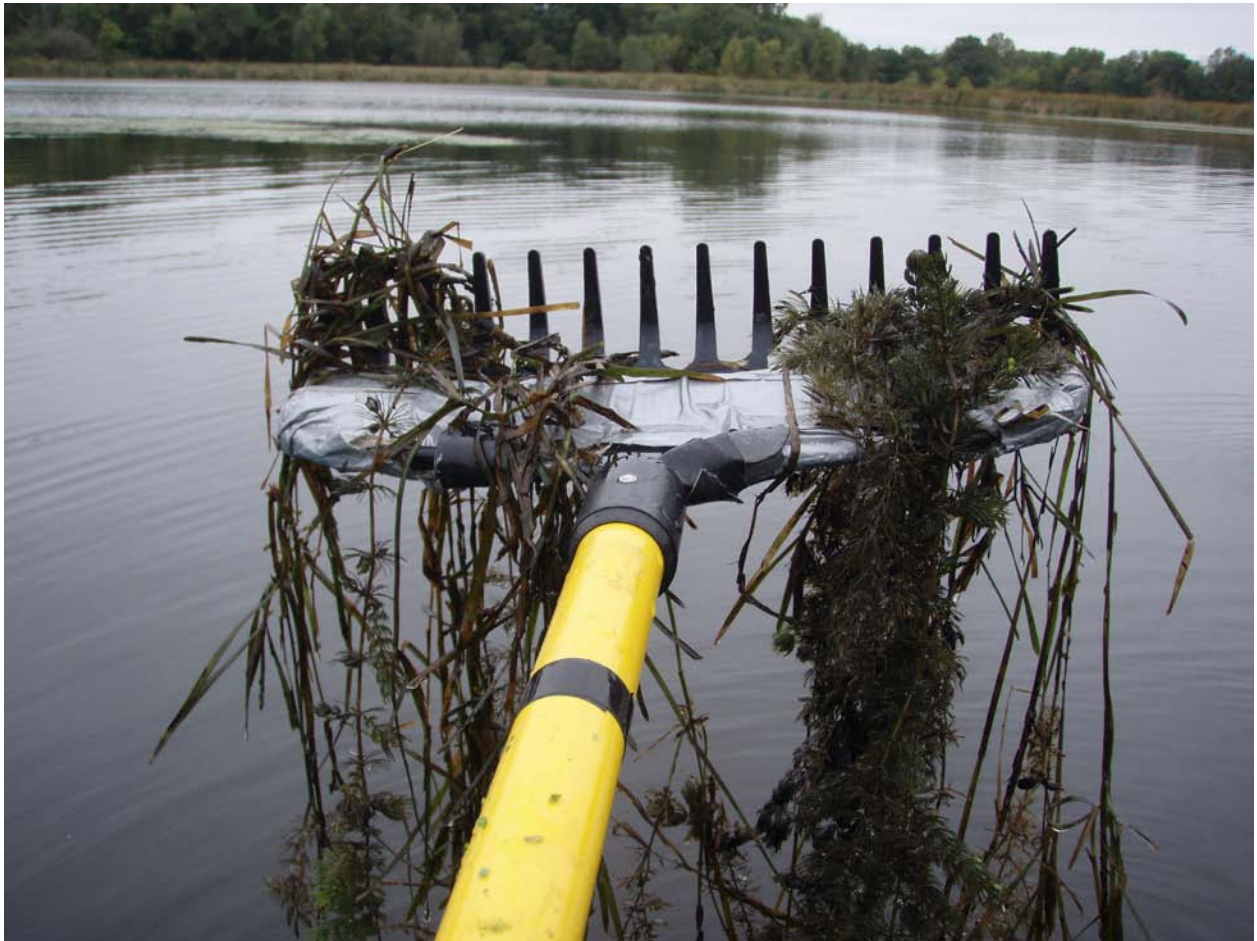
Figure 9. Flatstem pondweed and coontail were both common plants found in Buck Lake in 2010. Coontail was more abundant than flatstem.
