# Prior Lake Aquatic Plant Evaluation on August 4, 2016

*Prepared by Steve McComas, Blue Water Science, August 10, 2016*

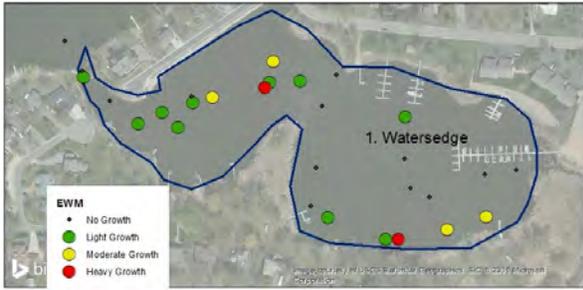
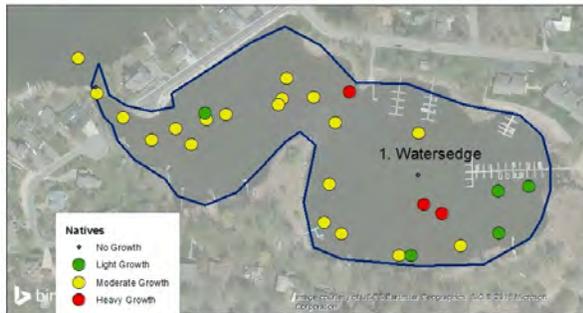
Watersedge Bay EWM and Natives  
August 4, 2016

Area 1, Watersedge Cove: heaviest plant growth was on the south side of the cove and was a mixture of native plants and EWM. The north side had fewer navigational hindrances. Buoys delineated a navigational channel.

**Figure 2. Aquatic plant densities for 3 surveyed areas showing densities for EWM and native plants at the individual survey points. Native plants were typically more abundant than EWM. In Area 2, duckweed had nearly 100% coverage. The cove is about 2 to 4 feet deep which are perfect growing conditions for duckweed.**

7. In Area 1 (Watersedge) buoys marked a navigational channel and was a good management approach. In the future, riparian owners could create pathways from their docks to the open channel using herbicides or a mechanical harvester.

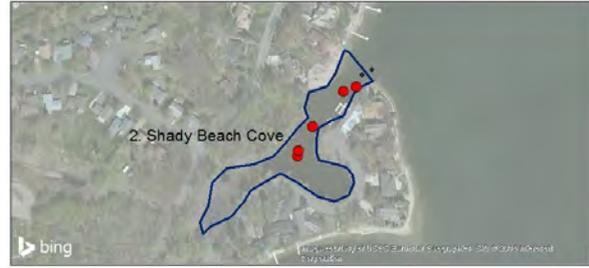
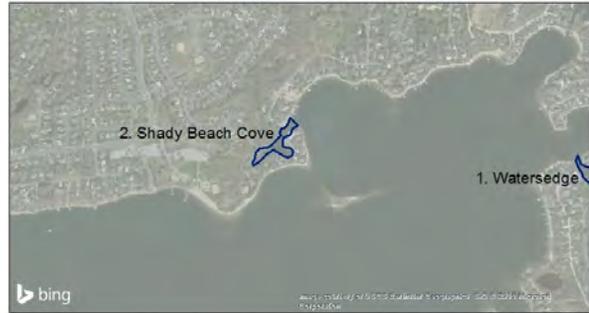
Shady Beach Cove Duckweed and Watermeal  
August 4, 2016

Area 2, Shady Beach Cove: had remarkable floating duckweed and watermeal coverage. This was largely a function of the shallow water depths of 2 to 4 feet. Algae were present, but sparse.

8. In Area 2 (Shady Beach Cove) duckweed and watermeal are the dominant plants. The herbicide, Clipper, has been found to be an effective control and needs to be applied 2 to 3 times per summer by a licensed applicator. Floating filamentous algae was present, but sparse.

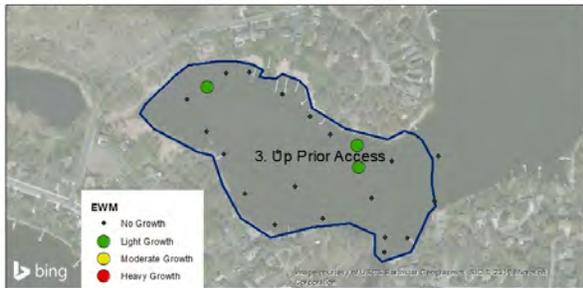
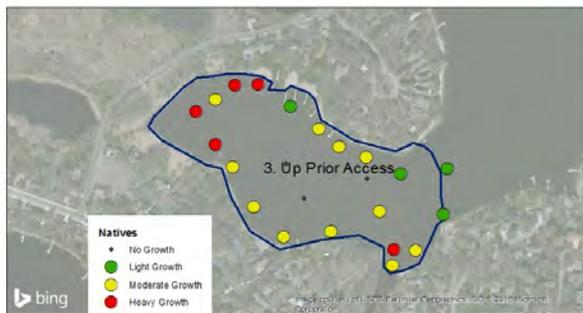
Upper Prior Access EWM and Natives  
August 4, 2016

Area 3, Upper Prior Access Bay: had patchy aquatic plant growth. The heaviest growth was from coontail and was found on the north side of the bay.

9. Area 3 (Upper Prior Access Bay) has some heavy growth of aquatic plants which are dominated by the native coontail. Early season application of Aquathol or a summer herbicide application would control the nearshore heavy growth. Because the public access is nearby, mechanical harvesting would also be an option.

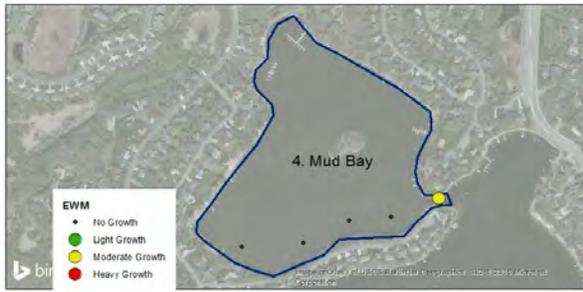
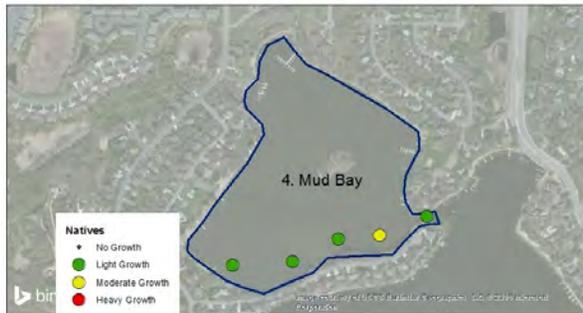
Mud Bay EWM and Natives  
August 4, 2016

Figure 2 - concluded. Native plants were the most common in Areas 4 and 6. The Lakefront Bay Area (5) had patchy EWM which was also common in the nearshore area along the natural shoreline.

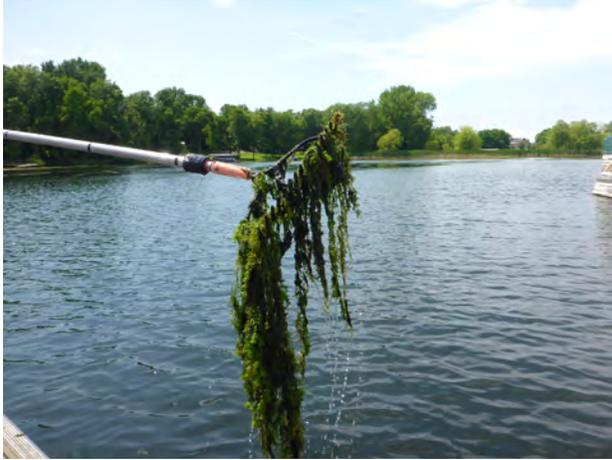
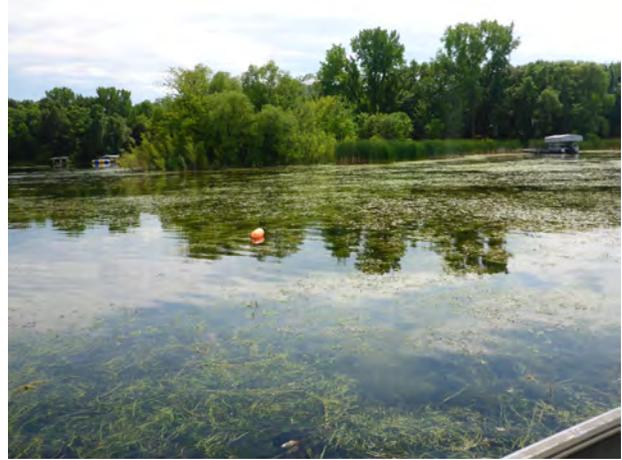
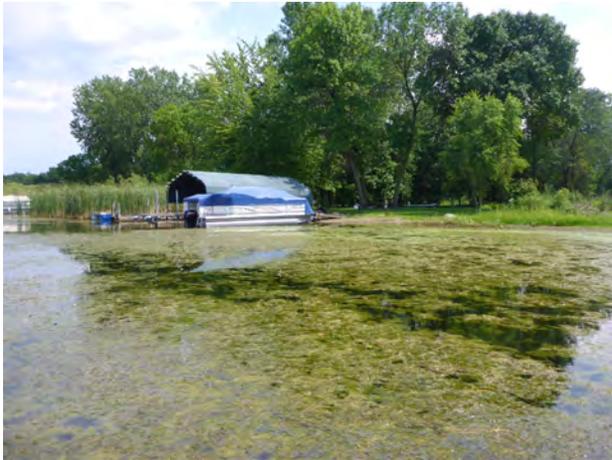
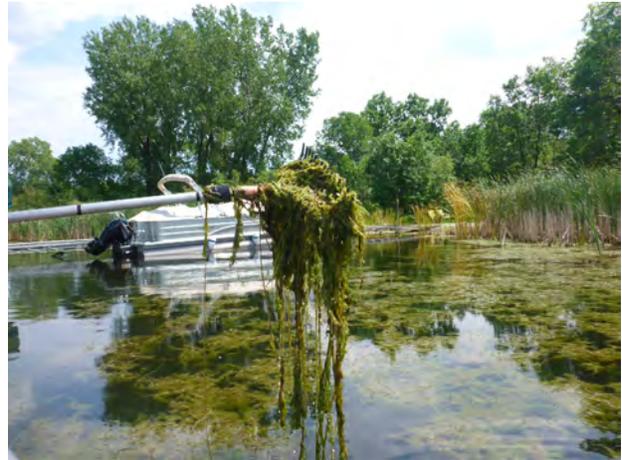
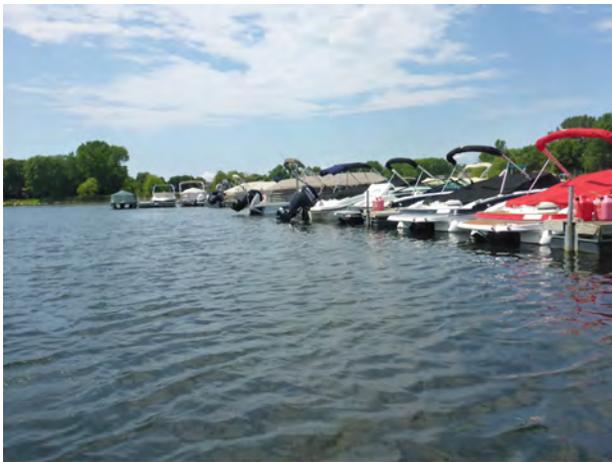
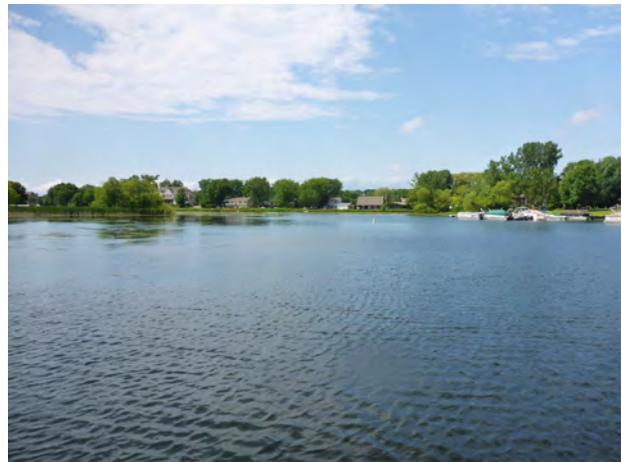
**1. Watersedge:** Heavy plant growth is found in nearshore areas on the south shore and is composed of a combination of EWM and native plants. Buoys have been installed to mark a navigational channel. In addition, channels could be created from the docks out to open water as well. The marina docks did not have navigational hindrances at the time of this survey.

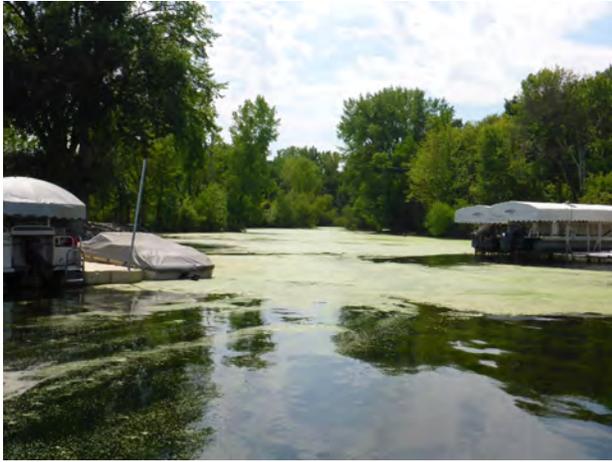
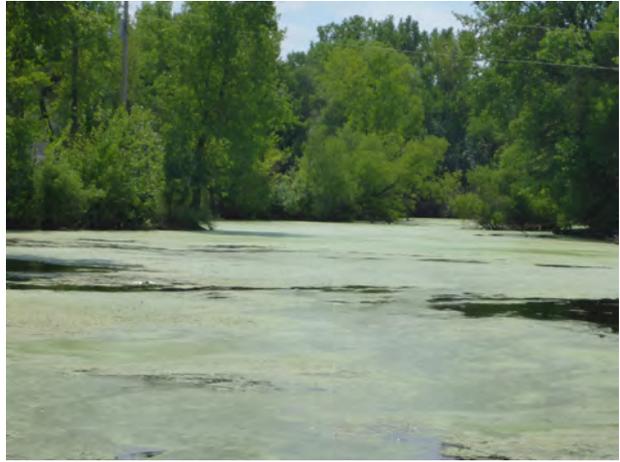
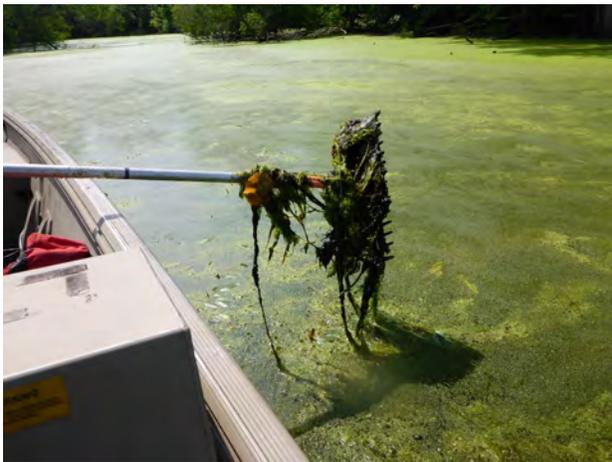
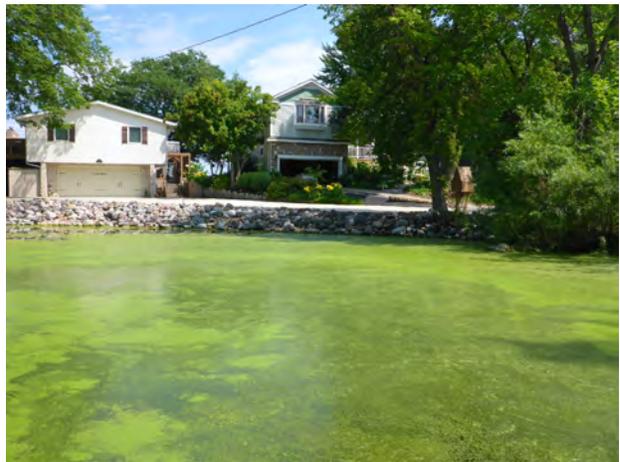
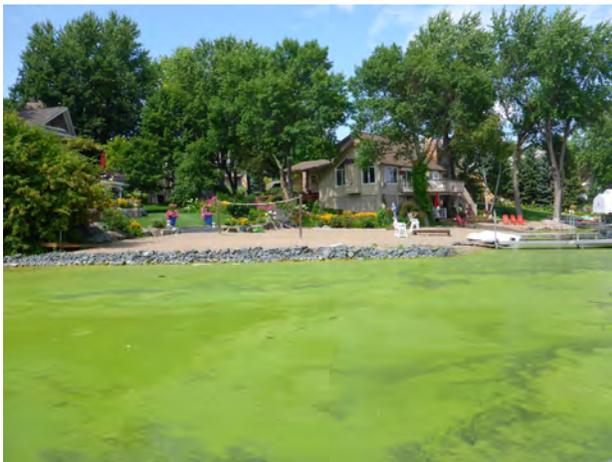
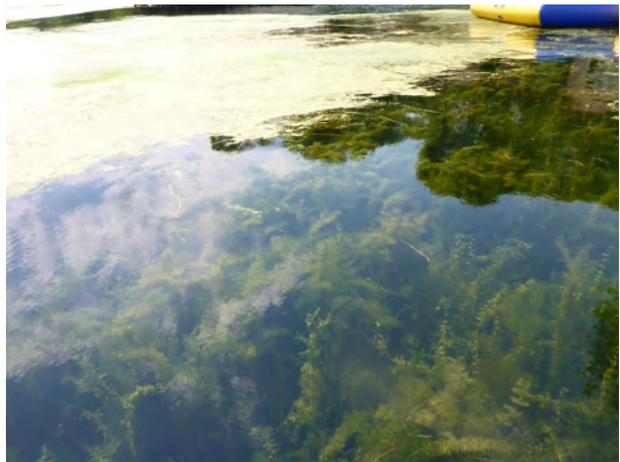
**2. Shady Beach Cove: Duckweed and watermeal are abundant in shallow water at depths of 2 to 4 feet. The green plants floating on the surface are duckweed and watermeal. Algae was minor in this area. Duckweed and watermeal are native plants and under the correct conditions can cover the water surface. This cove has the correct conditions. Submerged plants are dominated by coontail. When water depths reach 6 feet or more, duckweed is absent (picture in lower right).**

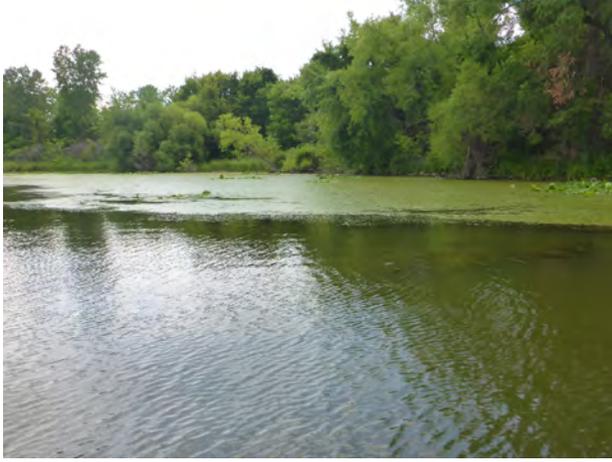
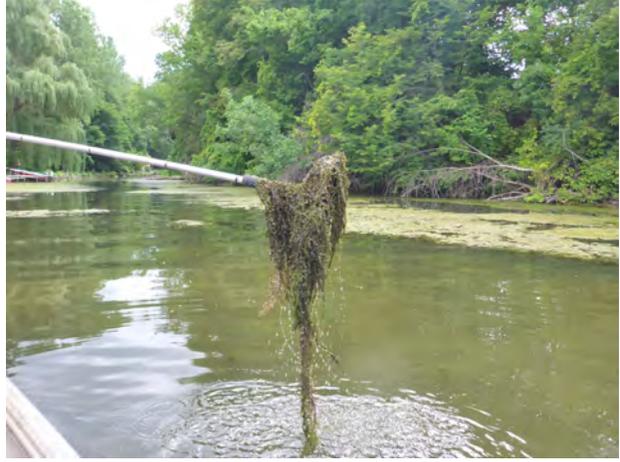
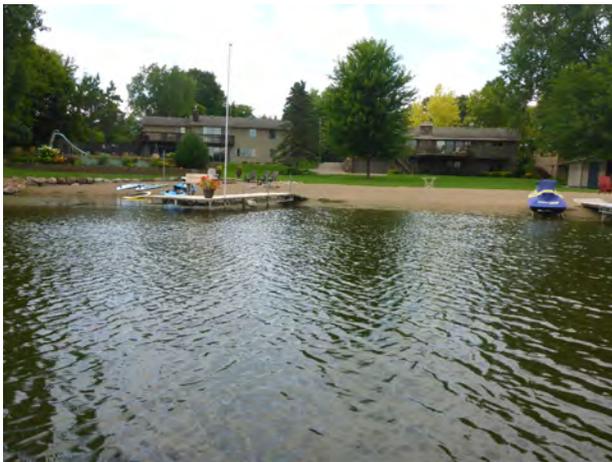
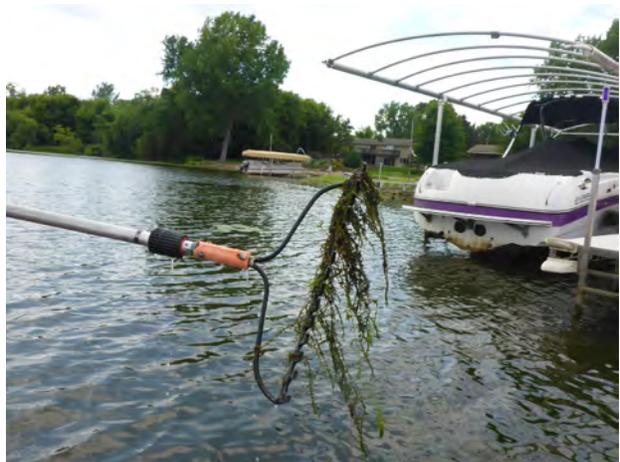
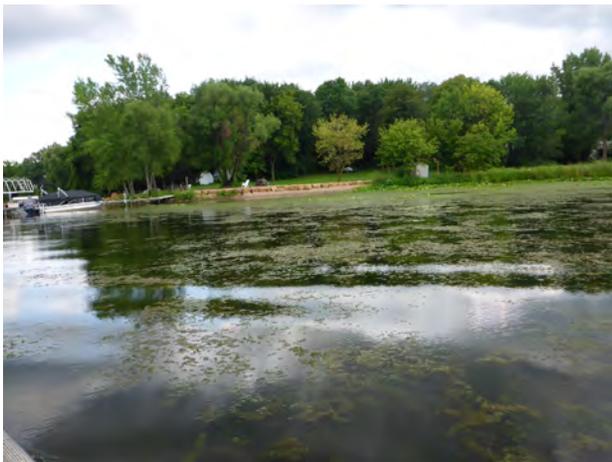
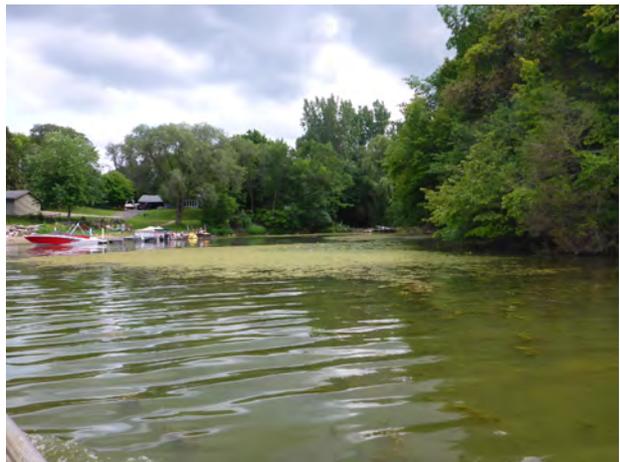
**3. Upper Prior Lake Access Bay: The most abundant plant growth was found along the north shoreline and in the west end of the bay. The dominant plant was coontail although EWM was present.**

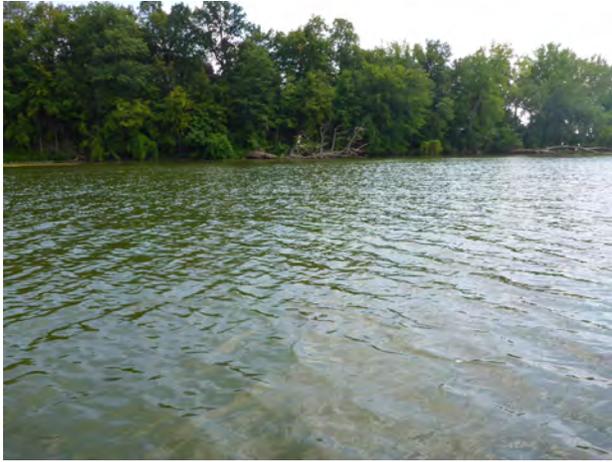
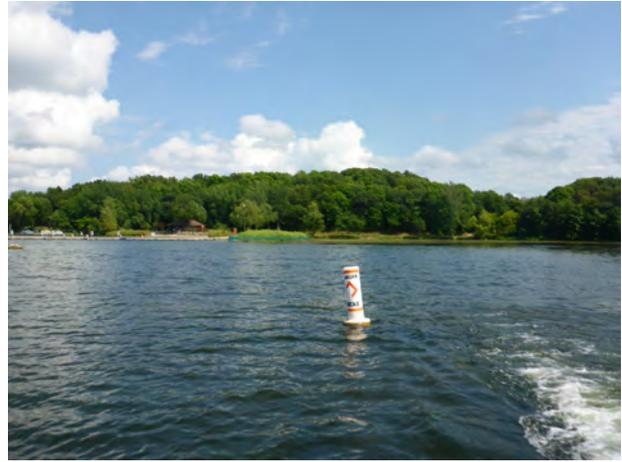
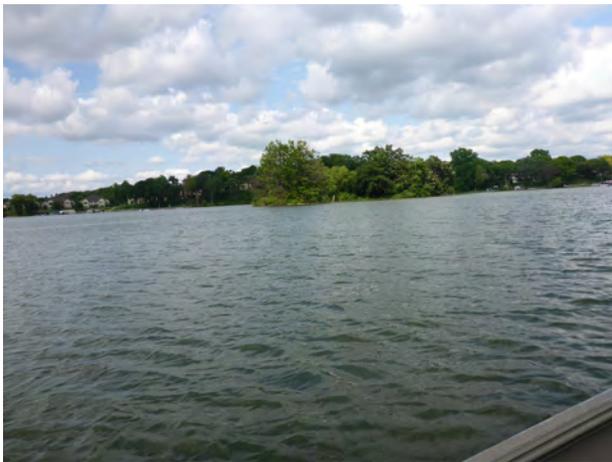
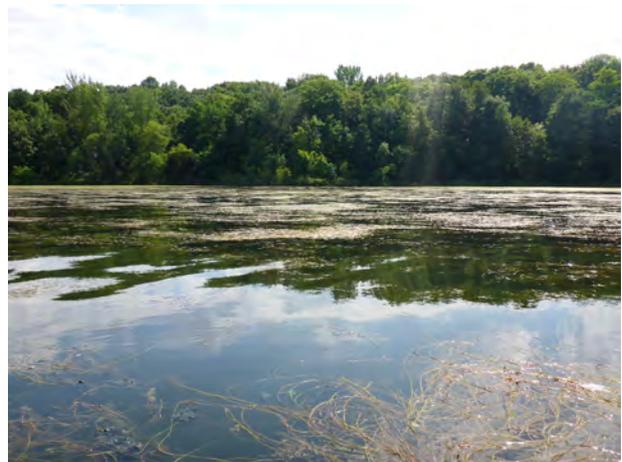
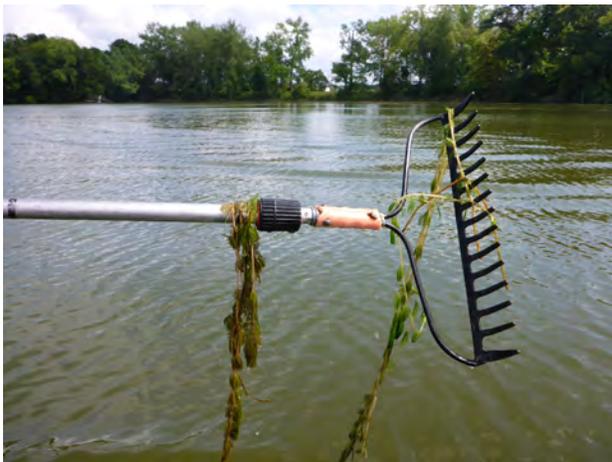
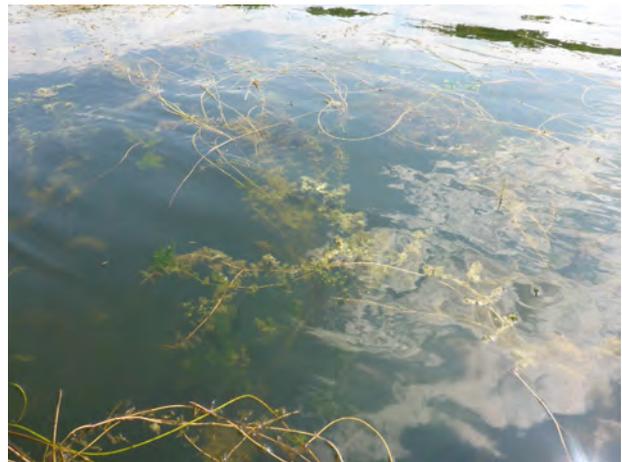
**4. Mud Bay: EWM is present, but patchy. This shallow bay is mostly navigable.**

**5. Lakefront Bay: EWM is common to abundant and the nearshore areas support beds of EWM. In the middle of the bay EWM is patchy.**

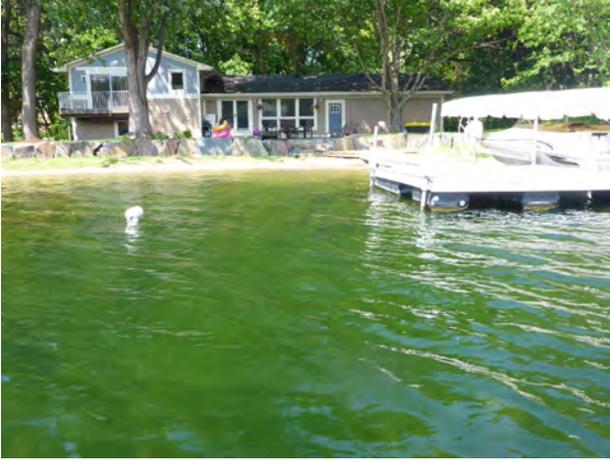
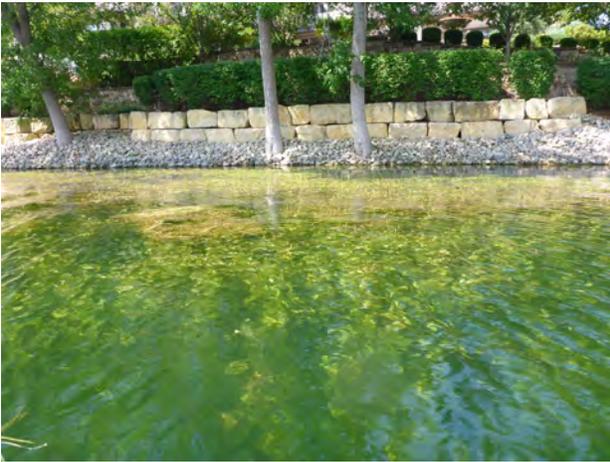
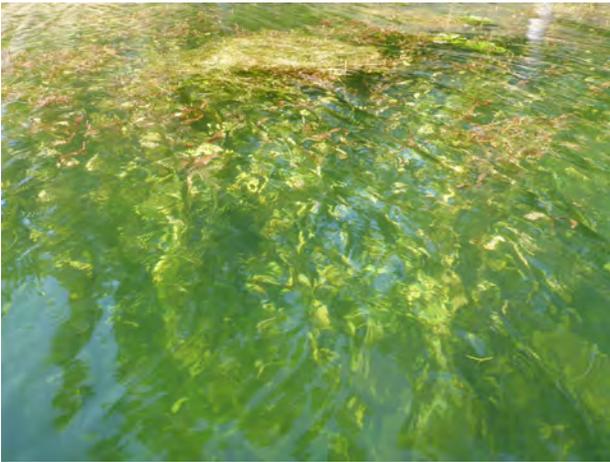
**6. Candy Cove: Aquatic plant growth is mostly light to moderate. The significant dropoff about 50 feet offshore limits nuisance growth to a narrow vegetative band.**
