SWAMP LAKE PHOSPHORUS AND PEAK FLOW REDUCTION FEASIBILITY STUDY

Adopted by the Prior Lake-Spring Lake Watershed District Board of Managers December 12, 2023

Swamp Lake Wetland Delineation Report

PLSLWD Swamp Lake IESF
Sand Creek Township, Scott County, MN
Stantec Project #: 227705785

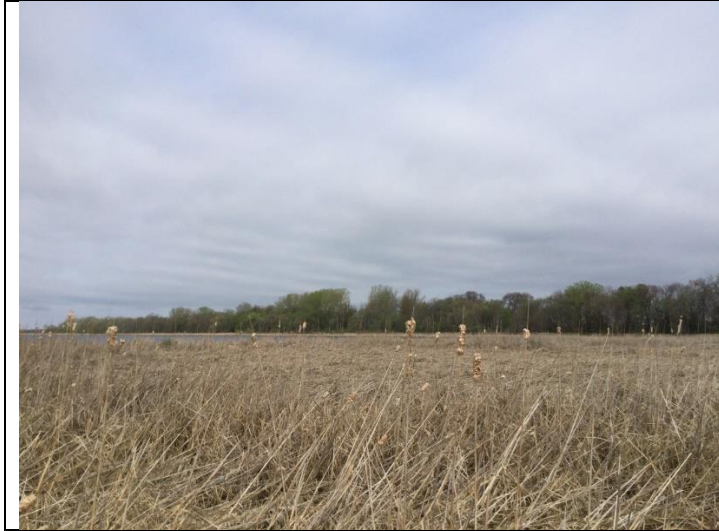
Photo 1: Wetland A (WA)

Photo Description: Photo of Wetland A taken from the west side of Redwing Avenue. Type 3 wetland with reed canary grass and narrow-leaved cattails (Type 2 fringe not visible). Swamp Lake is adjacent further west.

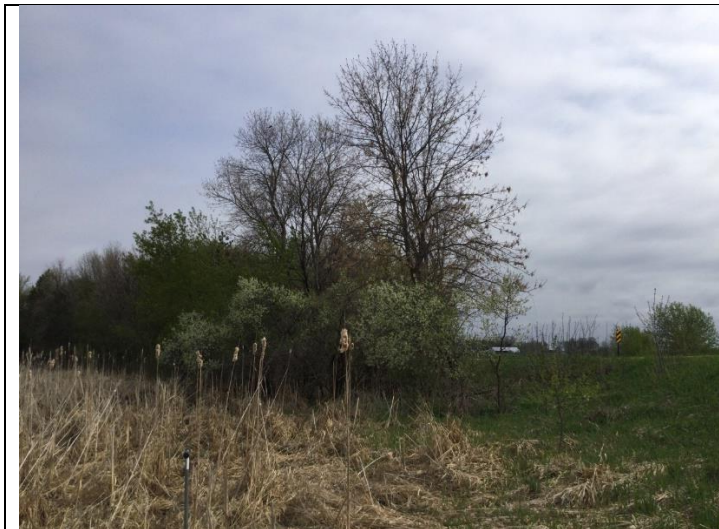
Photo 2: WA

Photo Description: Taken from the same location as Photo 1 but looking north towards the adjacent upland. Type 3 wetland with Type 2 fringe visible to the east.

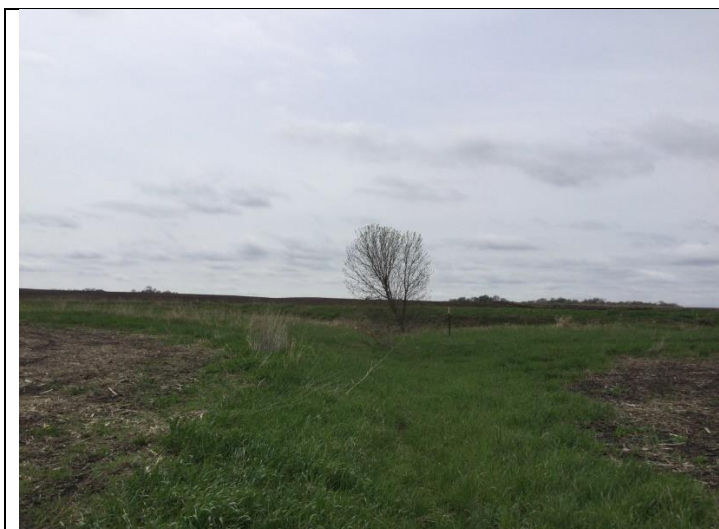
Photo 3: Sample Point A (SPA) - Upland

Photo Description: Upland drainage swale effectively drained by tile located between cropland and Stream A (SA). Smooth brome was dominant.

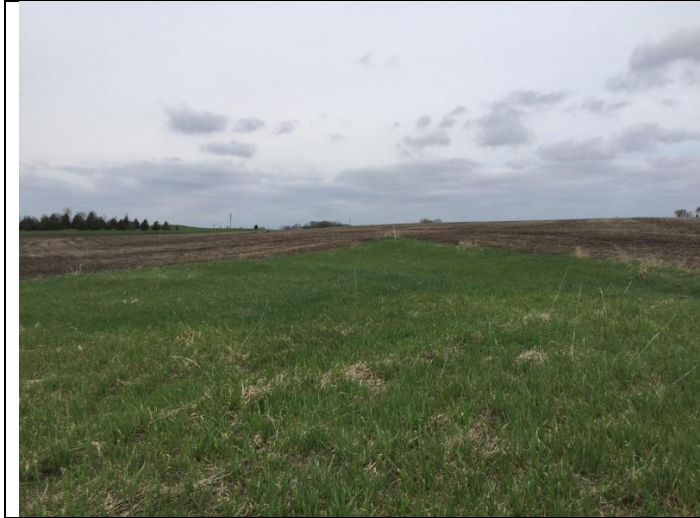
Photo 4: Sample Point B (SPB) - Upland

Photo Description: Upland area with a patch of dominant reed canary grass and a slight depression. Soils were determined to be non-hydric.

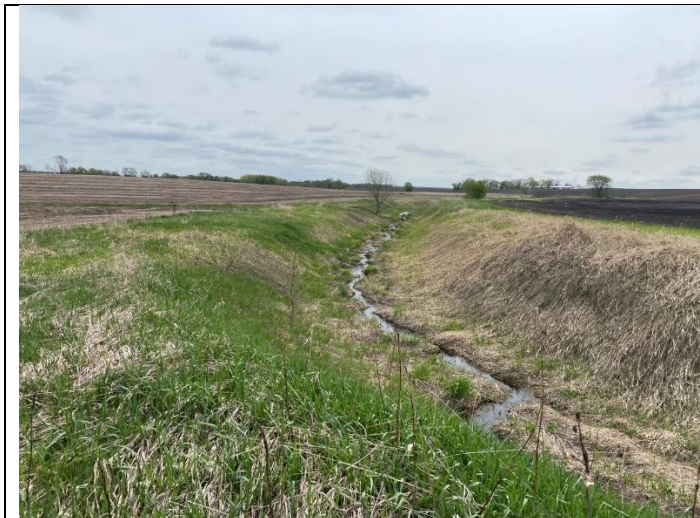
Photo 5: Stream A (SA)

Photo Description: Perennial stream running the length of the Study Area. Tile outlets were located at multiple locations along the length of the stream.

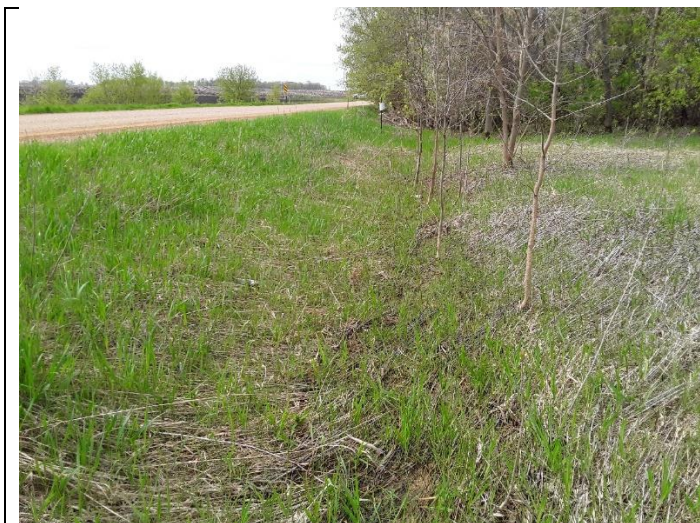
Photo 6: Stream B (SB)

Photo Description: Ephemeral stream located just west of Redwing Avenue. SB connects to SA further south near WA.

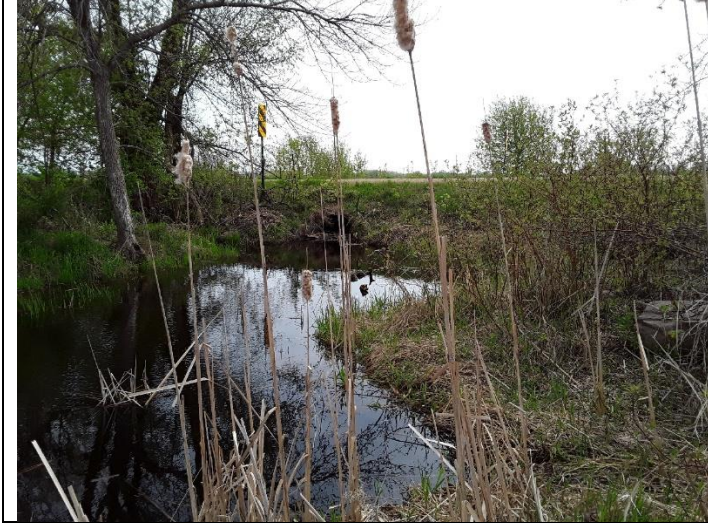
Photo 7: SA Junction

Direction Photo is Taken: East
