Fish Lake, Scott County, Curlyleaf Pondweed Assessment for 2011

Assessment Dates: May 12, 2011 and June 13, 2011

Prepared for:
Prior Lake/Spring Lake
Watershed District
Prior Lake, Minnesota

Prepared by:
Steve McComas
Blue Water Science
St. Paul, MN 55116

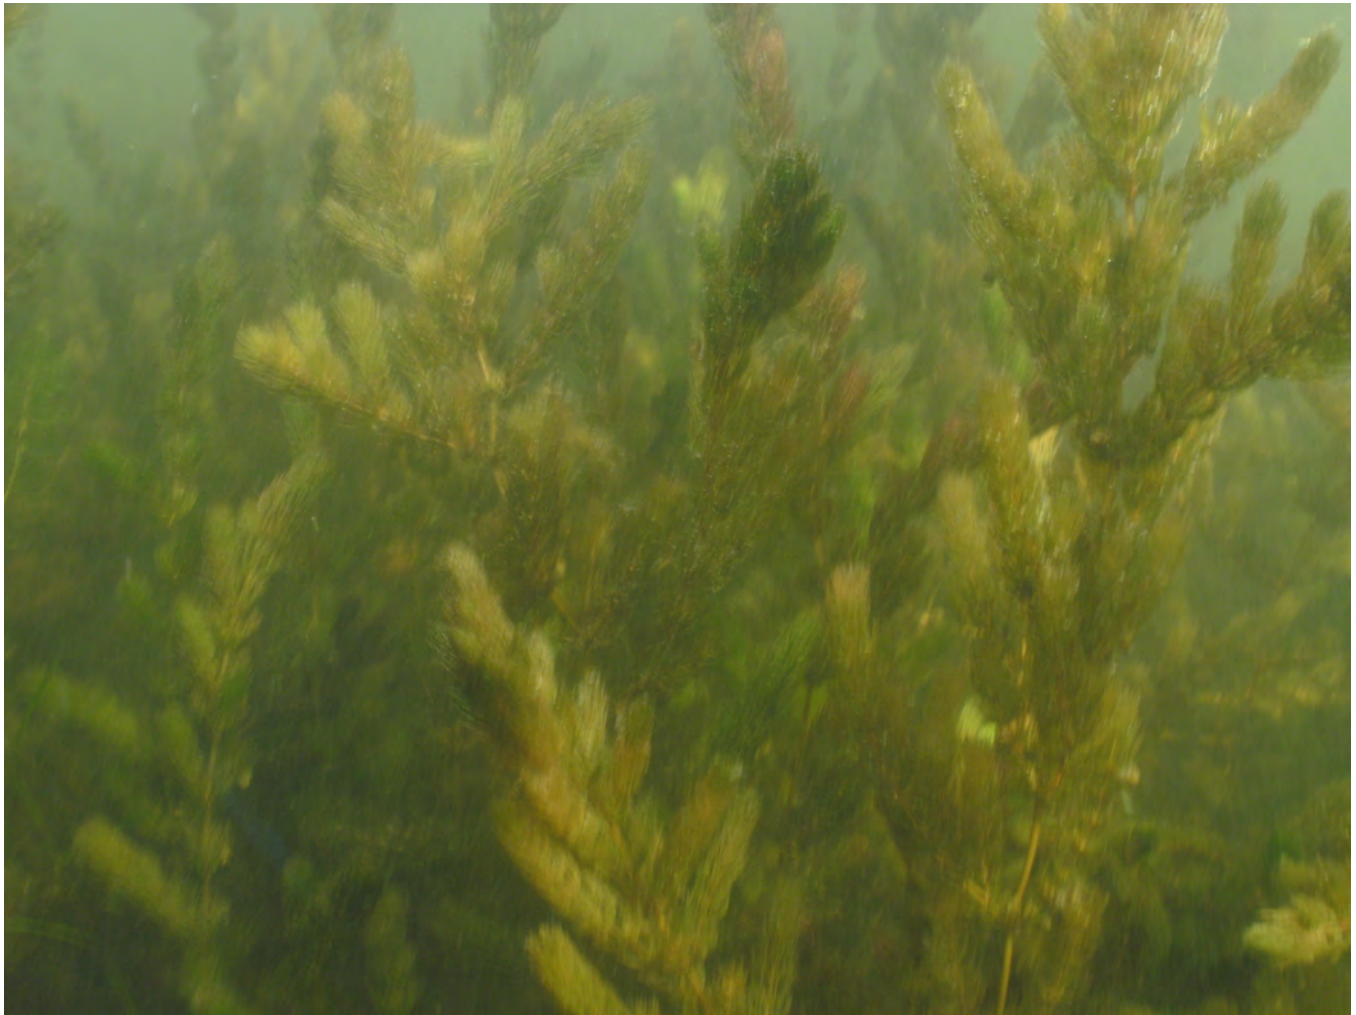
Coontail in Fish Lake, Scott County, MN, on June 13, 2011

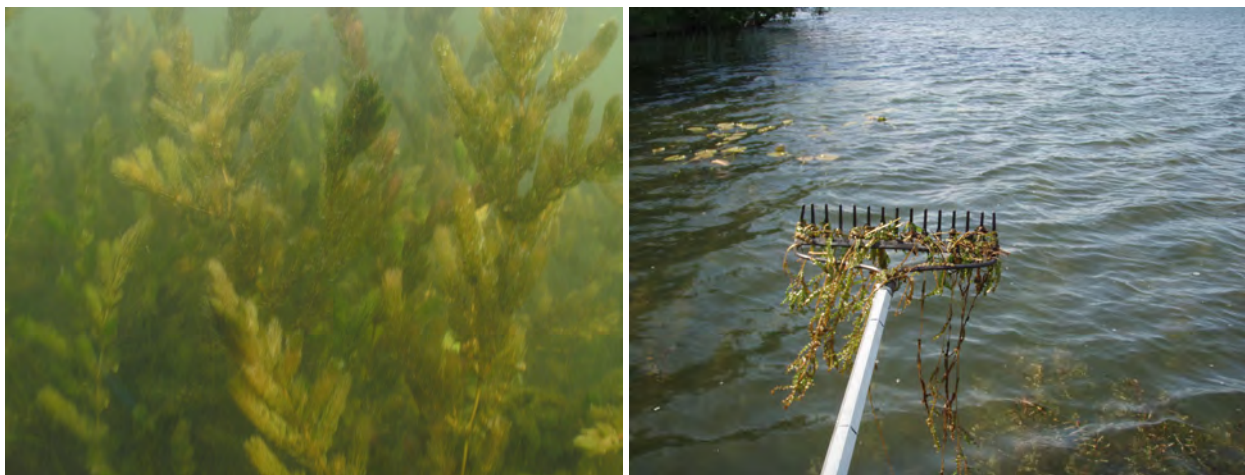
Figure 2. [left] Coontail was the most abundant plant in the survey. [right] Curlyleaf pondweed at Site 9 on June 13, 2011.

Curlyleaf at Site 9 had moderate to heavy growth. This type of growth is sometimes controlled.

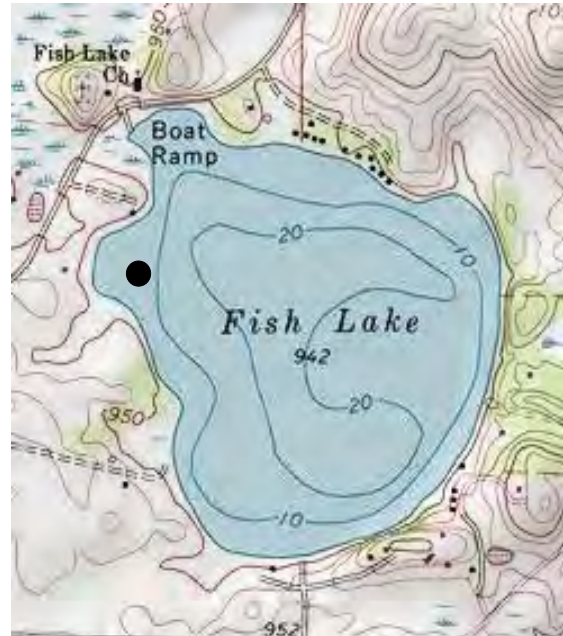
Figure 3. Underwater monitoring site (shown with a black dot).

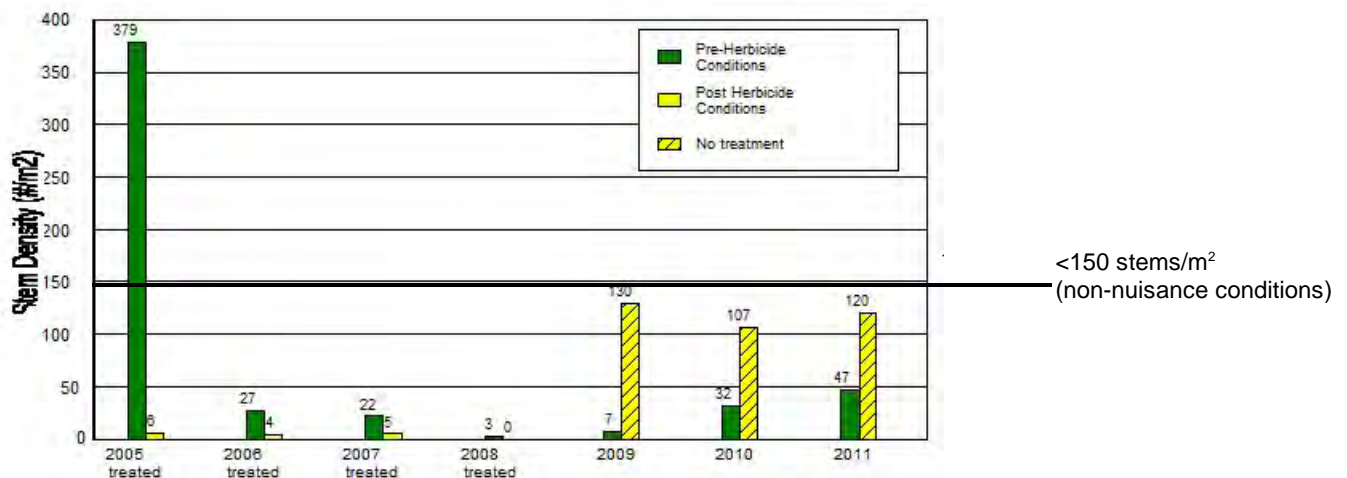
Figure 4. Average of Fish Lake curlyleaf pondweed stem densities for early season and late season conditions in 2005 through 2011 at a 6.0-foot water depth at the monitoring site shown above.

Curlyleaf Pondweed Stem Densities at a Treatment Site: Curlyleaf has been monitored at the same site on early and late season dates from 2005 through 2011 (Figure 3). Curlyleaf stem densities were initially high on April 18, 2005. Curlyleaf was treated within this site for four years (2005-2008). No herbicide was used in 2009, 2010, and 2011. Although the early season stem density was low at 47 stems/m² on May 12, 2011, the next sample date on June 13, 2011, curlyleaf stem density averaged 120 stems/m². Curlyleaf stem density has not exceeded 130 stems/m² since treatments stopped in 2008 (Table 1 and Figure 4).

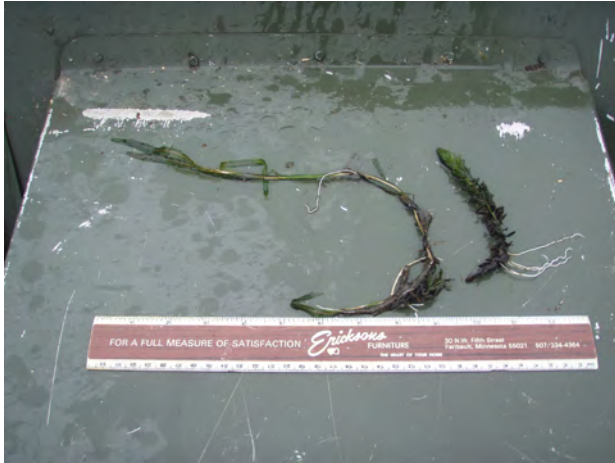
May 12, 2011

Curlyleaf Pondweed Growth Characteristics in 2011 at the Underwater Monitoring Site (monitoring site is shown in Figure 3)

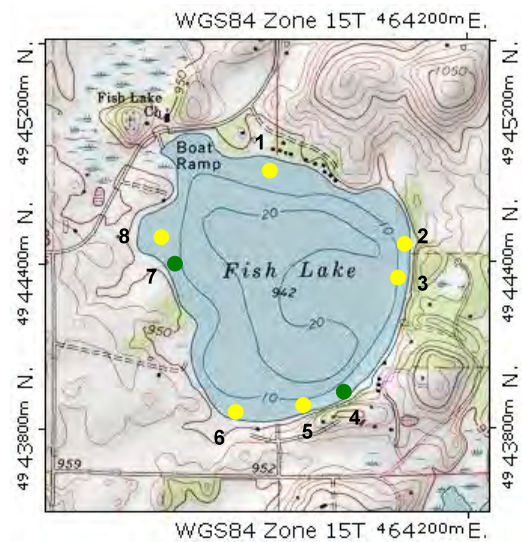
Figure 5. Sediment sample locations are shown with a circle. The circle color indicates the potential for nuisance curlyleaf pondweed to occur at that site. Key: green = light; yellow = moderate;

Without herbicide applications in Fish Lake, curlyleaf pondweed growth is predicted to produce mostly light to moderate growth (where plants occasionally top out) for a number of locations around Fish Lake (Figure 5).

Light to moderate growth typically is a non- nuisance condition. Non- nuisance growth refers to curlyleaf growth that is mostly below the surface and is not a recreational nor an ecological problem. Heavy growth refers to nuisance matting curlyleaf pondweed. This is the kind of nuisance growth predicted by high sediment pH and a low iron to manganese ratio. A chart showing the three types of growth conditions is shown on the next page.

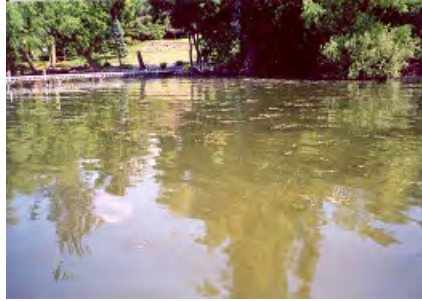
Light Growth Conditions

Biomass: 0 - 50 g-dry wt/m²

Estimated TP loading: <1.7 lbs/ac

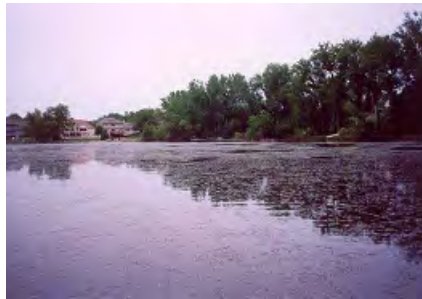
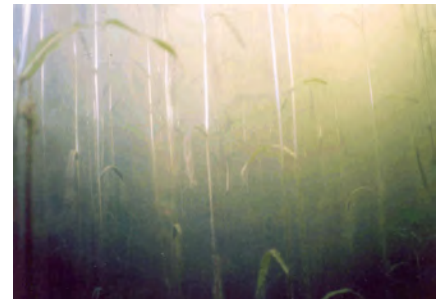
Moderate Growth Conditions

Broken surface canopy conditions.

Biomass: 50 - 85 g-dry wt/m²

Estimated TP loading: 2.2 - 3.8 lbs/ac

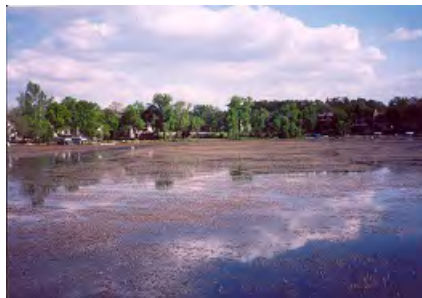
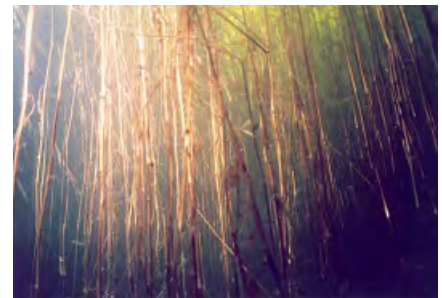
Heavy Growth Conditions

Solid or near solid surface canopy conditions.

Control is necessary for navigation and/or recreation.

Stem density: 400+ stems/m²

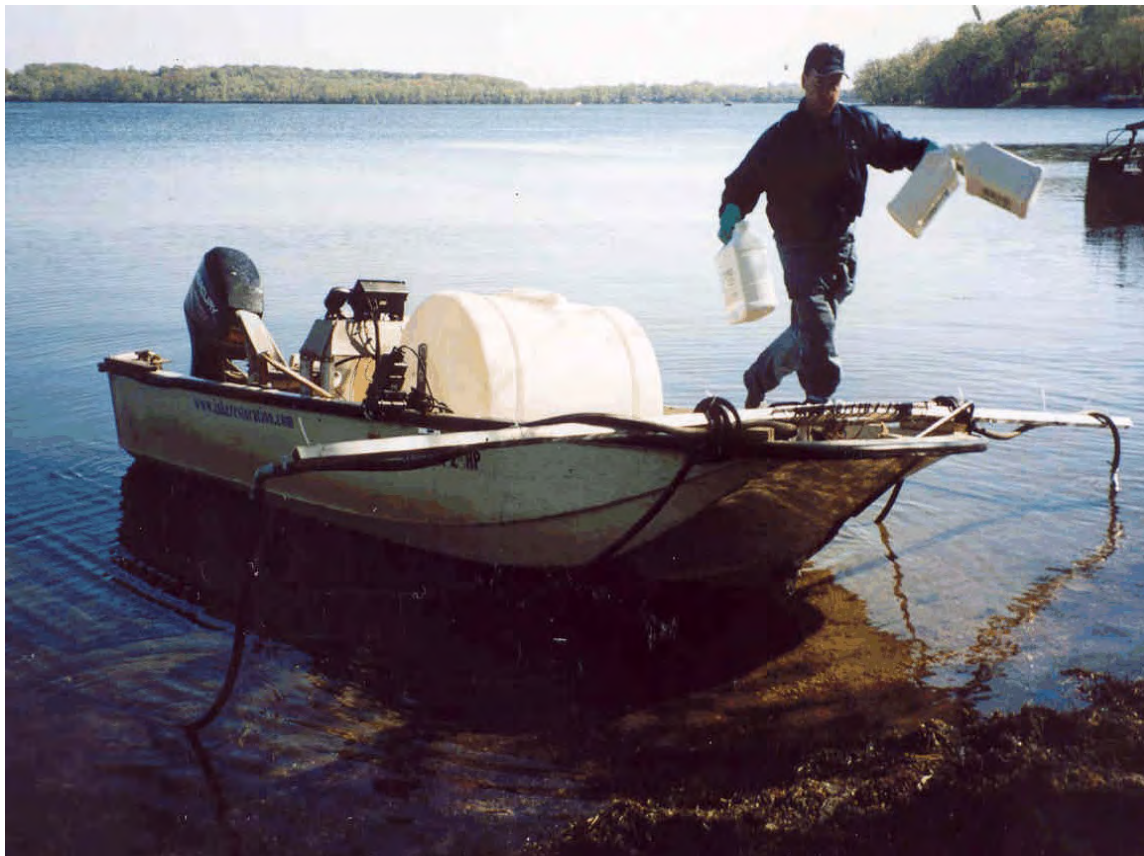
Figure 1. Herbicides were applied to a 15-acre area from 2005 through 2008. No herbicides were applied in 2009, 2010, or 2011.

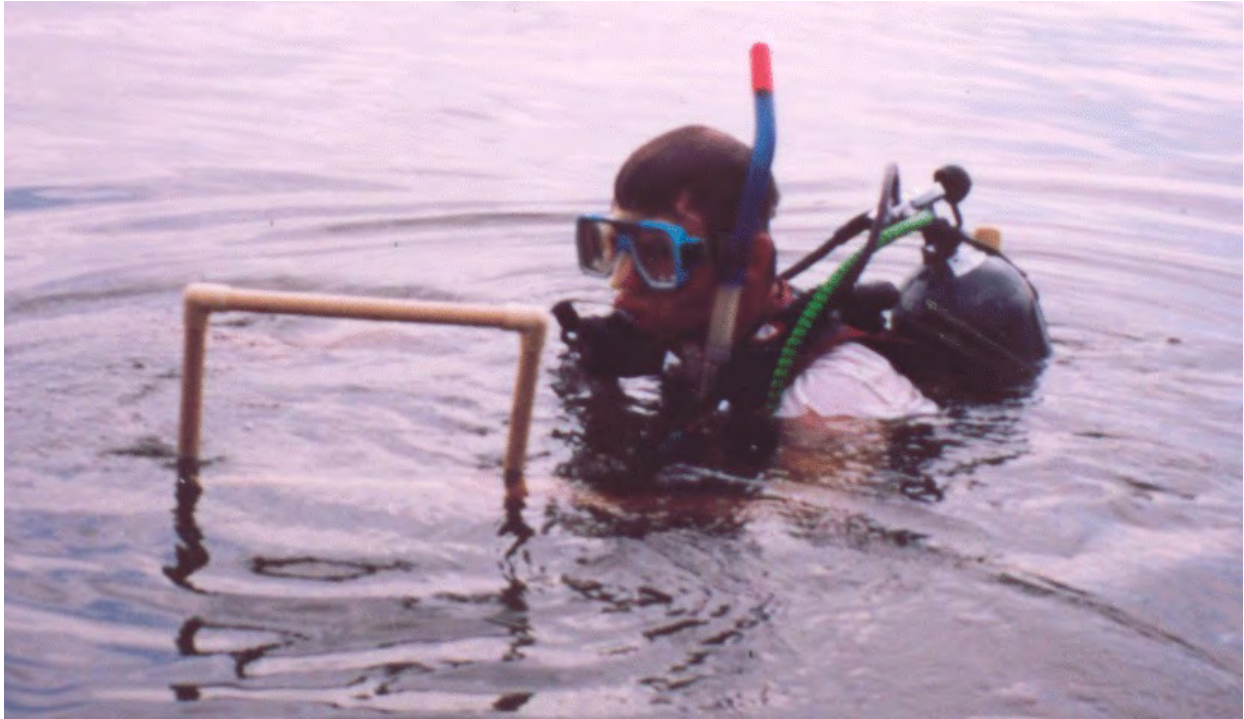
Figure 3. A 0.10 m² quadrat was used to quantify curlyleaf stem densities.

Curlyleaf Stem Density Methods: In 2011, one depth (5-6 feet) was sampled at one site on two sample dates. At the site, a total of ten curlyleaf stem density samples were taken using a 0.10 m² quadrat (Figure 3). The stem density samples were randomly collected along a 50 meter transect line that ran parallel to the shoreline at each station. Other plant species were also counted if present. The counts were made by scuba diving.

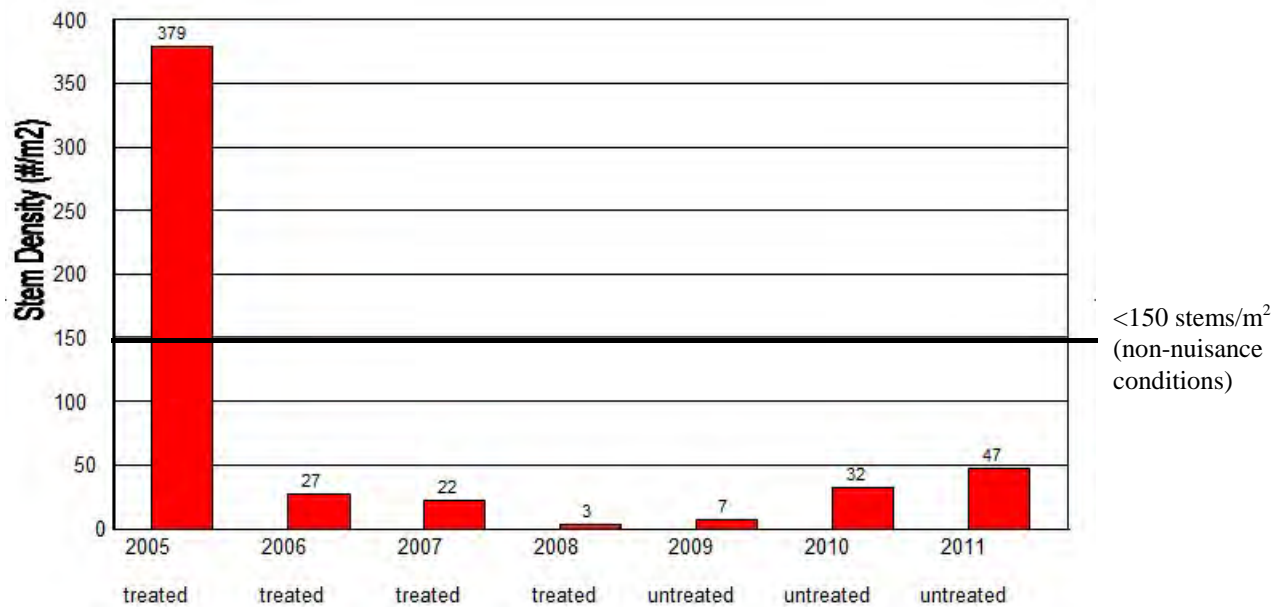
Figure 5. Curlyleaf stem densities for early season monitoring (using scuba diving) for 2005-2011.

Curlyleaf stem densities were determined by scuba diving at a location between sample sites 4-5 (Figure 1). Ten quadrat samples were taken at this location. The results for 2011 show curlyleaf was found at low stem densities (Table 2) but has increased slightly since 2008 (Figure 3). These stem densities were higher compared to densities found in 2008, but are still very low compared to pre-treatment stem densities from 2005 (Figure 5).

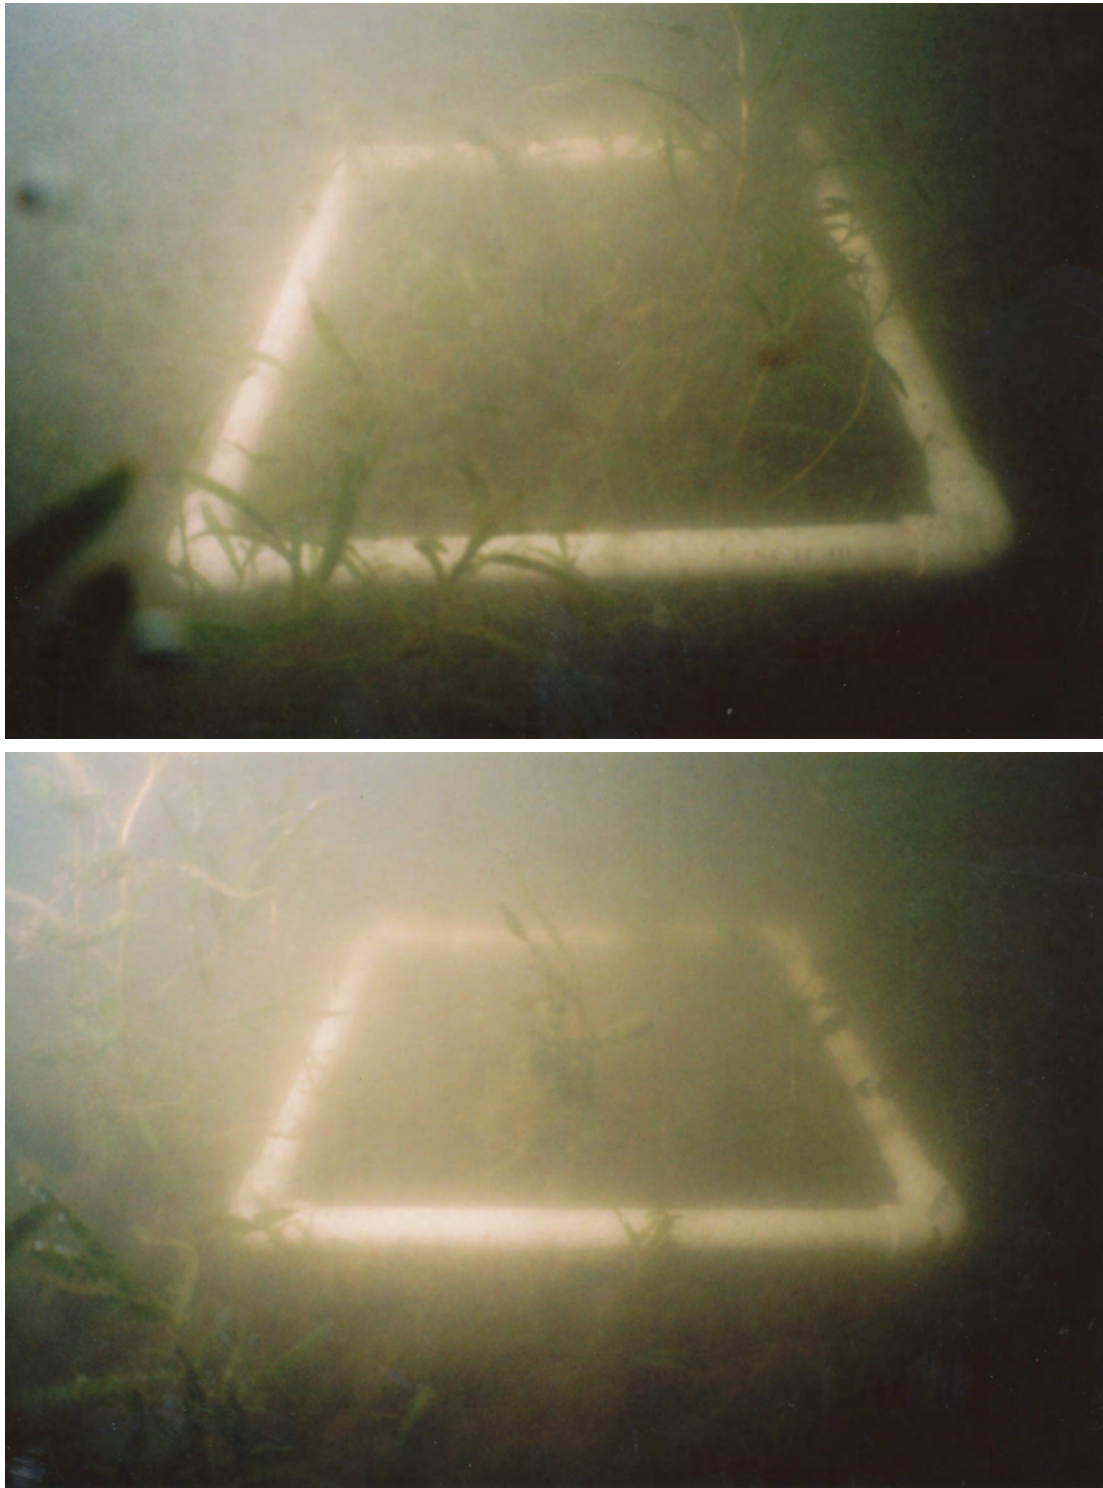
Figure 6. [top] The white frame is a quadrat sampler. All stems within the quadrat are counted. Curlyleaf was found at low densities at the sample sites monitored by scuba diving. [bottom] Curlyleaf pondweed and coontail were found together at 40% of the quadrat samples.

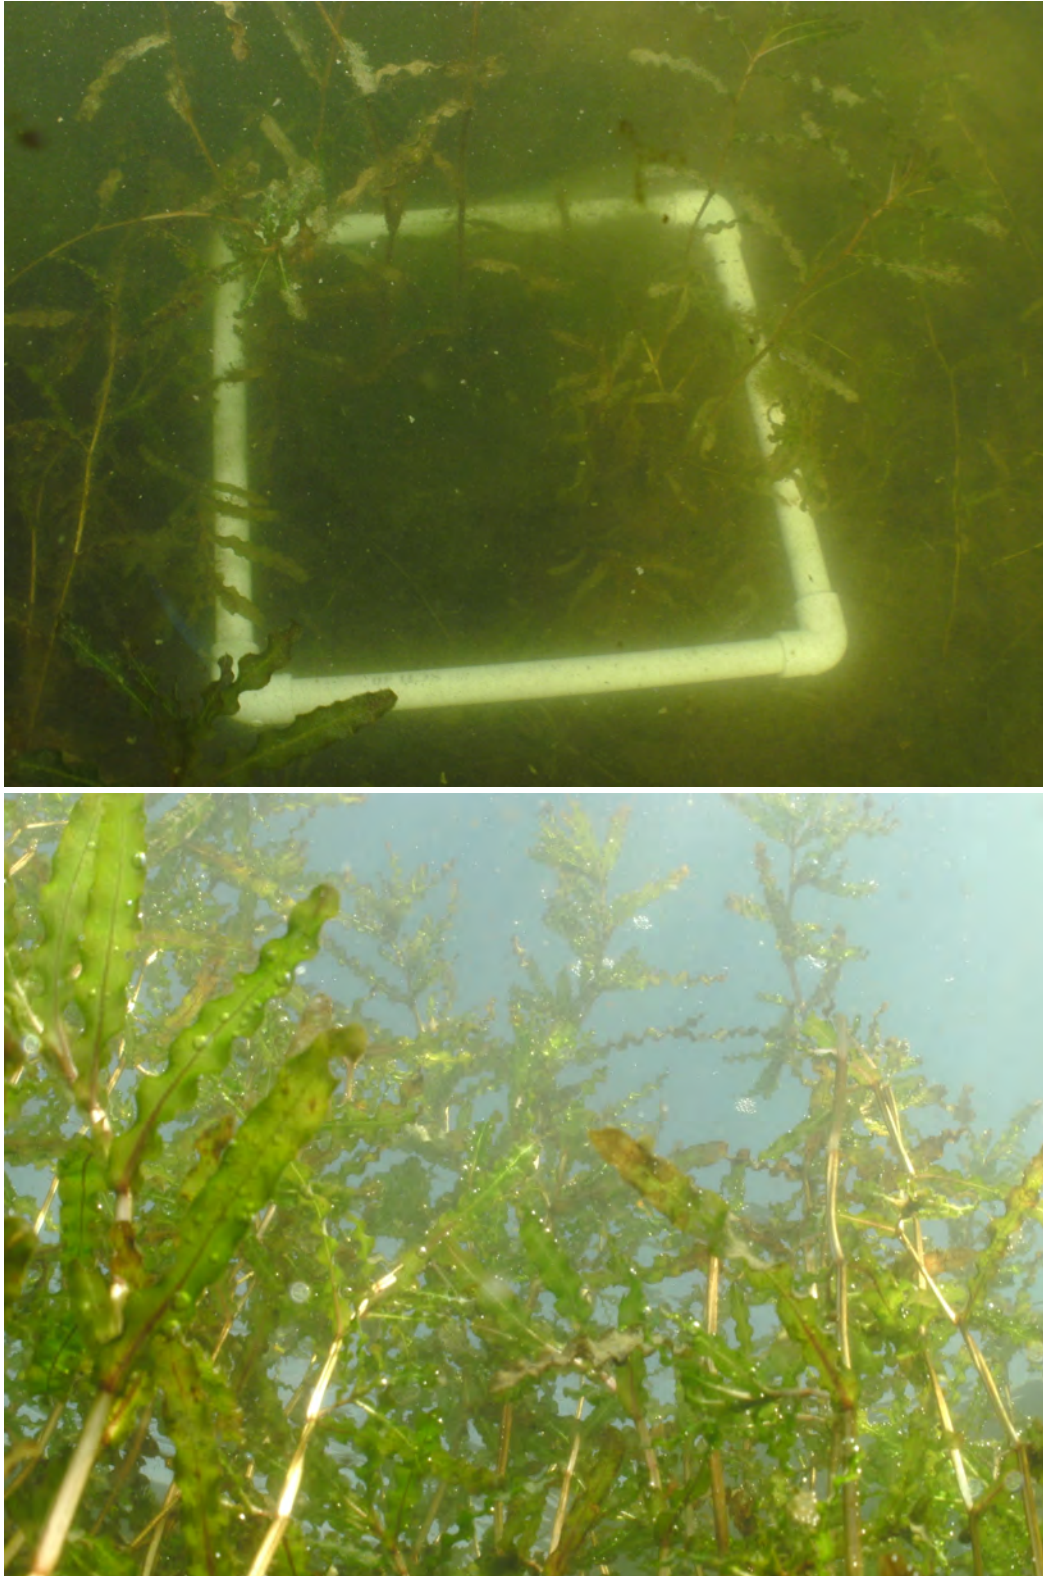
Figure 8. [top] The white frame is a quadrat sampler. All stems within the quadrat are counted. Curlyleaf was found at low densities at the sample sites monitored by scuba diving. [bottom] Curlyleaf pondweed was reaching within a couple of feet of the water surface in a couple of sites.

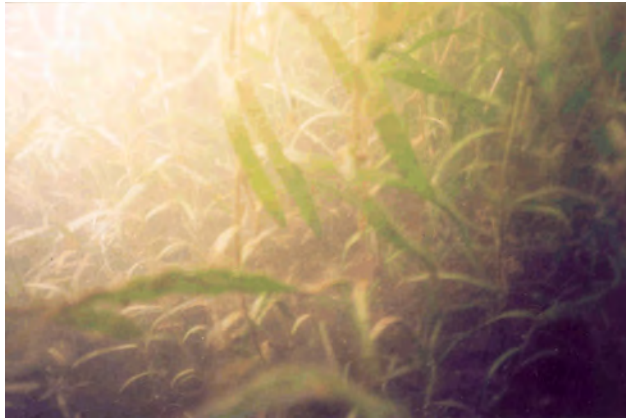
April 18, 2005

Subsurface Curlyleaf Pondweed Conditions in Fish Lake in 2005, 2006, 2007, 2008, 2009, 2010, 2011

Conclusions: At the curlyleaf monitoring site used in this study, prior to a herbicide application in 2005, curlyleaf stem densities were recorded at an average stem density of 379 stems/m². This would put curlyleaf growth into the moderate to heavy growth category. After one season of an herbicide treatment program (in 2005), curlyleaf stem densities were dramatically reduced the following season (2006) in Fish Lake. Stem densities in April of 2006 (prior to the 2006 herbicide treatment) were 27 stems/m².

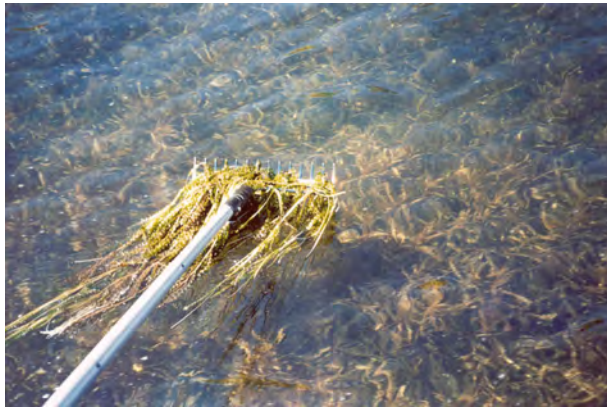
Curlyleaf Pondweed Conditions in early June in 2003 and 2005-2011

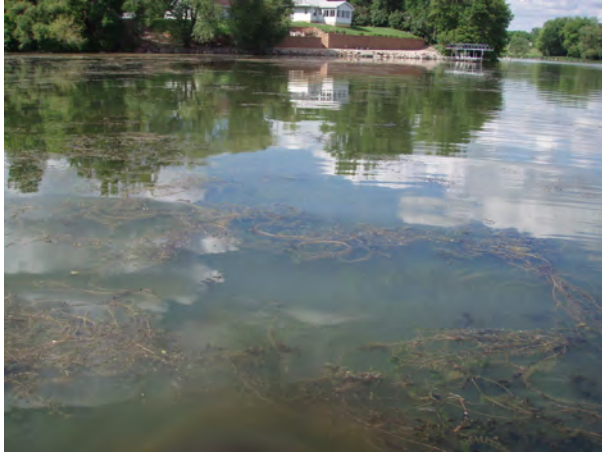
2010

Curlyleaf Pondweed Conditions in early June in 2003 and 2005-2011

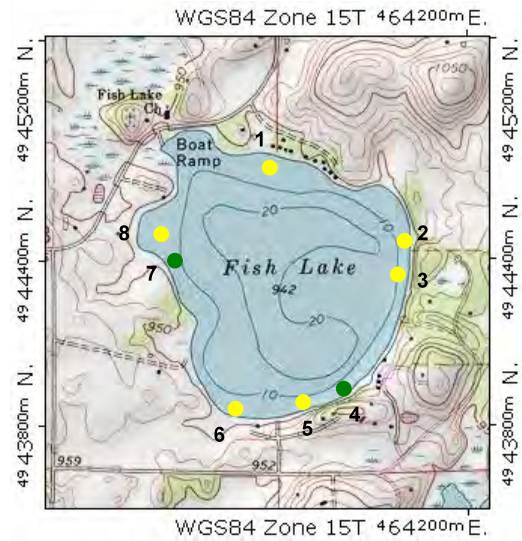
Figure 10. Sediment sample locations are shown with a circle. The circle color indicates the potential for nuisance curlyleaf pondweed to occur at that site. Key: green = low; yellow = medium; red = high potential.

If herbicide applications were to stop in Fish Lake, curlyleaf pondweed growth is predicted to produce mostly light nuisance growth (where plants occasionally top out) for a number of locations around Fish Lake (Figure 10).

Light nuisance growth has intermediate growth characteristics between non-nuisance and nuisance growth. Non-nuisance growth refers to curlyleaf growth that is mostly below the surface and is not a recreational nor an ecological problem. Heavy growth refers to nuisance matting curlyleaf pondweed. This is the kind of nuisance growth predicted by high sediment pH and a low iron to manganese ratio. A chart showing the three types of growth conditions is shown on the next page.

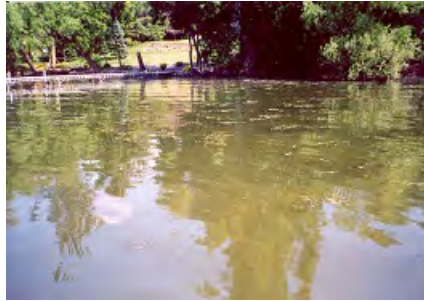
Biomass: 0 - 50 g-dry wt/m²

Estimated TP loading: <1.7 lbs/ac

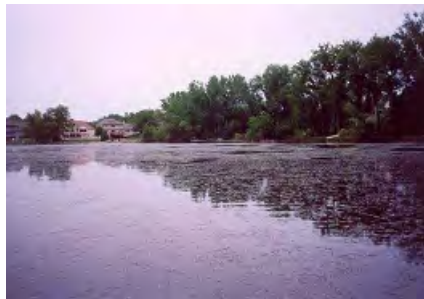
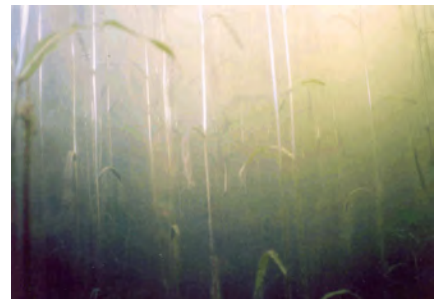
Moderate Growth Conditions

Broken surface canopy conditions.

Biomass: 50 - 85 g-dry wt/m²

Estimated TP loading: 2.2 - 3.8 lbs/ac

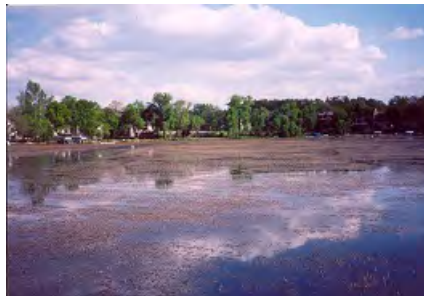
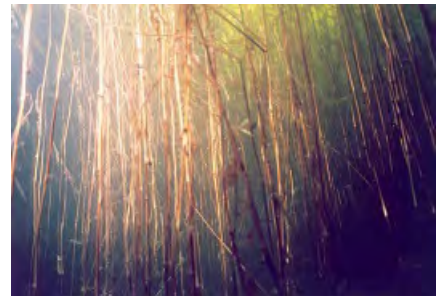
Heavy Growth Conditions

Solid or near solid surface canopy conditions.

Control is necessary for navigation and/or recreation.

Stem density: 400+ stems/m²
