# Aquatic Plant Point Intercept Survey for Buck Lake, Scott County, Minnesota

Point Intercept Plant Survey Conducted September 1, 2021

Prepared for:  
Prior Lake-Spring Lake  
Watershed District

Prepared by:  
Steve McComas  
Jo Stuckert  
Blue Water Science

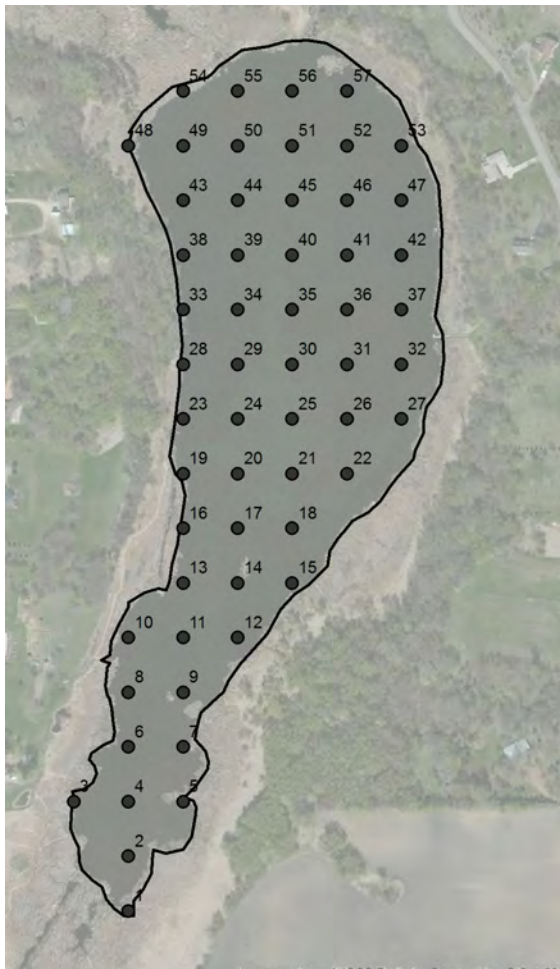
Figure 2. Sample locations for the point intercept survey site map.

One survey was conducted on Buck lake in 2021. An aquatic plant point intercept survey of Buck Lake was conducted by Blue Water Science on September 1, 2021 and 57 points were sampled. Sample points were placed 50 meters apart on a grid that covered the lake (Figure 2).

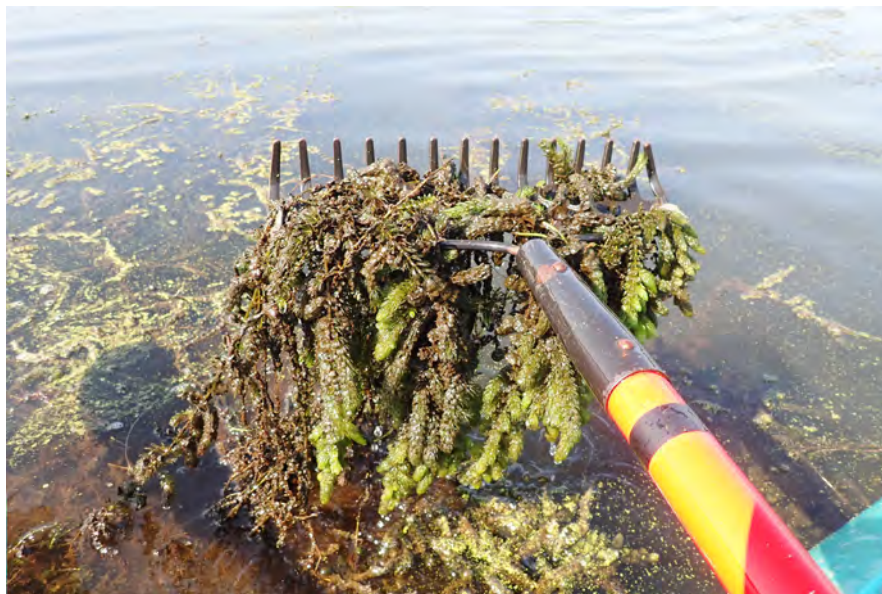
**Figure 3. A mix of submerged aquatic plants on a sample rake. Coontail was the dominant plant.**

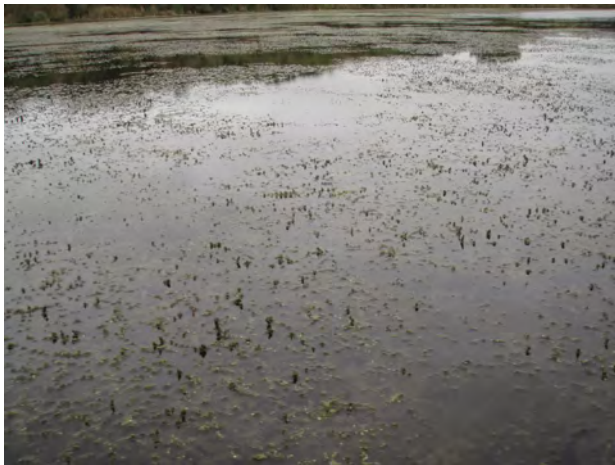
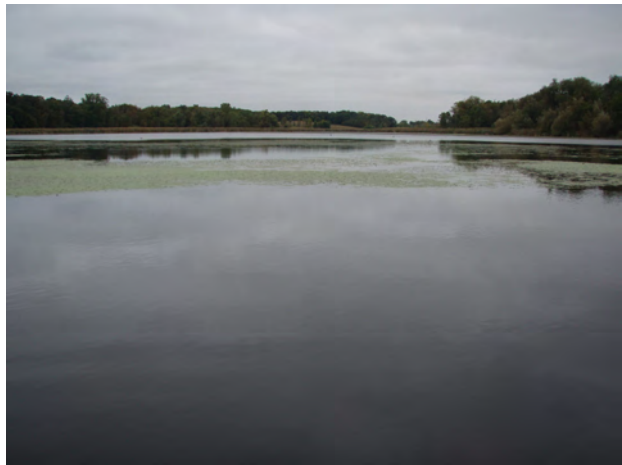
**Figure 5. [left] Coontail was found growing to the surface in some areas of Buck Lake on September 16, 2010.**

**[right] Buck Lake plant conditions on September 16, 2010. Some plants were growing to the surface.**

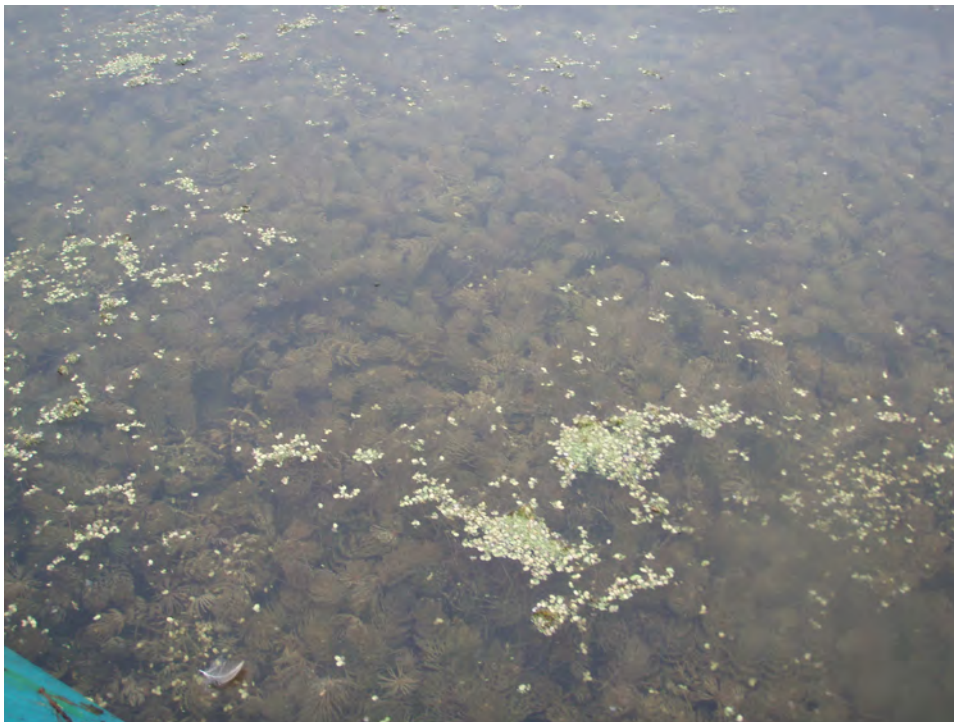
**Figure 6. Buck Lake has fairly good water clarity, especially in areas with thick coontail growth. Duckweed (shown floating on the water) was common as well.**

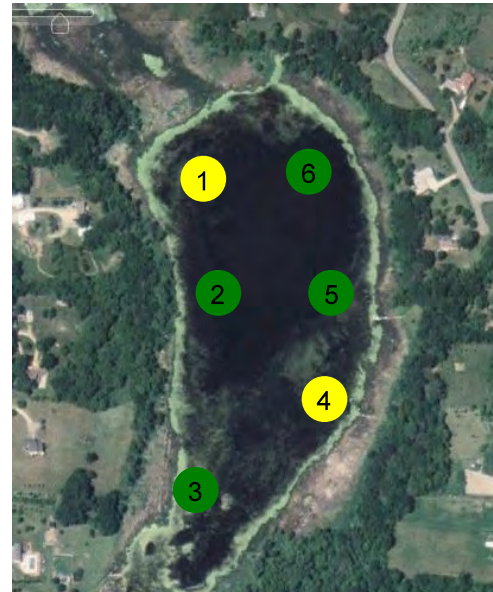
Curlyleaf pondweed growth is predicted to produce mostly low to moderate nuisance growth (where plants top out) at only several locations (Figure 7).

**Figure 7. Curlyleaf pondweed growth is predicted to be light to moderate based on lake sediment characteristics. Green circles = light growth and yellow circles = moderate growth.**

Lake sediment sampling results from 1997 have been used to predict lake bottom areas that have the potential to support nuisance curlyleaf pondweed plant growth. Based on the key sediment parameters of pH, sediment bulk density, organic matter, and the Fe:Mn ratio (McComas, unpublished), the predicted growth characteristics of curlyleaf pondweed are shown in Table 6 and Figure 7.

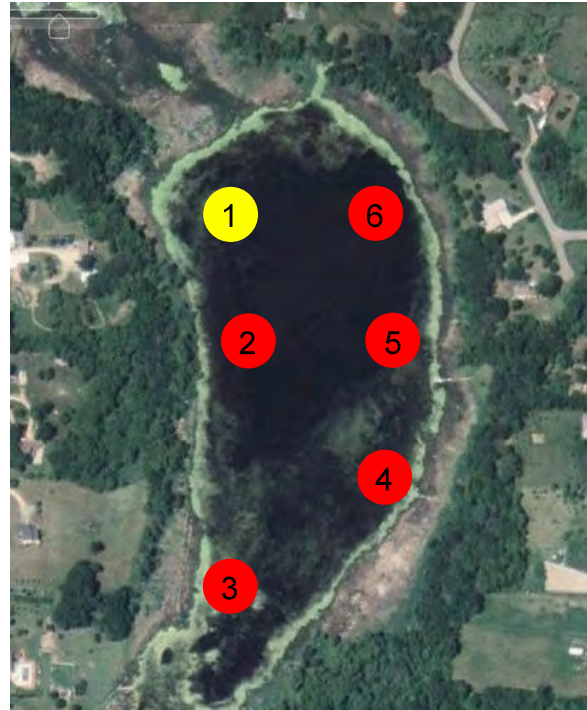
**Figure 8. Eurasian watermilfoil growth is predicted to be moderate to heavy. Yellow circle = moderate growth and red circles = heavy growth.**

Based on results from other lakes we predict that the combination of high organic matter and high nitrogen values (greater than 10 ppm as exchangeable ammonium) will sustain nuisance milfoil growth on an annual basis unless some other factor limits growth. Limiting factors include things such as milfoil weevils, light penetration, and other unknown variables. When lake bottom areas have moderate fertility (less than 6 ppm of exchangeable nitrogen), we predict there is the potential to support nuisance growth in some years, but not on a continuous basis.
