LOWER PRIOR LAKE: 2024 Water Quality Report Card

LOWER PRIOR LAKE: Project Highlight

Prior Lake Outlet Pipe Pipe-Lining

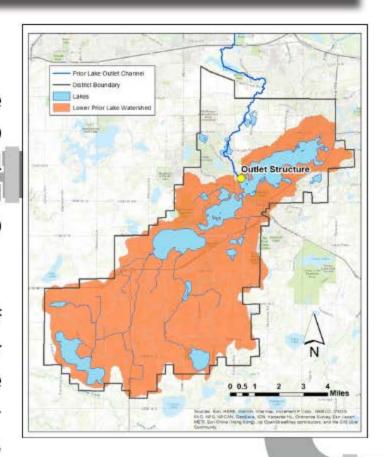
The Prior Lake Outlet Channel (PLOC) is the only relief valve for the naturally landlocked Prior Lake watershed, making it essential to flood reduction. The first section of the Prior Lake Outlet Channel (PLOC) is a 0.4 mile long pipe. Water from run-off, streams, and lakes across over 30 sq. miles drain through this pipe (see map to the right).
