Curlyleaf Pondweed and Eurasian Watermilfoil Delineations and Assessments in Spring Lake, Scott County, Minnesota, 2024

Curlyleaf Pondweed Delineation: April 17, 2024
Curlyleaf Pondweed Treatment: May 3, 2024 (19.34 ac)
Curlyleaf Pondweed Assessment: May 20, 2024
EWM Assessment: July 23, 2024

Prepared for:
**Spring Lake Association
and Prior Lake/Spring
Lake Watershed District**

Prepared by:
**Steve McComas
Jo Stuckert
Connor McComas
Blue Water Science
St. Paul, MN 55116**

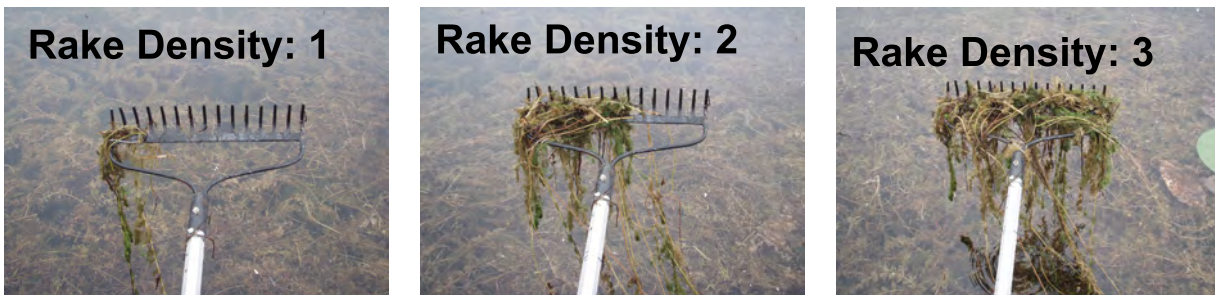
Figure 1. Aquatic plant density ratings from 1 to 3.

At each meandered sample point, a sampling rake was lowered into the water and a plant sample was taken. The plant species were recorded and the density of each species was assigned. Densities were based on the coverage on the teeth of the rake. Density ratings ranged from 1 to 3 with 1 being sparse and 3 being heavy growth (Figure 1). Based on these sample sites, a plant distribution map was constructed.

A CLP assessment and EWM delineation was conducted by Blue Water Science on May 20, 2024. The assessment is a post-treatment evaluation, it involved surveying the entire lake nearshore area, observing CLP growth, and sampling aquatic plants with rakes. The plant species were recorded and the density of each species was assigned. Densities were based on the coverage on the teeth of the rake. Density ratings were from 1 to 3 with 1 being sparse and 3 being a nuisance. Plant density chart is shown below.

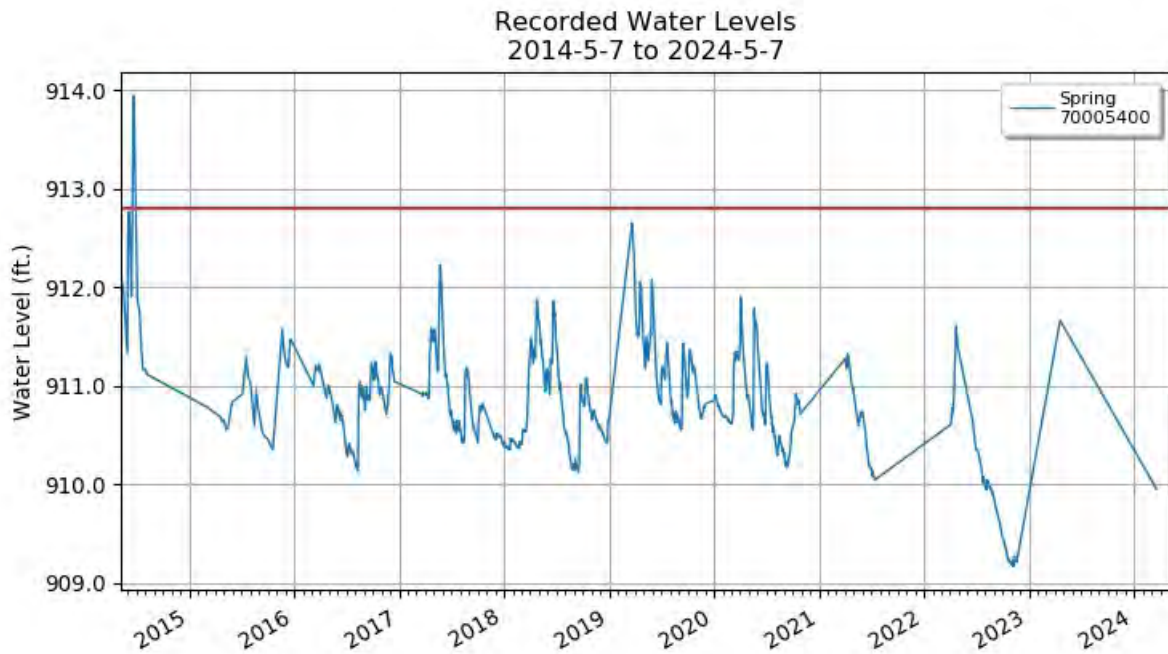
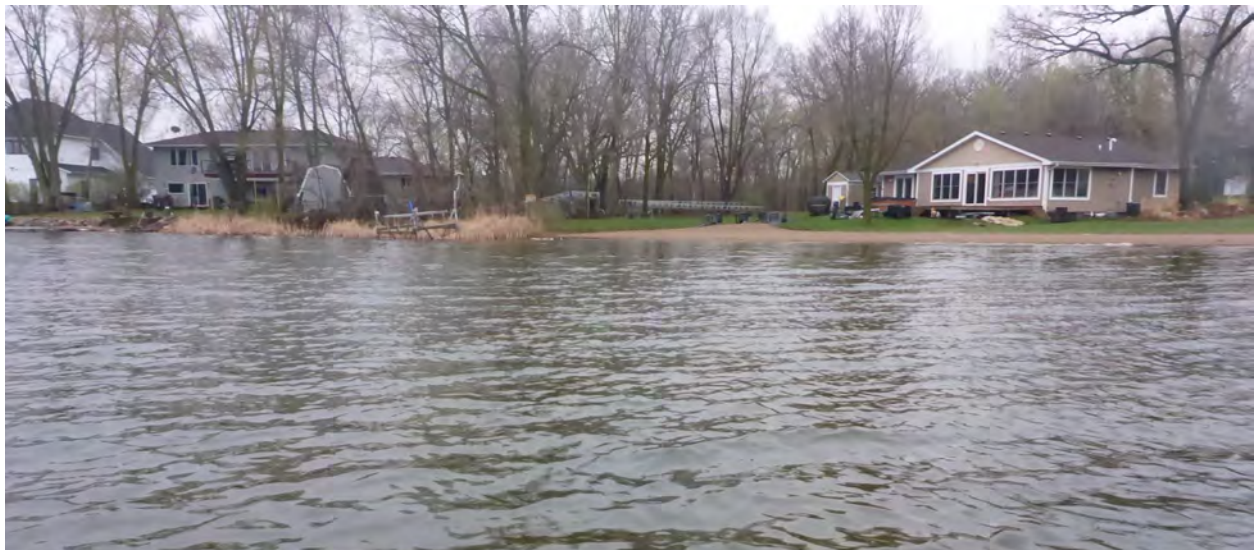
Figure 6. [top] Spring Lake water levels since 2015. [bottom] Shoreline of Spring Lake showing extended sandy shores.

Lake Water Levels: The water levels in Spring Lake in the early summer of 2023 and 2024 were some of the lowest since 2015 (Figure 6). Delineating nearshore curlyleaf pondweed on April 17, 2024 was challenging due to the low water levels. We sampled to water depths of approximately 2 feet in the riparian (0-150 feet from shore). No treatable CLP was found in the riparian zone.
