BUCK LAKE: 2024 Water Quality Report Card

BUCK LAKE: Project Highlight

Buck Stream Restoration

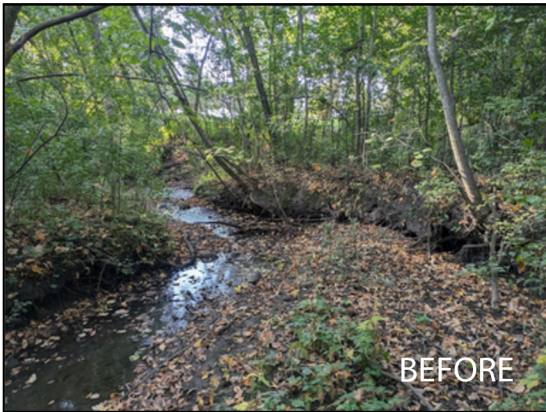
BEFORE

Buck Stream, a tributary flowing into the east side of Buck Lake, is one of the few remaining streams in the Prior Lake area that retains its natural character. It winds through wetlands, woodlands, and riffles, supported by vegetated banks. However, the stream eroded beyond its natural floodplain—an essential "ground sponge" that absorbs floodwaters. This erosion led to 76 tons of sediment and excess nutrients washing into Buck Lake each year, turning the water brown and harming its quality. Without intervention, the stream would have continued to degrade, further impacting Buck Lake.

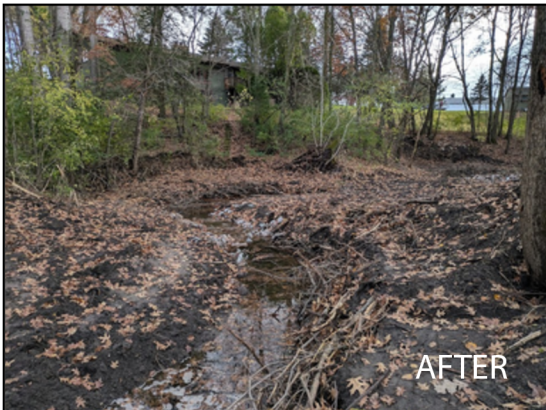
AFTER

In fall 2024, the Watershed District, Scott SWCD, and two landowners partnered to restore 1,300 crucial feet of Buck Stream with support from the Clean Water Fund. The project replaced invasive buckthorn dominating the banks with native plants, which will emerge in Spring 2025, to stabilize the stream and improve habitat. The Watershed District hopes to restore additional sections of the stream as more grant funding becomes available.
