# Aquatic Plant Point-Intercept Survey for Crystal Lake, Scott County, Minnesota

[Plant Survey Conducted September 1, 2016]

Prepared for:  
Prior Lake-Spring Lake  
Watershed District

Prepared by:  
Steve McComas  
Jo Stuckert  
Blue Water Science

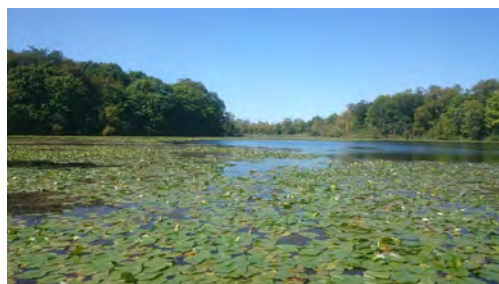
**Figure S1. White water lilies were common in Crystal Lake.**

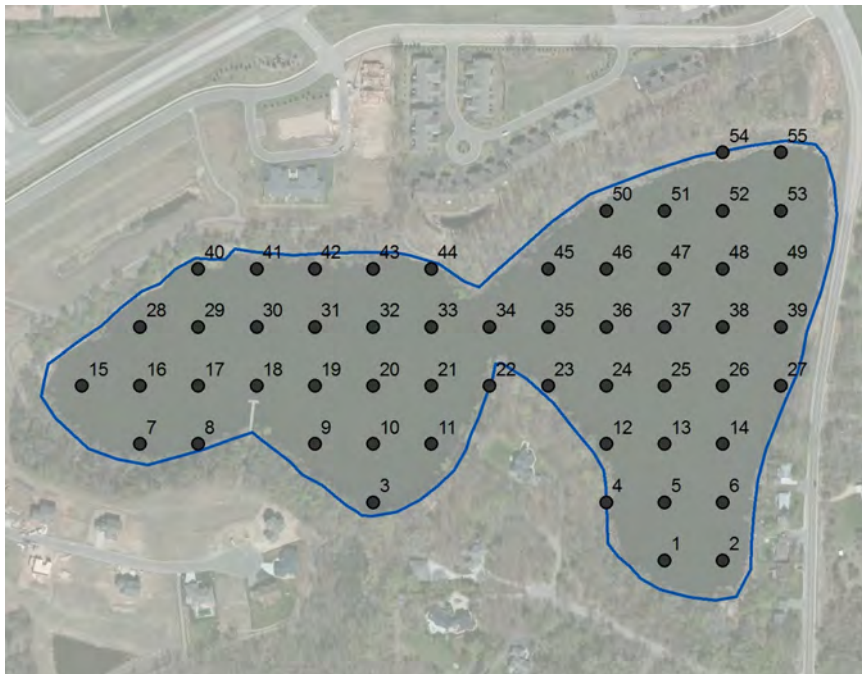
An aquatic plant point-intercept survey of Crystal Lake was conducted by Blue Water Science on September 1, 2016 and 55 points were sampled. Sample points were placed 50 meters apart on a grid that covered the lake (Figure 1). At each sample point, a sampling rake was lowered into the water and a plant sample was taken. The plant species were recorded and the density of each species was assigned. Densities were based on the coverage on the teeth of the rake. Density ratings were from 1 to 5 with 1 being sparse and 5 being a nuisance. Based on these sample sites, a plant distribution map was constructed.

Figure 1. Sample location map for the aquatic plant survey conducted on Crystal Lake.

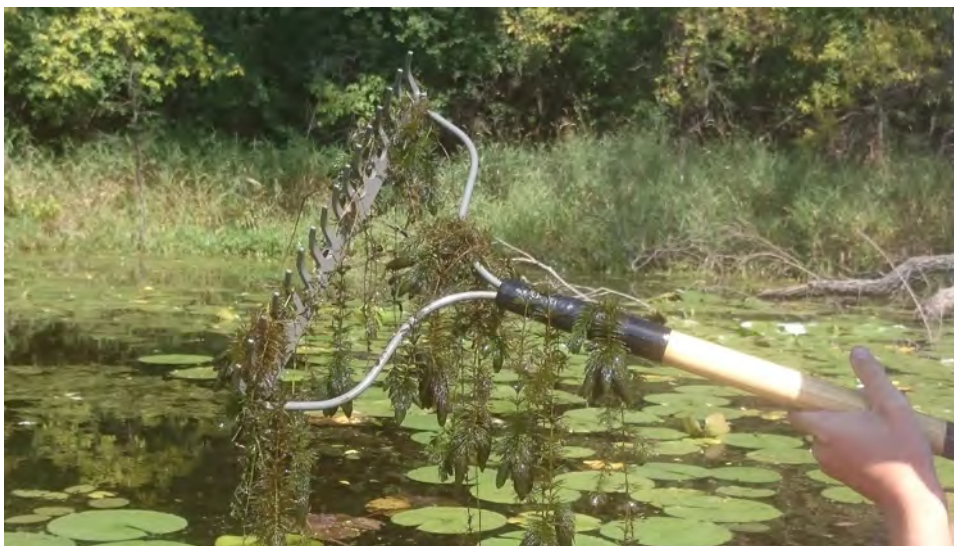
Results of the summer aquatic plant survey conducted on September 1, 2016 found there were 5 submerged plants (Table 1)(Figure 2). Coontail was the dominant aquatic plant.

**Figure 2. Coontail was the most common plant found in Crystal Lake in 2016.**

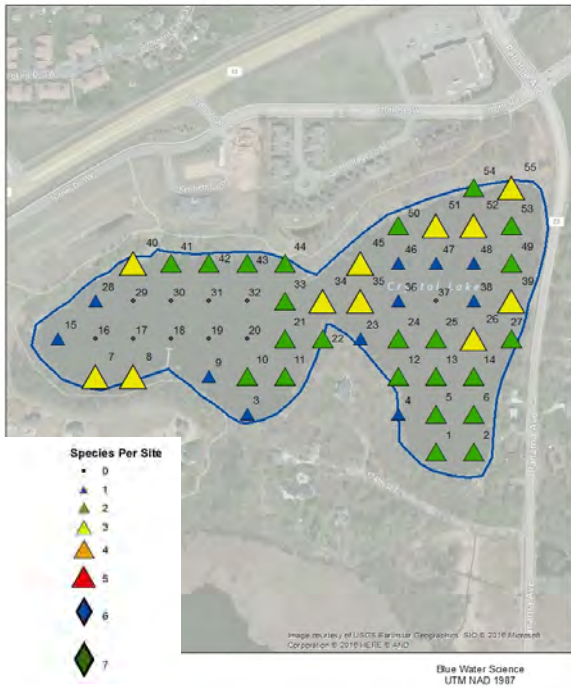
Crystal Lake Species Richness  
September 1, 2016

Eurasian watermilfoil was not observed in this survey. However, curlyleaf pondweed was sampled at 1 location. A species richness map along with distribution maps of 3 dominant aquatic plants are shown in Figure 3.

**Figure 3. Crystal Lake aquatic plant maps.**  
Key: green square = light growth, yellow square = moderate growth, and red square = heavy growth.

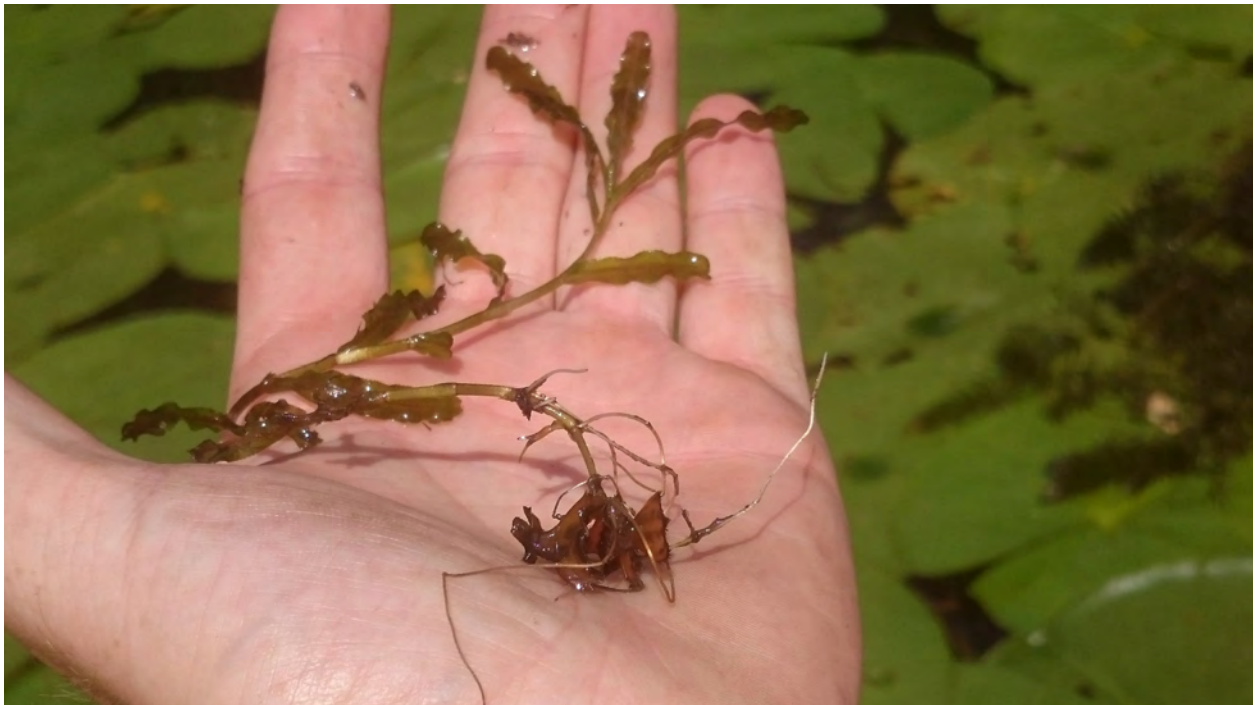
**Figure 4. Curlyleaf pondweed was found in Crystal Lake on September 1, 2016.**
